Compliance Recall

Code: 919A

Over-the-Air (OTA) Software Update Available	
USA	YES
CANADA	YES

Corrective Action	<p>Perform a vehicle software update. In addition to the recall remedy, the updated vehicle software may contain enhancements/improvements to some of the vehicle's other systems.</p> <p>Dealers should update vehicles according to the repair instructions in this circular.</p> <p>In January 2025, this software update will also be available Over-the-Air (OTA) for certain customer-owned vehicles.</p>				
Code Visibility	On May 17, 2024, the campaign code was applied to affected vehicles.				
Owner Notification	<p>Owner notification will take place in December 2024. Owner letter examples are included in this bulletin for your reference.</p> <p>Owner notification for the OTA availability will take place via email beginning in December 2024.</p>				
Additional Information	<p>Please alert everyone in your dealership about this action, including Sales, Service, Parts and Accounting personnel. Contact Warranty if you have any questions.</p> <p>IMPORTANT REMINDER ON VEHICLES AFFECTED BY SAFETY & COMPLIANCE RECALLS</p> <p><u>New Vehicles in Dealer Inventory:</u> It is a violation

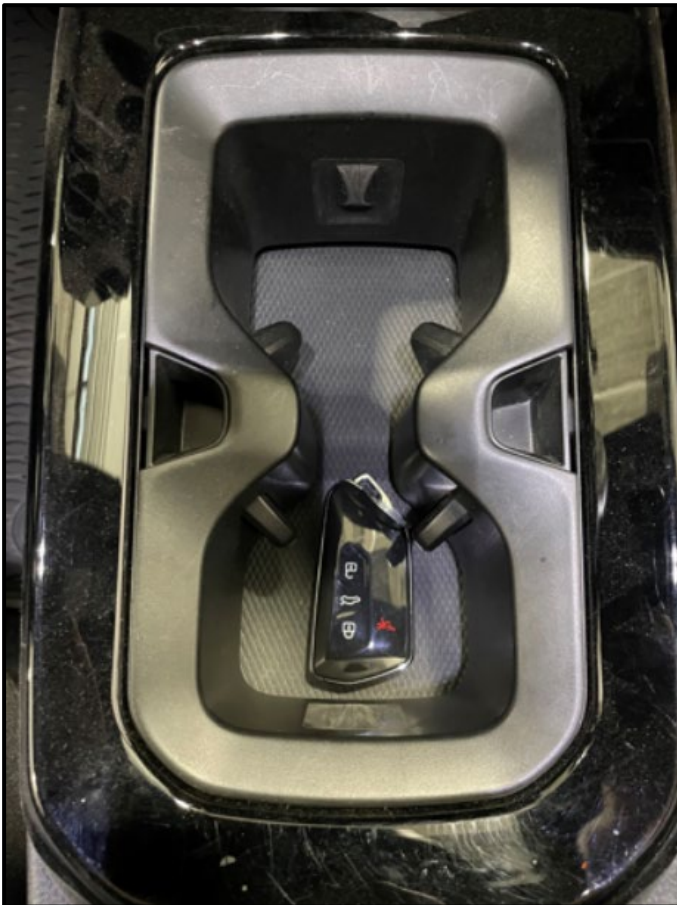
- Place the vehicle key over the reader coil in the center console cup holder.
- Any additional keys must be a minimum of 20 meters away from the vehicle.

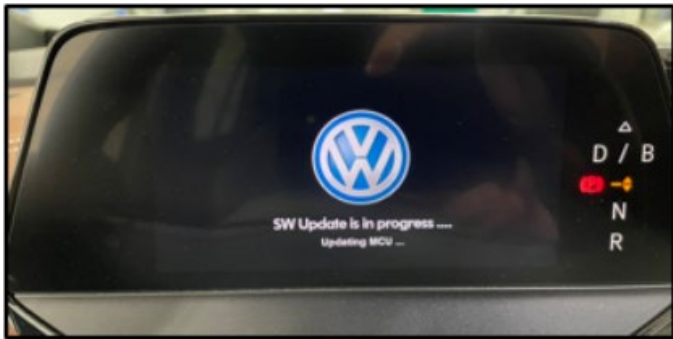
- The update will start on its own after about two minutes.
- During the update, the instrument cluster display will change multiple times.

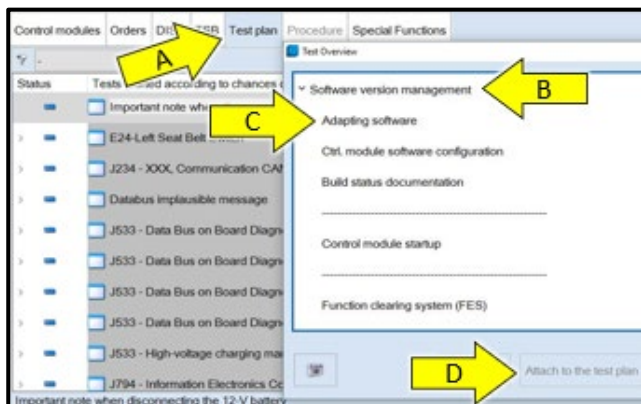
- Once the GFF scan is complete, select “Test plan” <arrow A>, then “Software version management” <arrow B>, then “Adapting software” <arrow C>, then select “Attach to the test plan” <arrow D>.
