# Compliance Recall

## Code: 919A

#### Vehicle Software

### Corrective Action

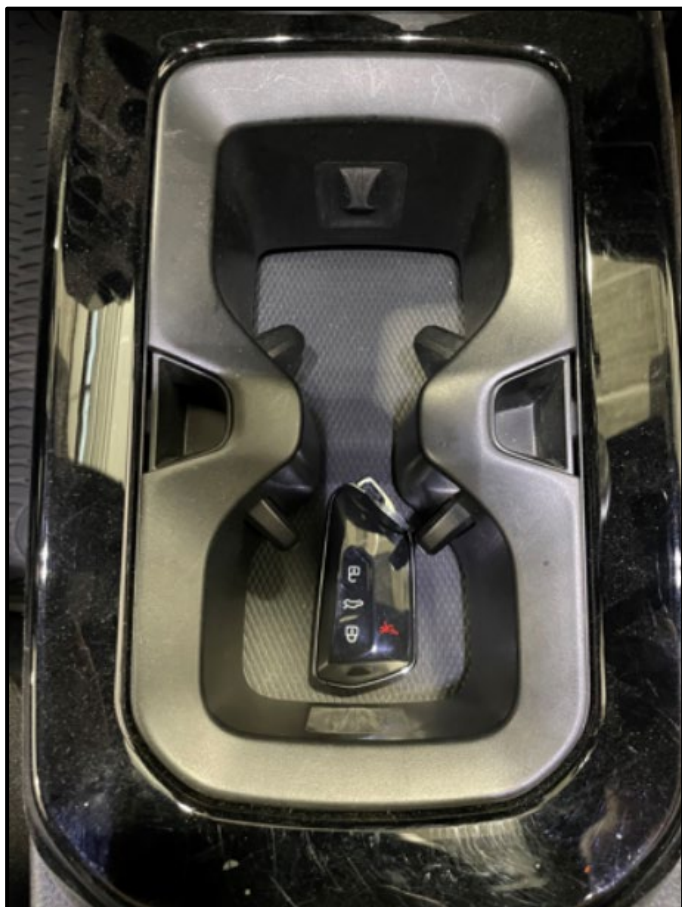
- Place the vehicle key over the reader coil in the center console cup holder.
- Any additional keys must be a minimum of 20 meters away from the vehicle.

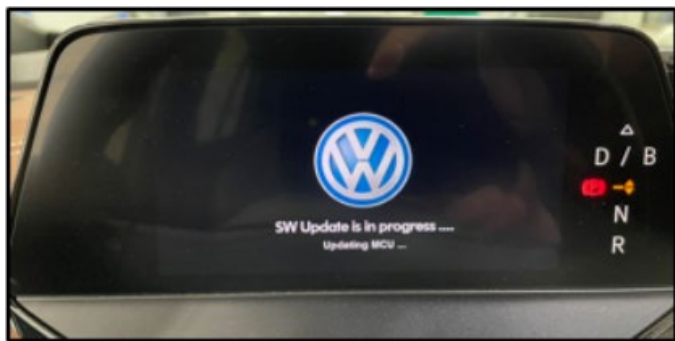
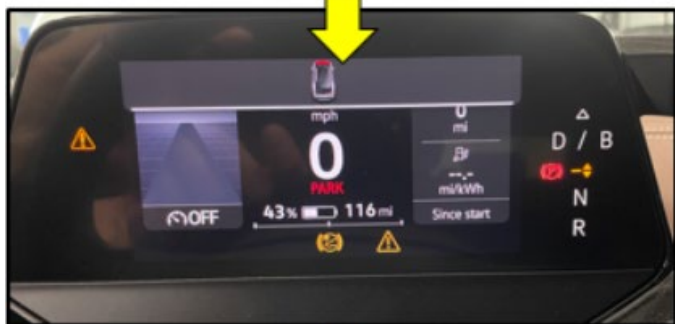
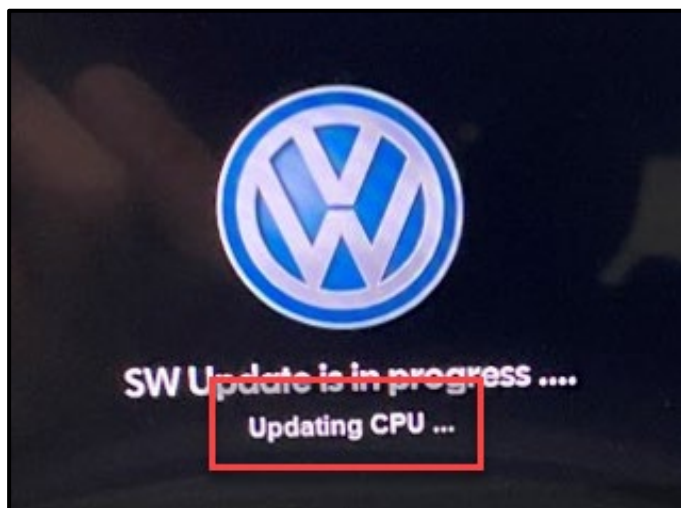
- The update will start on its own after about two minutes.
- During the update, the instrument cluster display will change multiple times.

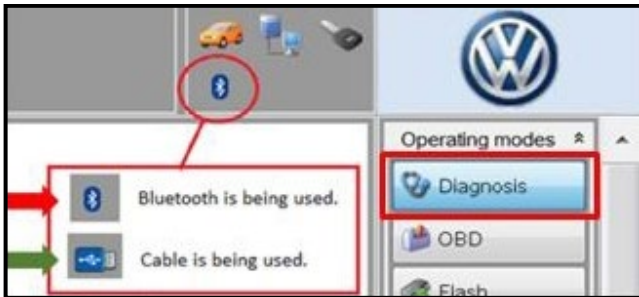
- Turn battery charger OFF, then back ON.
- Connect battery charger.
- **Cycle the ignition OFF, then back ON.**
- Confirm that scan tool is communicating with the diagnostic head by USB <Green Arrow>.
  - If the Bluetooth symbol is shown <Red Arrow> then disconnect the diagnostic head from the vehicle and reconnect the USB cable to the diagnostic head and then reattach to the vehicle.
- Upon ODIS startup, verify the "Diagnosis" operating mode is selected <as shown>.
- Turn the hazards on.

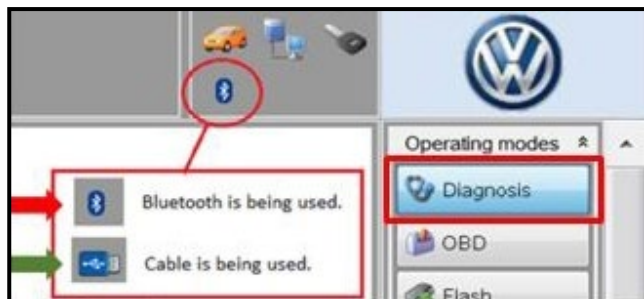
- Turn battery charger OFF, then back ON.
- Connect battery charger.
- Turn the hazards on.
- Confirm that scan tool is communicating with the diagnostic head by USB <Green Arrow>.
  - If the Bluetooth symbol is shown <Red Arrow> then disconnect the diagnostic head from the vehicle and reconnect the USB cable to the diagnostic head and then reattach to the vehicle.
- Upon ODIS startup, verify the "Diagnosis" operating mode is selected <as shown>.
- Once the GFF scan is complete, select "Test plan" <arrow A>, then "Software version management" <arrow B>, then "Adapting software" <arrow C>, then select "Attach to the test plan" <arrow D>.
- Select "Adapting software" <arrow A> from the test plan list.
- Select "Perform test" <arrow B>.
