Vehicle Inspection Procedure and Preparation for Repair

Section B: Repair Procedure Recall 6624E

<u>Section B: Repair Procedure Recall 6724E & SSPD6</u>

6624E, 6724E and SSPD6 REPAIR PROCEDURE

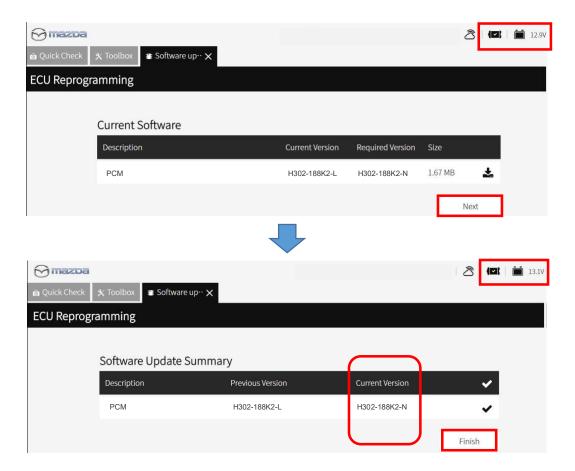
6. After completion of software update, the previous and current software version are shown. Check current version at "Calibration File information" below. Then, click on "Finish" to exit the ECU reprogramming.

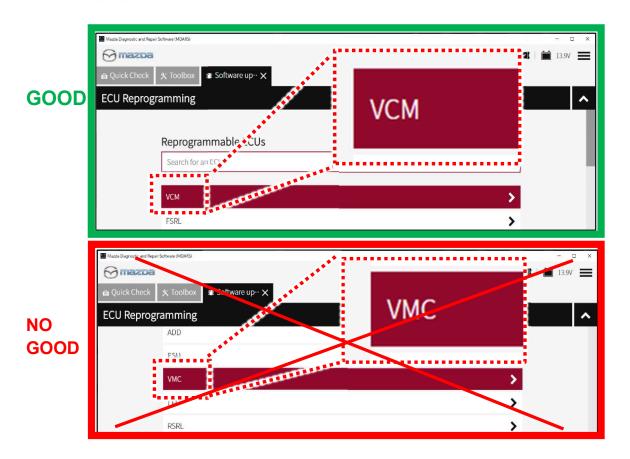
IMPORTANT: VCM and **VMC** modules have similar names but have different functions. When reprogramming, check carefully to avoid making mistakes in the reprogramming module.

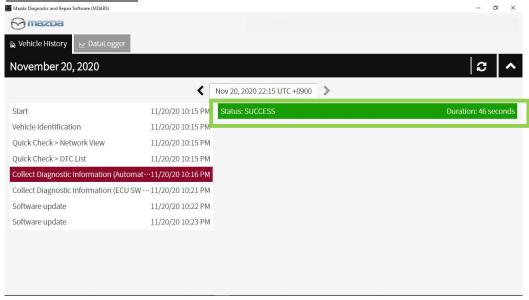
B. Click the 'Collect Diagnostic Information' and the make sure the status is 'SUCCESS' In green. **NOTE:** Verify by selecting 'Collect Diagnostic Information' <u>after all required</u> <u>modules are updated</u>. It is not necessary to confirm the 'Collect Diagnostic Information' after required module reprogram <u>every time</u>.

Only the latest "Collect Diagnostic Information" is the considered valid and that needs to show "SUCCESS"

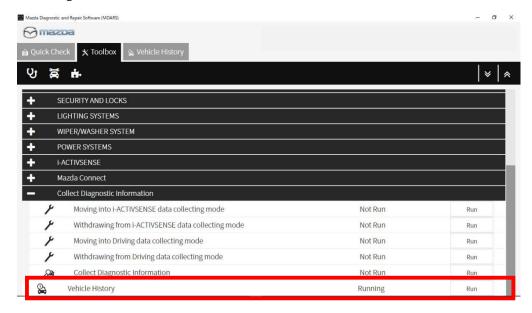
C. 'Collect Diagnostic information' then click 'Run' at the tool box tab.

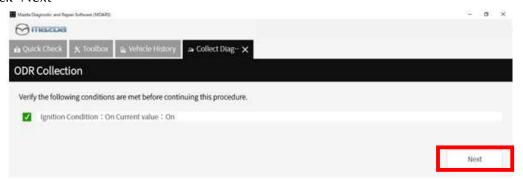
D. Click 'Next'

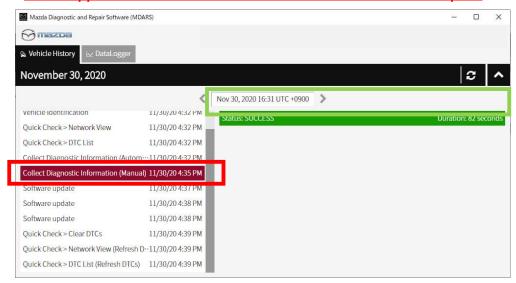
G. Check to make sure "Collect Diagnostic Information (Manual) appears and Status shows 'SUCCESS' in green. <u>If this step is not completed, your warranty claim will not be approved and the customer will need to return for a re-repair.</u>
