Compliance Recall Code: 941L

Subject	Headlamp C	ontrol Unit S	oftware			
Document History	Date			Summary		
	06/06/202	4 Updated	Updated work instructions and claiming information			
	05/29/202	4 Original	Original publication			
Affected Vehicles	Country	Beginning Model Year	Ending Model Year	Vehicle	Vehicle Count	
	USA	2022	2024	Q4 SPORTBACK E-TRON	3,683	
	USA	2022	2024	Q4 E-TRON	14,114	
	CAN	2022	2024	Q4 SPORTBACK E-TRON	236	
	CAN	2022	2024	Q4 E-TRON	4,756	
Problem Description	 Check Campaigns/Actions screen in Elsa on the day of repair to verify that a VIN qualifies for repair under this action. Elsa is the <u>only</u> valid campaign inquiry & verification source. Campaign status must show "open." If Elsa shows other open action(s), inform your customer so that the work can also be completed at the same time the vehicle is in the workshop for this campaign. Affected vehicles were equipped with headlight control module software intended for the EU market that may not comply with U.S. and Canada regulatory requirements. The software exhibits ECE-compliant lighting behavior intended for other markets that affects the parking lamp performance when the headlights are turned on and tu

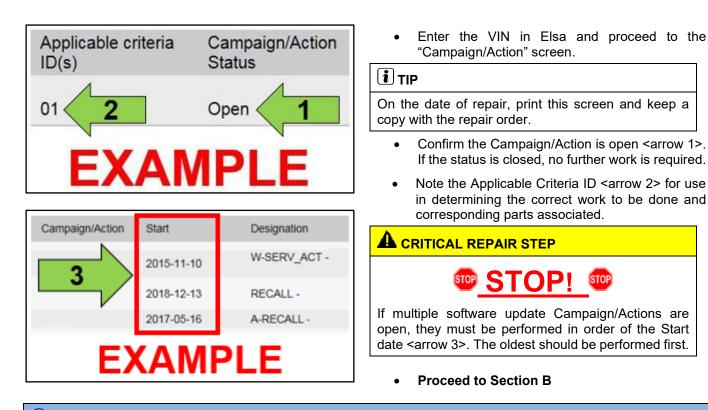
Section A - Check for Previous Repair

- Connect battery charger.
- Switch off all consumers, air conditioning, heater blower motor, lights, heated seats, etc.
- Ensure the latest version of ODIS is downloaded.
- Ensure diagnostic head is connected to ODIS tester via USB cable.
- Move selector lever to P.
- Use operating mode, **DIAGNOSIS**.
- Select "Special Functions".
- Select "SVM Code Input".
- Enter SVM code 941LA016 and follow the on-screen prompts.
- After the SVM has completed, locate the "BCI" numbers on the top of **both** headlamp assemblies <arrow>.
