**May 31, 2024**

Version 1

## Safety Recall: 2019-22 HR-V Audio Unit Improved Software Update

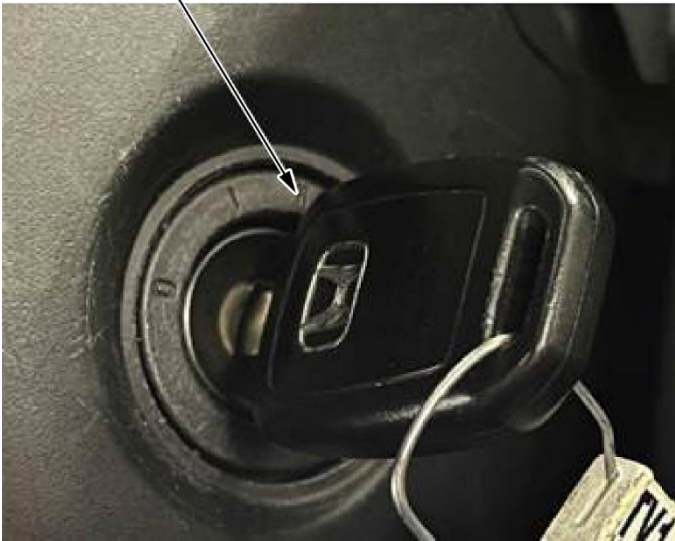
ON (II) POSITION

1. Make sure there are no devices (USB flash drives, smartphones, etc.) connected to the USB port.
2. Connect a Midtronics GR8-1100P AST in **Power Supply Mode**, or the Midtronics DCA-8000 Dynamic Diagnostic Charging System in **Reflash Mode**, or the Associated Equipment Corporation ESS6100 100A Smart Charger in **Power Supply Mode | DIAG+**, connected directly to the vehicle's 12-volt battery, and leave it connected during the entire update procedure to maintain constant voltage.
3. Apply the parking brake to keep the headlights off during the procedure.
4. Turn the ignition switch to ON (II).

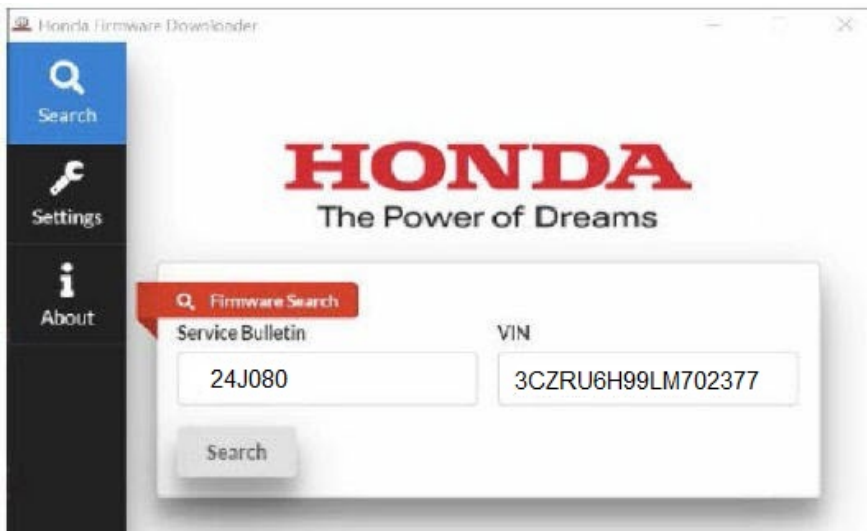
12. In the Service Bulletin field, refer to the table below and enter the appropriate Honda Firmware Downloader Service Bulletin Number that is associated with the vehicle software version on the vehicle you are working on. Then, enter the vehicle's VIN into the VIN field.

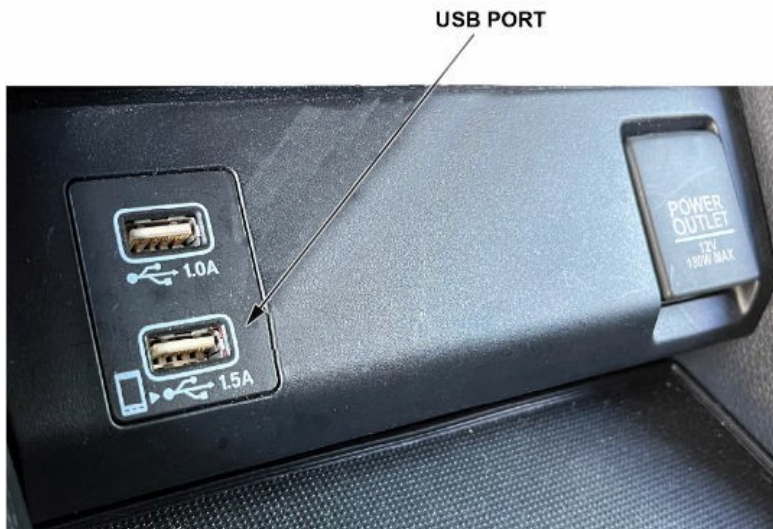
17. Insert the USB flash drive into the vehicle USB port.

NOTE Once the software update begins, do not remove the USB flash drive or the unit may be damaged.

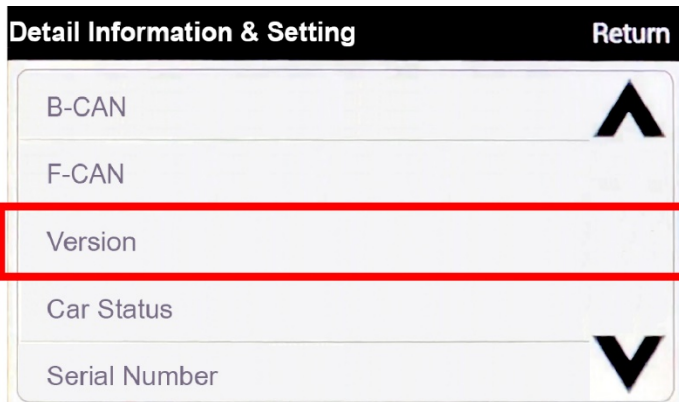
27. Select **Version**.
