June 7, 2024

Safety Recall: 2018-20 Fit Audio Unit Improved Software Update

CORRECTIVE ACTION

Update the audio unit system with the latest software.

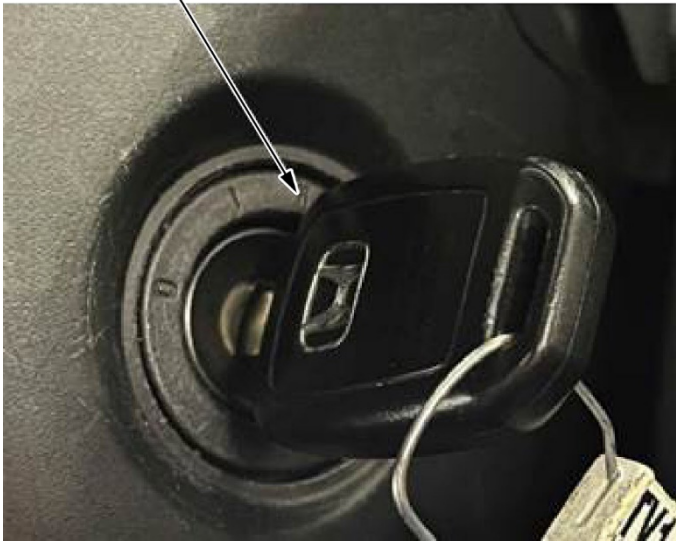
ON (II) POSITION

1. Make sure there are no devices (USB flash drives, smartphones, etc.) connected to the USB port.
2. Connect a Midtronics GR8-1100P AST in **Power Supply Mode**, or the Midtronics DCA-8000 Dynamic Diagnostic Charging System in **Reflash Mode**, or the Associated Equipment Corporation ESS6100 100A Smart Charger in **Power Supply Mode | DIAG+**, connected directly to the vehicle's 12-volt battery, and leave it connected during the entire update procedure to maintain constant voltage.
3. Apply the parking brake to keep the headlights off during the procedure.
4. Turn the ignition switch to ON (II).

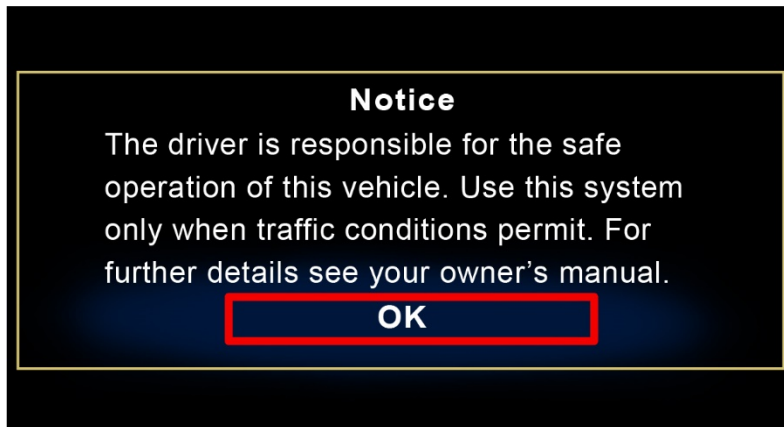
- The disclaimer screen should display, then cycle to the home screen.

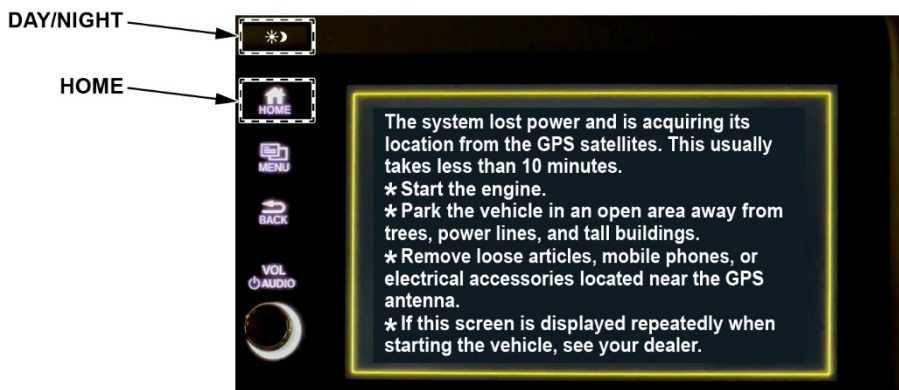
NOTE: If you see this screen, press and hold DAY/NIGHT and HOME at the same time to bypass this screen.

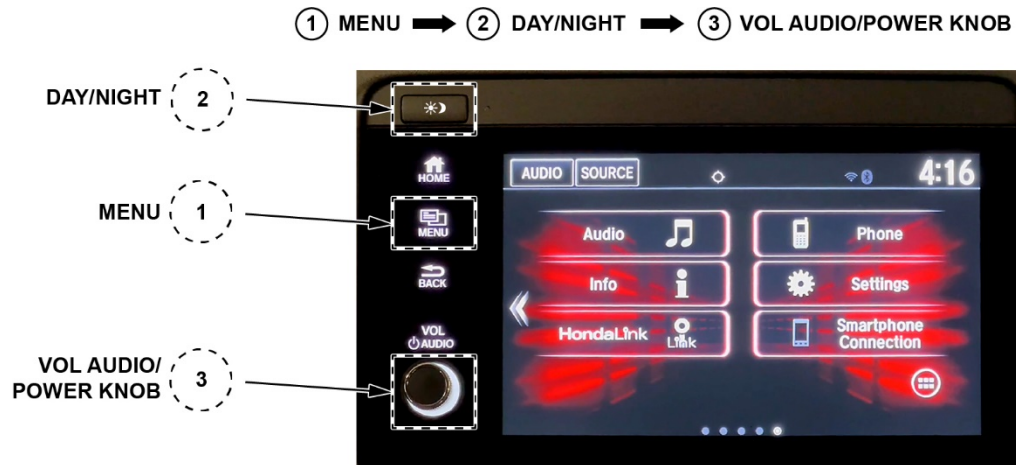
5. From the HOME screen press and hold the following buttons, in the sequence shown, to enter diagnostic mode, **(1)MENU > (2)DAY/NIGHT > (3)VOL AUDIO power knob.**

- Press and hold the buttons in the exact numbered sequence shown to prevent unwanted system reboot.
- Make sure there are no devices (USB flash drives, smartphones, etc.) installed in the USB port.
- Remove any gloves before doing the button push and hold sequence. Not doing so may cause the MENU button to not respond.

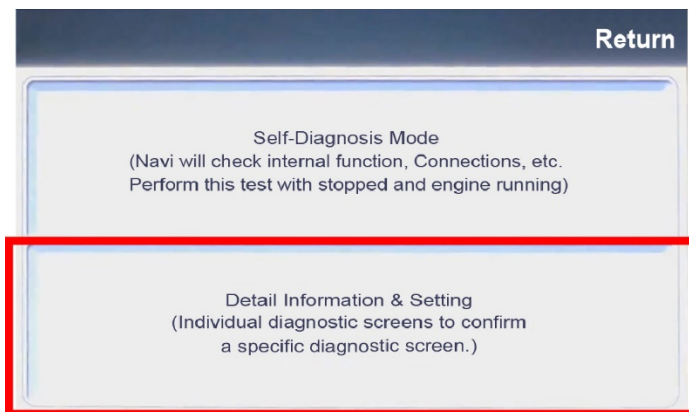
6. Select **Detail Information & Settings**.

- If the H logo appears when doing the **(1)MENU > (2)DAY/NIGHT > (3)VOL AUDIO power knob** push and hold sequence:
 - **Do not** cycle the ignition switch.
 - Wait **3 minutes** and the unit will return to the disclaimer screen shown in step 4.
- If the screen goes blank when doing the **(1)MENU > (2)DAY/NIGHT > (3)VOL AUDIO power knob** push and hold sequence:
 - **Do not** cycle the ignition switch.
 - Press the **DAY/NIGHT** button to return to the HOME screen.

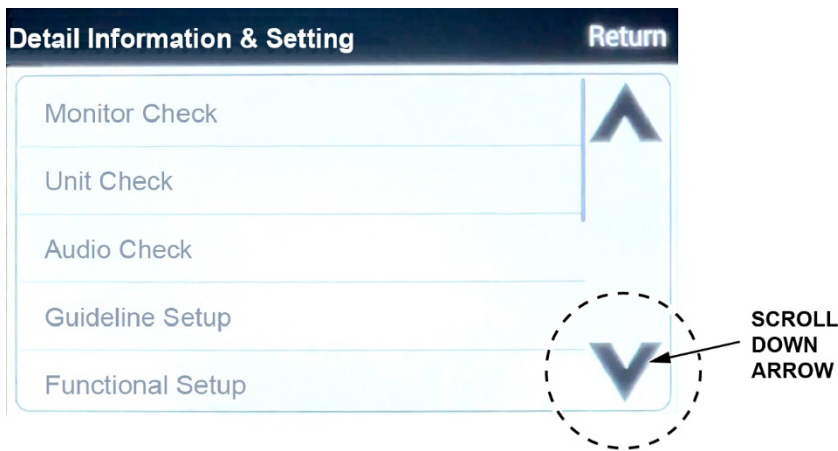
7. Select the scroll down arrow.

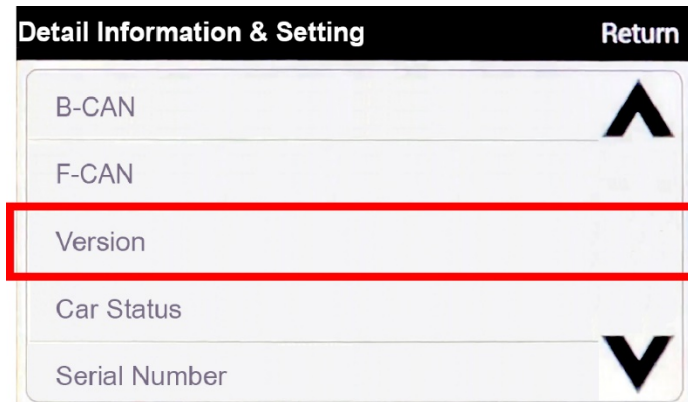
8. Select **Version**.

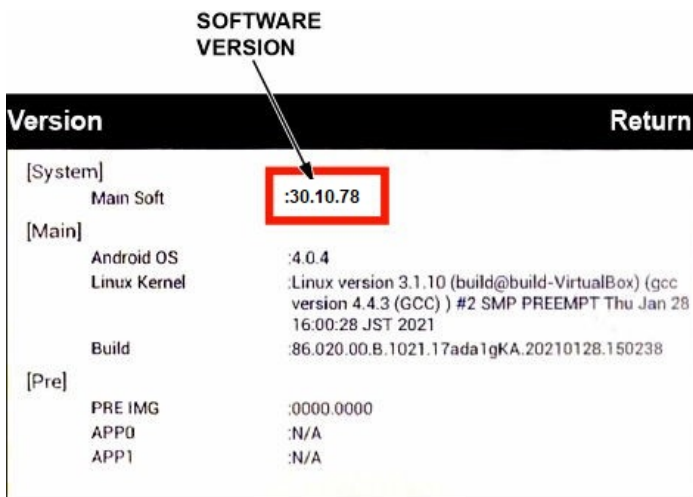
9. Confirm the current software version.

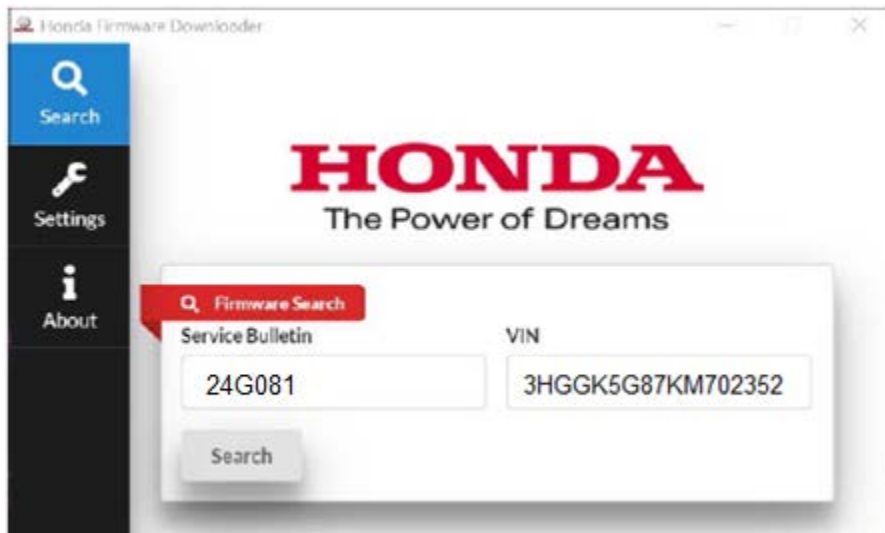
12. In the Service Bulletin field, refer to the table below and enter the appropriate Honda Firmware Downloader Service Bulletin Number that is associated with the vehicle software version on the vehicle you are working on. Then, enter the vehicle's VIN into the VIN field.

- This is very important as there are different update software versions depending on the original, or the first update audio unit software version.
- If you have USB drives with the first update software version loaded, you will need to erase the USB drives.
- The Service Bulletin and VIN fields must be entered in ALL CAPS.

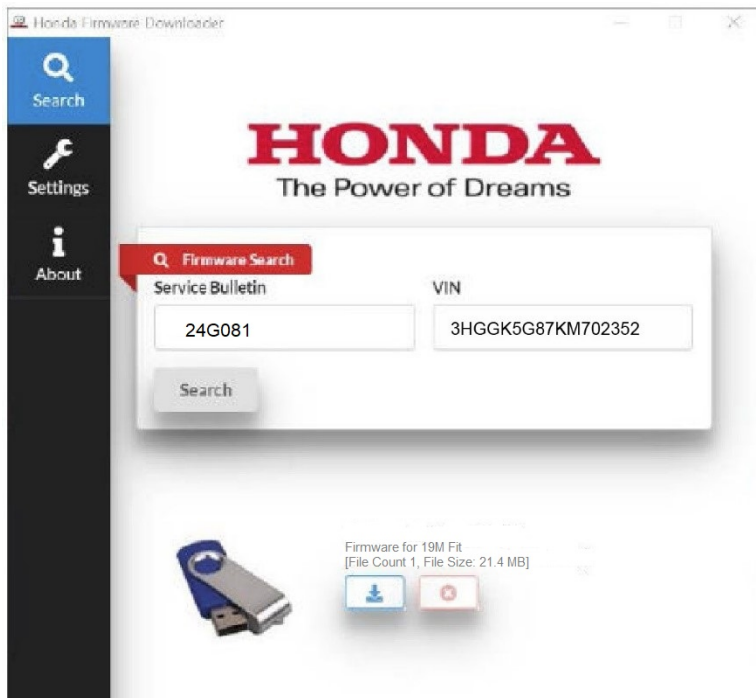
13. Select the download icon.

NOTE: The software download may take up to **15 minutes** depending on the size of the file.

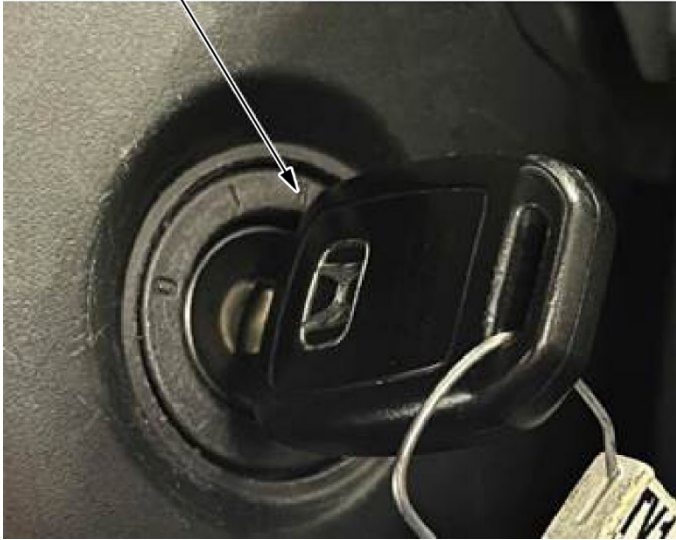
ON (II) POSITION

15. Turn the ignition switch to ON (II).

- Make sure there are no devices (USB flash drives, smartphones, etc.) installed in the USB port.
- Connect a fully charged battery jumper to the vehicle and leave it connected during the entire update procedure to maintain constant voltage.
- Apply the parking brake to keep the headlights off during the procedure.

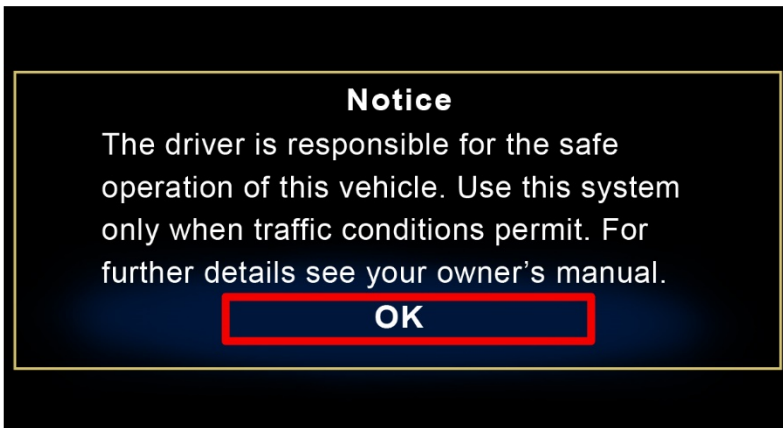
- The disclaimer screen should display, then cycle to the home screen.

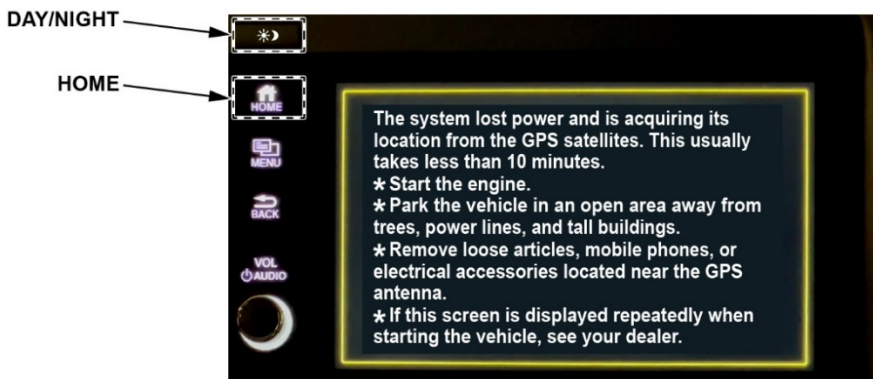
NOTE: If you see this screen, press and hold DAY/NIGHT and HOME at the same time to bypass this screen.

Press and hold the **DAY/NIGHT & HOME** at the same time to bypass this screen.

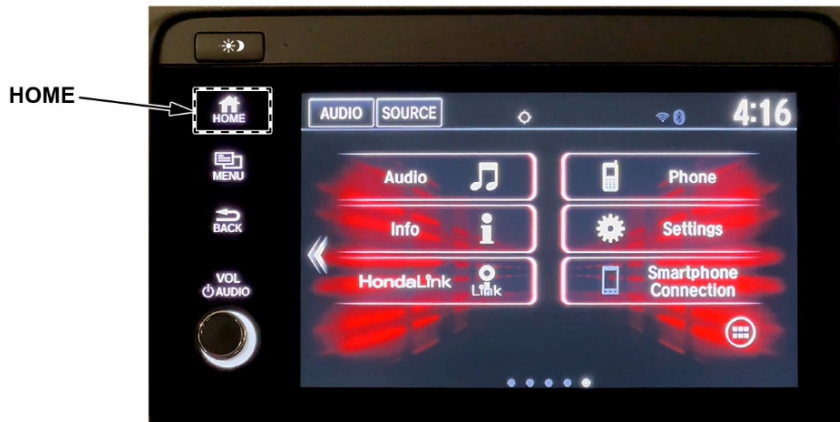
16. Select the HOME screen.

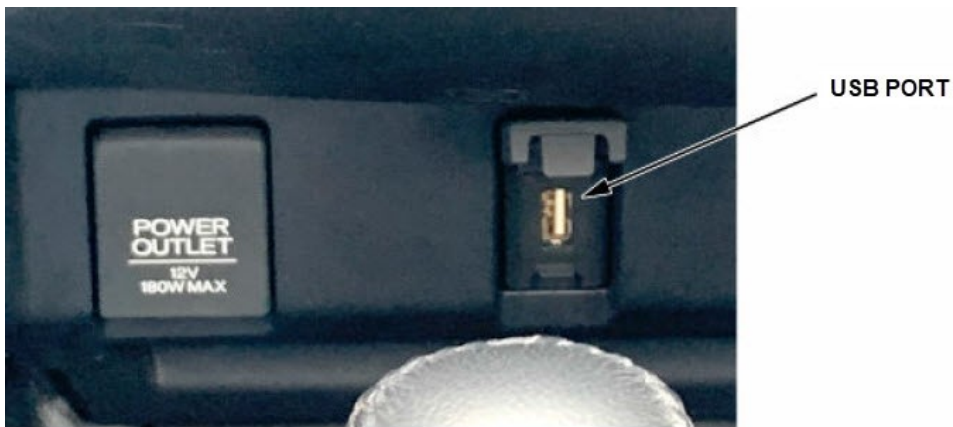
17. Insert the USB flash drive into the vehicle USB port.

NOTE Once the software update begins, do not remove the USB flash drive or the unit may be damaged.

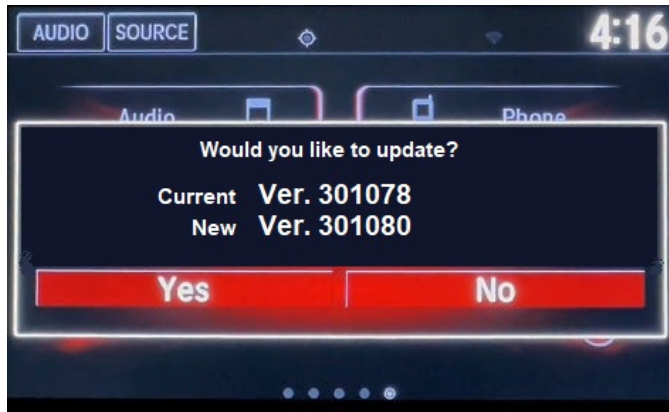
18. Software update pop up will display.

- Make sure the displayed current and new software versions are correct, then select **Yes**.

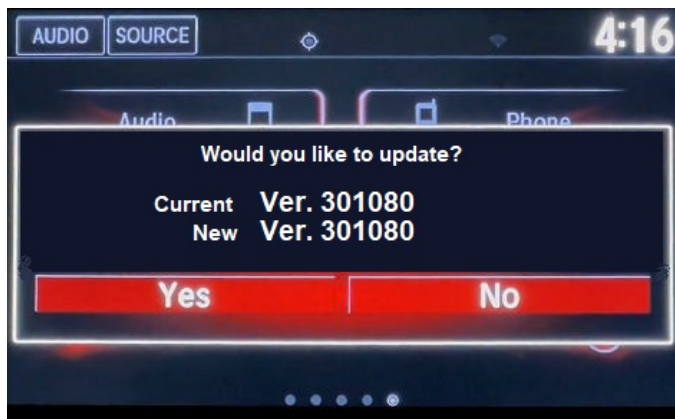
- If this pop up does not display, recheck the loaded software version on the USB flash drive.
- If the current and new software versions are the same, the system is already up to date.

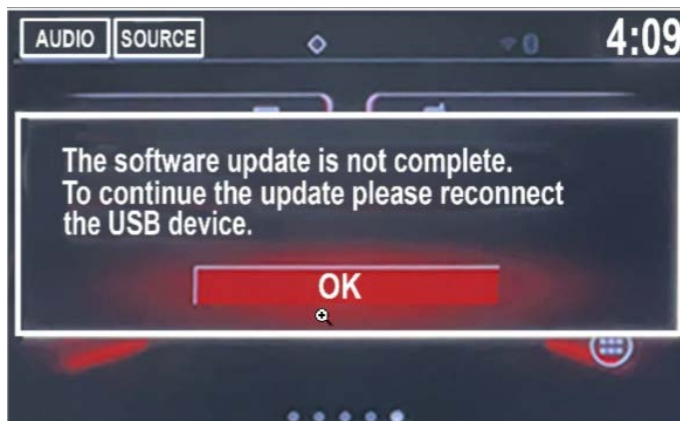
- If the USB flash drive is removed before selecting **Yes** or **No**, an error message will display.

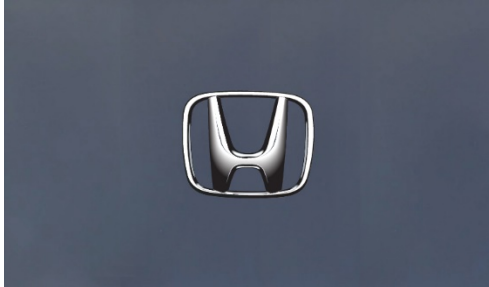
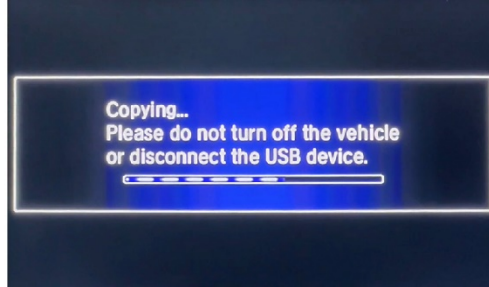
19. The system will reboot and copy the software files. This process will take about **5 minutes** and the system will reboot multiple times.

- The screens shown below will cycle and appear multiple times (approximately 4 to 5 times). **Do not** turn off the vehicle or remove the USB flash drive until the update is complete or the unit may be damaged.
- If power is lost during this update procedure, do not remove the USB flash drive. Turn the ignition switch to ON (II) and the H logo will appear for about **5 minutes**. The unit will restart the update procedure on its own.

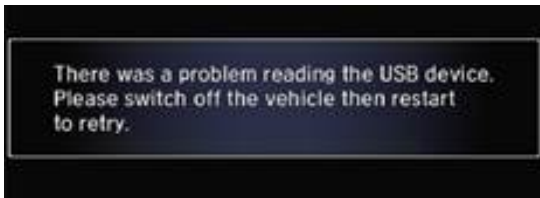
- If an error message appears, turn the ignition switch to OFF (0), remove the USB flash drive, then turn the ignition switch to ON (II) and continue from step 16.

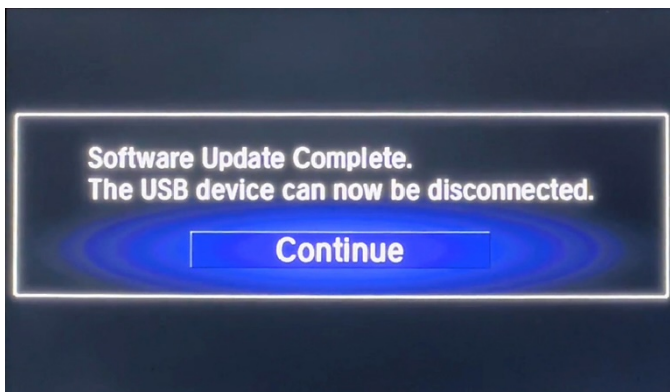
20. Remove the USB flash drive and select **Continue**.

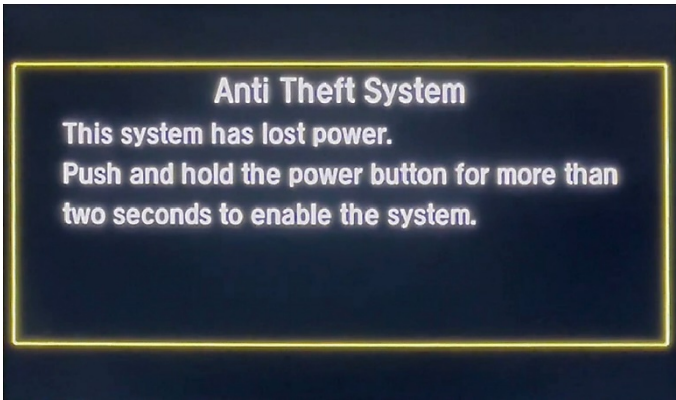
22. The Anti-theft System screen will display when the update is complete. Follow the screen prompts to proceed.

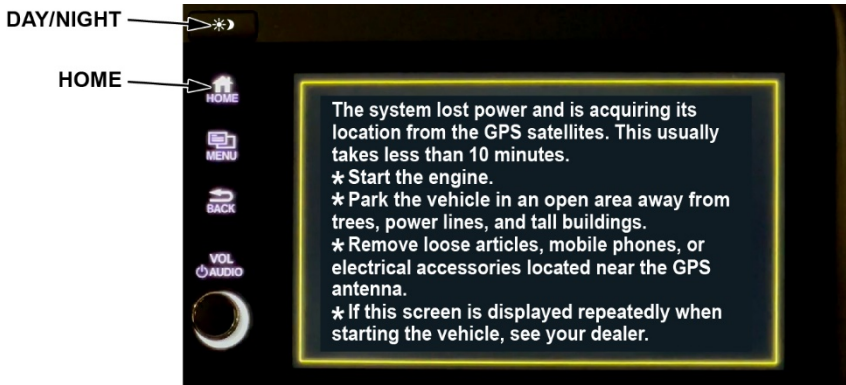
23. Press and hold the **DAY/NIGHT** and **HOME** buttons at the same time to bypass this screen.

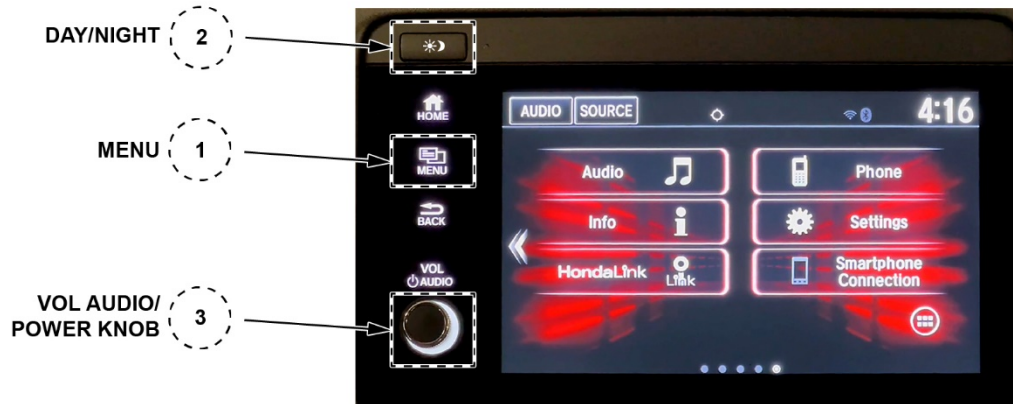
① MENU ➡ ② DAY/NIGHT ➡ ③ VOL AUDIO/POWER KNOB

24. From the Home screen press and hold the following buttons, in the sequence shown, to enter diagnostic mode, **(1)MENU > (2)DAY/NIGHT > (3)VOL AUDIO power knob**.

- Remove any gloves before doing the button push and hold sequence. Not doing so may cause the **MENU** button to not respond.
- Press and hold the buttons in the exact numbered sequence shown to prevent an unwanted system reboot.
- Make sure there are no devices (USB flash drives, smartphones, etc.) connected to the USB port.

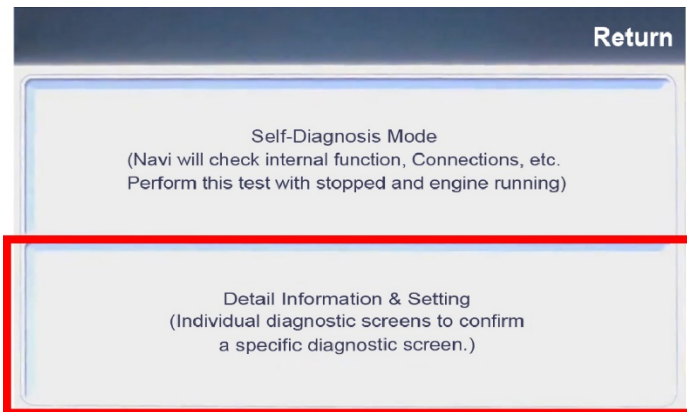
25. Select **Detail Information & Settings**.

- If the H logo appears when doing the **(1) MENU > (2)DAY/NIGHT > (3)VOL AUDIO power knob** push and hold sequence:
 - **Do not** cycle the ignition switch.
 - Wait **3 minutes** and the unit will return to the disclaimer screen shown in step 15.
- If the screen goes blank when doing the **(1)MENU > (2)DAY/NIGHT > (3)VOL AUDIO power knob** push and hold sequence:
 - **Do not** cycle the ignition switch.
 - Press the **DAY/NIGHT** button to return to the **HOME** screen.

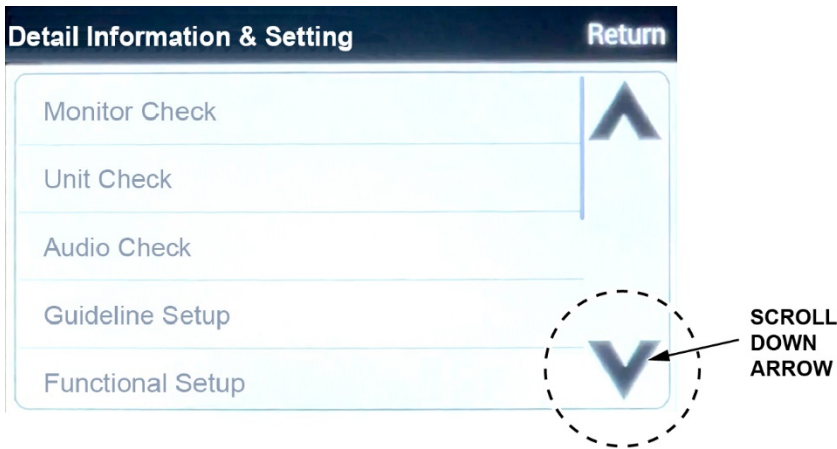
26. Select the scroll down arrow.

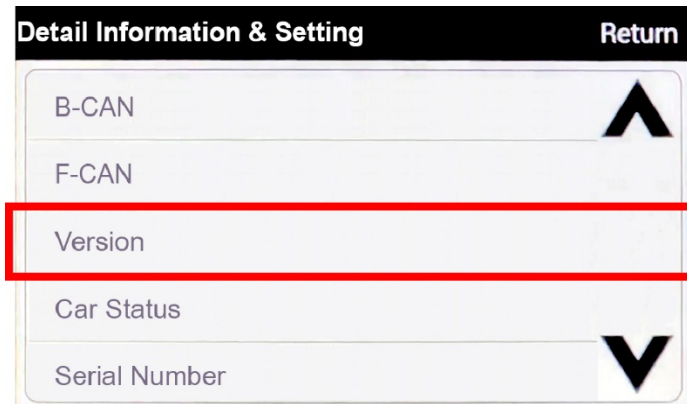
27. Select Version.

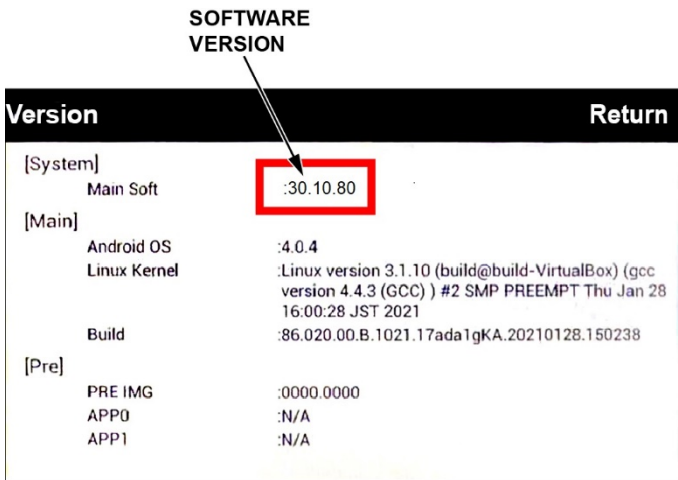
28. Confirm the software update version.
