March 13, 2025

Version 3

## Safety Recall: 2018-20 Fit Audio Unit Improved Software Update

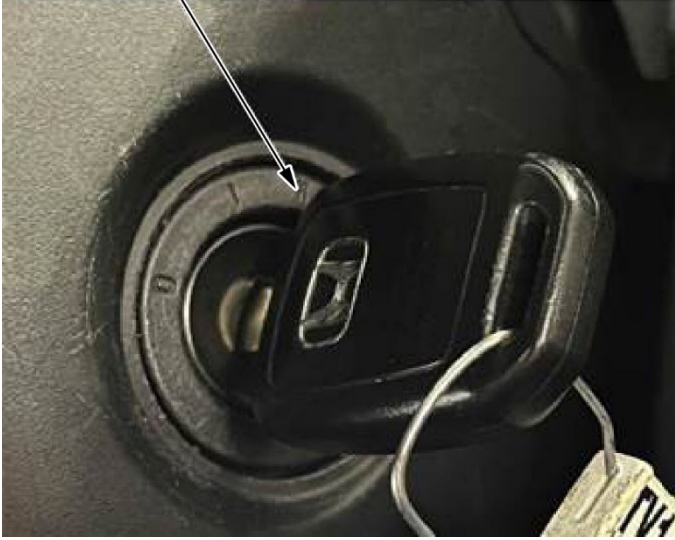
ON (II) POSITION

4. Turn the ignition switch to ON (II).

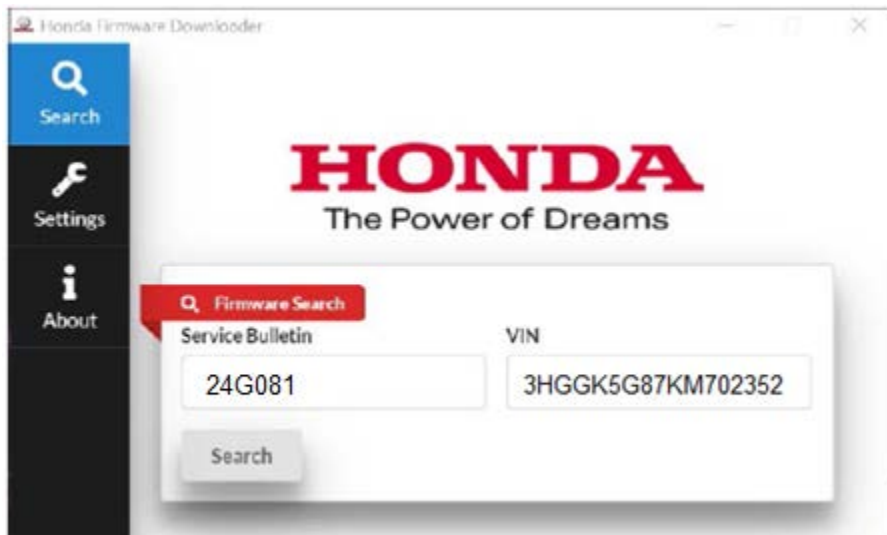
12. In the Service Bulletin field, refer to the table below and enter the appropriate Honda Firmware Downloader Service Bulletin Number that is associated with the vehicle software version on the vehicle you are working on. Then, enter the vehicle's VIN into the VIN field.

- This is very important as there are different update software versions depending on the original, or the first update audio unit software version.
- If you have USB drives with the first update software version loaded, you will need to erase the USB drives.
- The Service Bulletin and VIN fields must be entered in ALL CAPS.

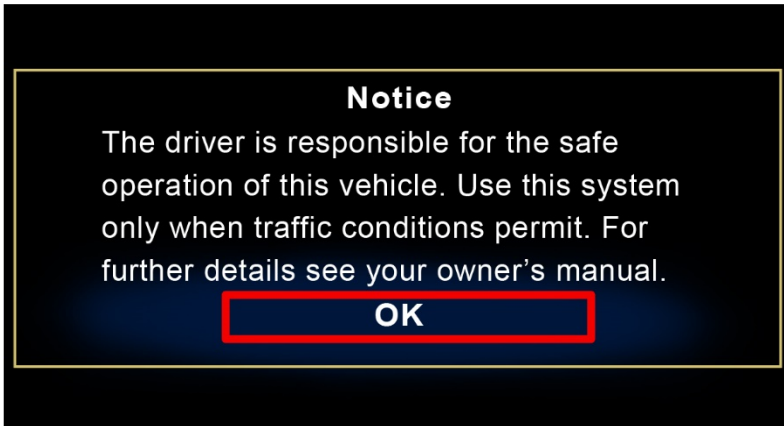
- The disclaimer screen should display, then cycle to the home screen.

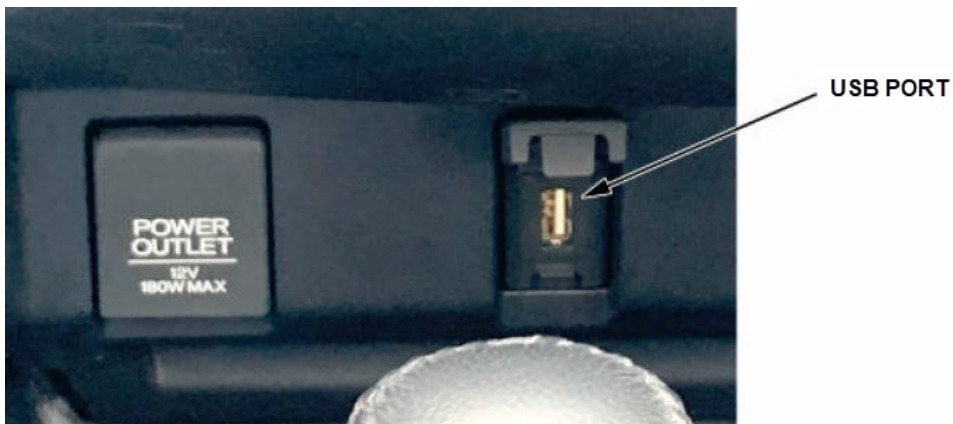
17. Insert the USB flash drive into the vehicle USB port.

NOTE Once the software update begins, do not remove the USB flash drive or the unit may be damaged.

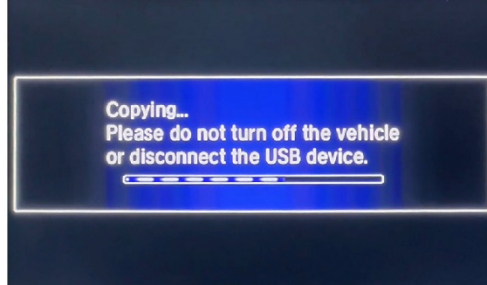
19. The system will reboot and copy the software files. This process will take about **5 minutes** and the system will reboot multiple times.

- The screens shown below will cycle and appear multiple times (approximately 4 to 5 times). **Do not** turn off the vehicle or remove the USB flash drive until the update is complete or the unit may be damaged.
- If power is lost during this update procedure, do not remove the USB flash drive. Turn the ignition switch to ON (II) and the H logo will appear for about **5 minutes**. The unit will restart the update procedure on its own.
