Safety Recall: 2018-20 Fit Audio Unit Improved Software Update

BACKGROUND

Due to an improper hardware circuit configuration, if the battery state of charge drops below 9 volts during cranking this may cause logic and/or timing mismatch in the display audio unit resulting in a blank display condition. In certain situations, the rearview camera may not display when shifting to reverse, increasing the risk of a back-up collision or injury. This is noncompliant with Federal Motor Vehicle Safety Standards.

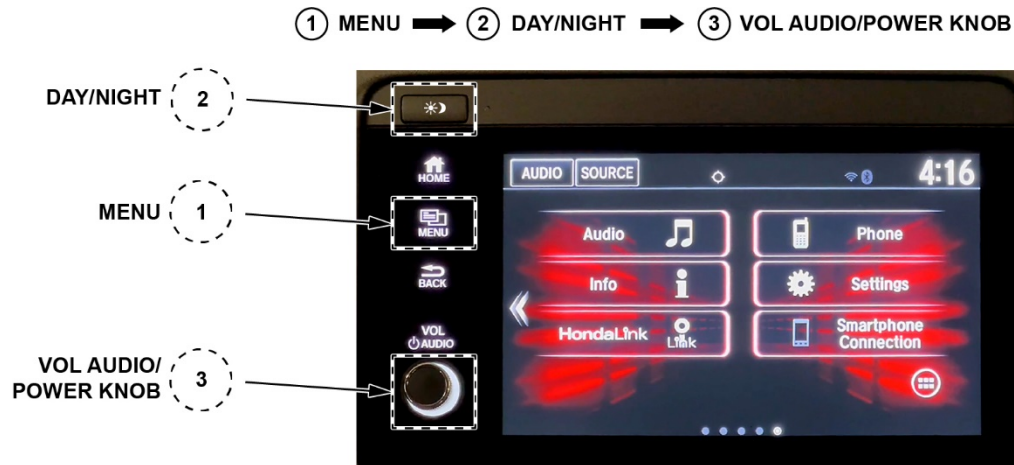
5. From the HOME screen press and hold the following buttons, in the sequence shown, to enter diagnostic mode, **(1)MENU > (2)DAY/NIGHT > (3)VOL AUDIO power knob.**

- Press and hold the buttons in the exact numbered sequence shown to prevent unwanted system reboot.
- Make sure there are no devices (ISB flash drives, smartphones, etc.) installed in the USB port.
- Remove any gloves before doing the button push and hold sequence. Not doing so may cause the MENU button to not respond.

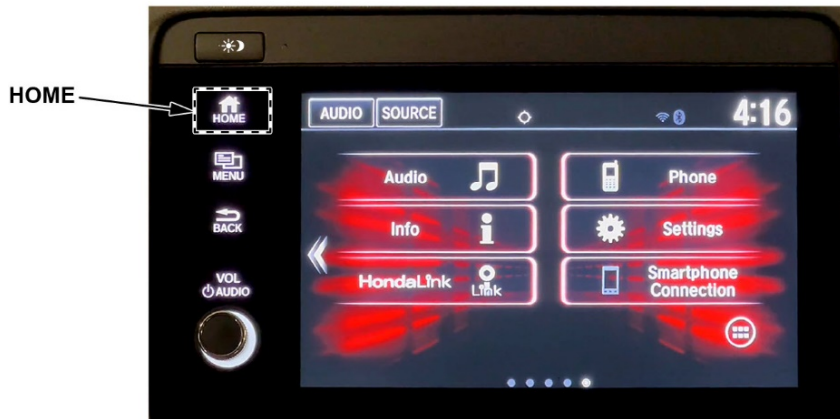
16. Select the HOME screen.

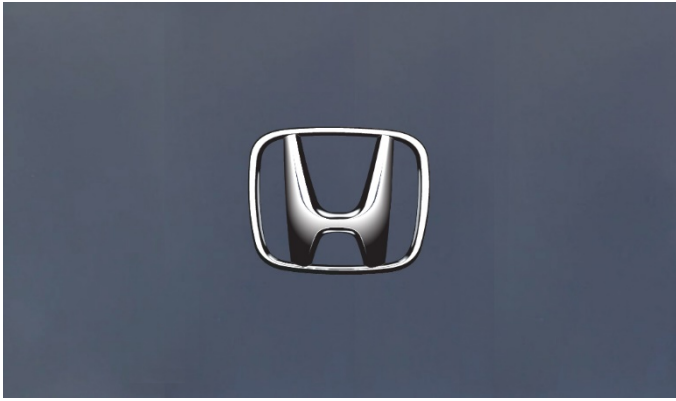
21. The system will reboot to this screen for about **1 minute**.

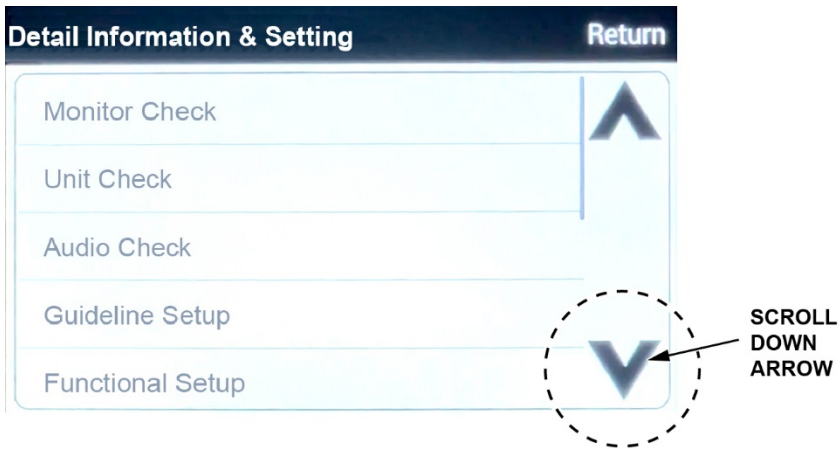
26. Select the scroll down arrow.
