March 13, 2025

Version 3

Safety Recall: 2019-22 HR-V Audio Unit Improved Software Update

Supersedes 24-080 dated June 7, 2024, to revise the information highlighted in **yellow**.

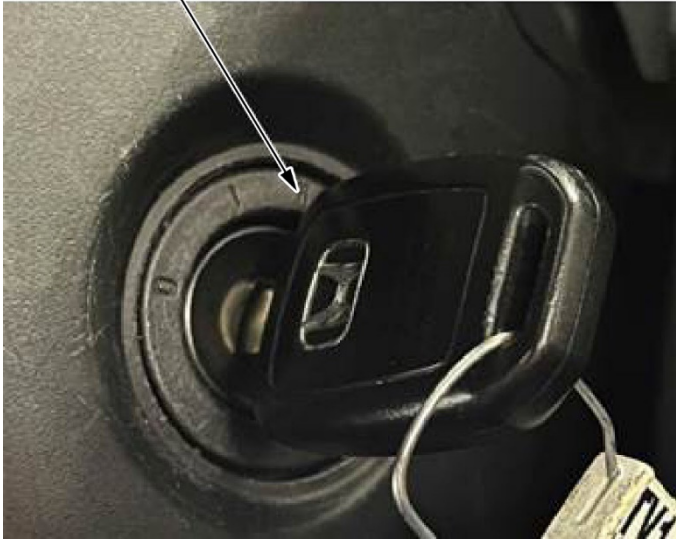
ON (II) POSITION

4. Turn the ignition switch to ON (II).

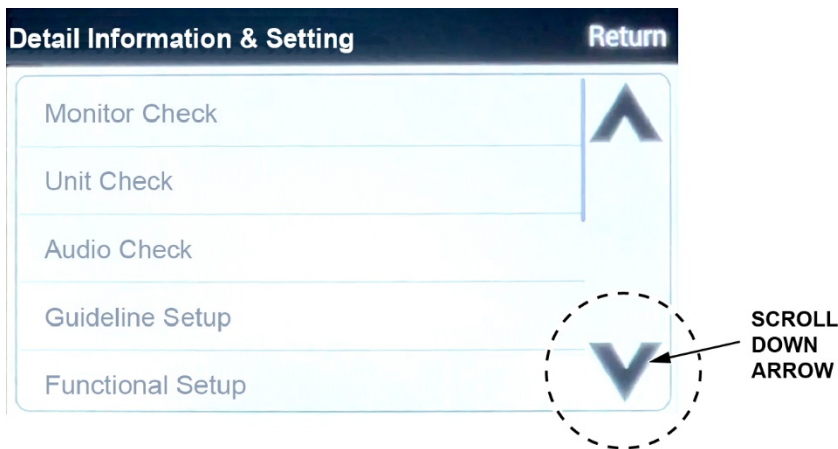
7. Select the scroll down arrow.

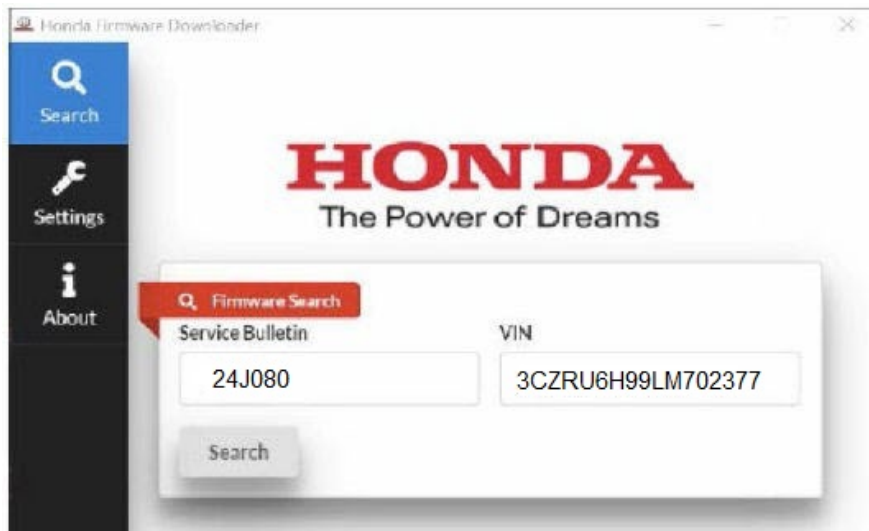
12. In the Service Bulletin field, refer to the table below and enter the appropriate Honda Firmware Downloader Service Bulletin Number that is associated with the vehicle software version on the vehicle you are working on. Then, enter the vehicle's VIN into the VIN field.

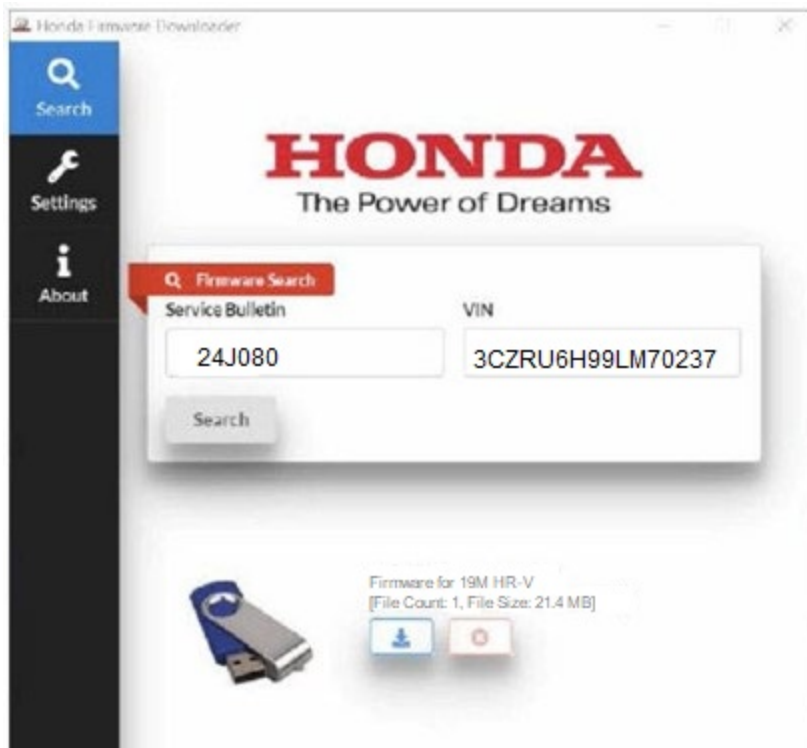
13. Select the download icon.

NOTE: The software download may take up to **15 minutes** depending on the size of the file.

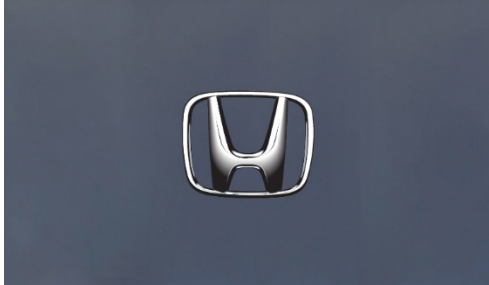
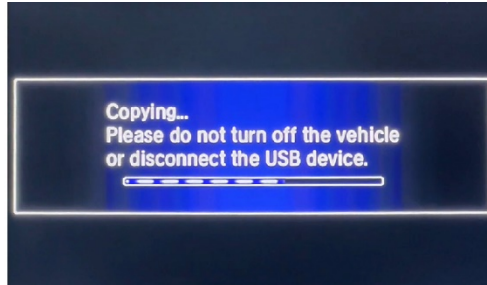
19. The system will reboot and copy the software files. This process will take about **5 minutes** and the system will reboot multiple times.

- The screens shown below will cycle and appear multiple times (approximately 4 to 5 times). **Do not** turn off the vehicle or remove the USB flash drive until the update is complete or the unit may be damaged.
- If power is lost during this update procedure, do not remove the USB flash drive. Turn the ignition switch to ON (II) and the H logo will appear for about **5 minutes**. The unit will restart the update procedure on its own.

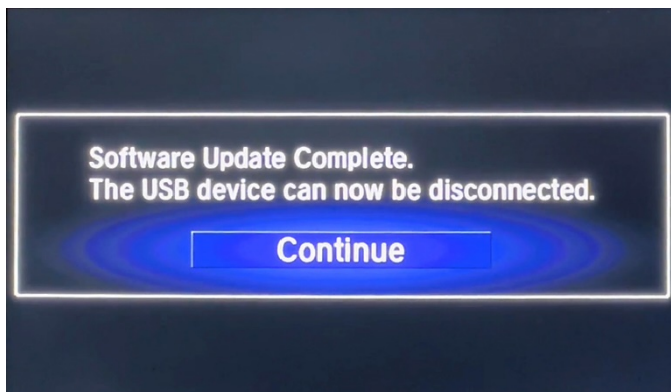
20. Remove the USB flash drive and select **Continue**.
