June 7, 2024

Safety Recall: 2019-22 HR-V Audio Unit Improved Software Update

Year	Model	Trim Level	VIN Range
2019–22	HR-V (2WD and AWD with key ignition switch ONLY)	Sport	Check the iN VIN status inquiry for eligibility.

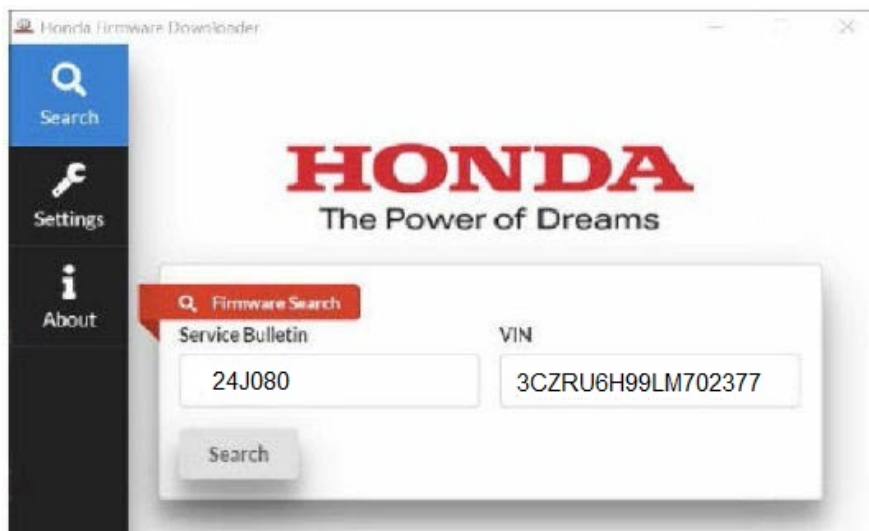
12. In the Service Bulletin field, refer to the table below and enter the appropriate Honda Firmware Downloader Service Bulletin Number that is associated with the vehicle software version on the vehicle you are working on. Then, enter the vehicle's VIN into the VIN field.

- This is very important as there are different update software versions depending on the original, or the first update audio unit software version.
- If you have USB drives with the first update software version loaded, you will need to erase the USB drives.
- The Service Bulletin and VIN fields must be entered in ALL CAPS.

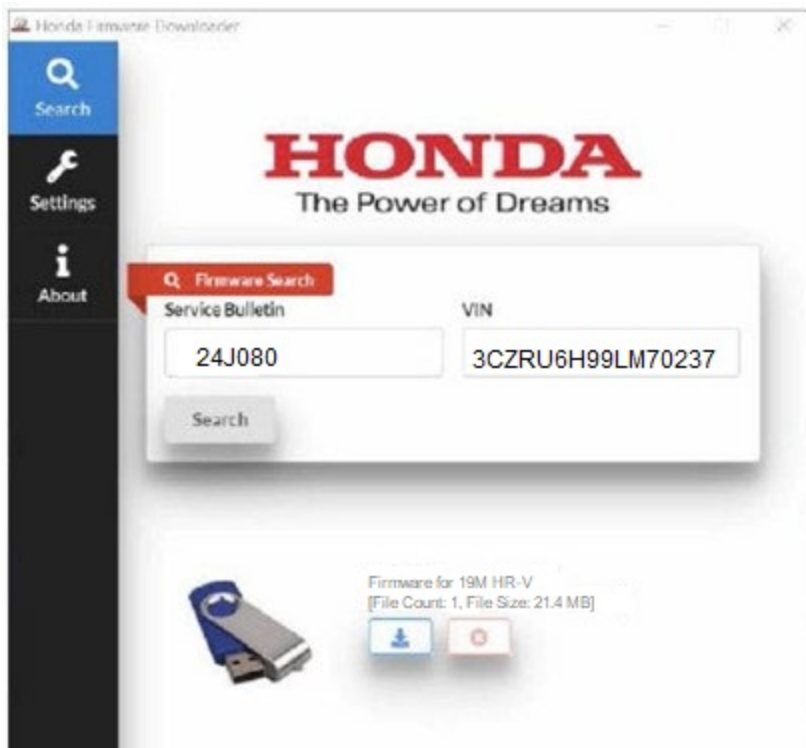
13. Select the download icon.

NOTE: The software download may take up to **15 minutes** depending on the size of the file.

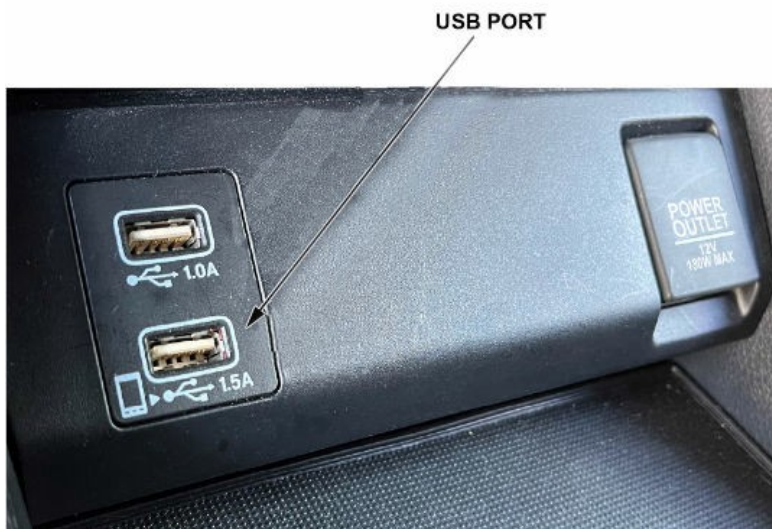
17. Insert the USB flash drive into the vehicle USB port.

NOTE Once the software update begins, do not remove the USB flash drive or the unit may be damaged.

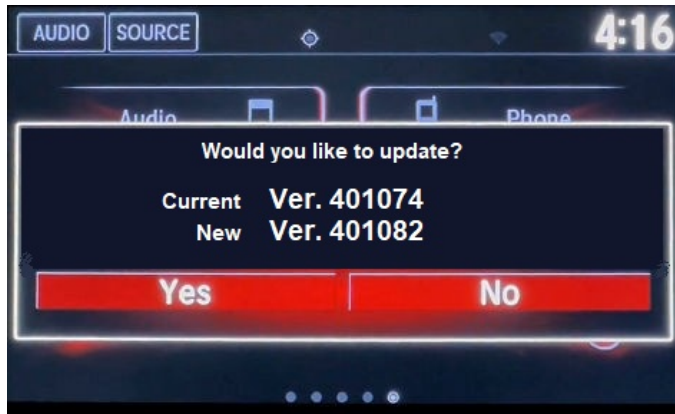
18. Software update pop up will display.

- Make sure the displayed current and new software versions are correct, then select **Yes**.

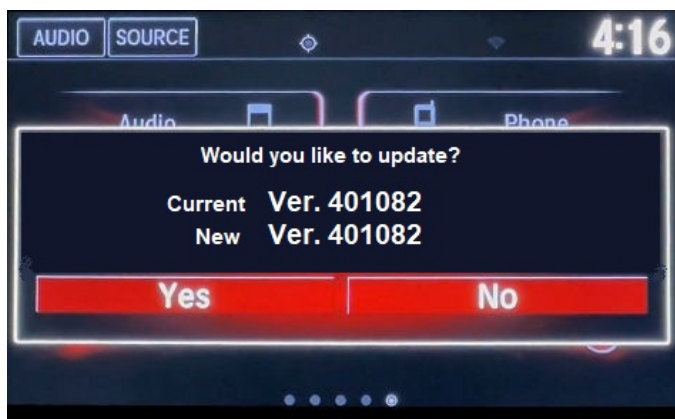
- If this pop up does not display, recheck the loaded software version on the USB flash drive.
- If the current and new software versions are the same, the system is already up to date.

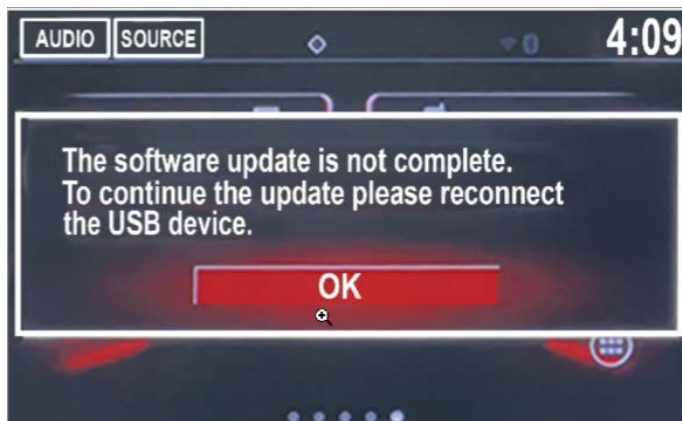
- If the USB flash drive is removed before selecting **Yes** or **No**, an error message will display.

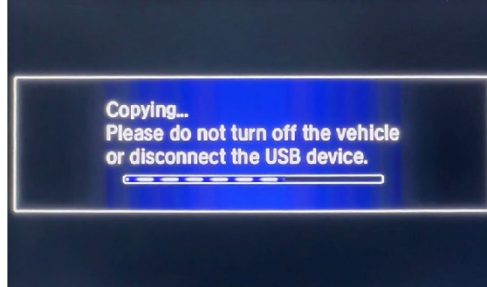
19. The system will reboot and copy the software files. This process will take about **5 minutes** and the system will reboot multiple times.

- The screens shown below will cycle and appear multiple times (approximately 4 to 5 times). **Do not** turn off the vehicle or remove the USB flash drive until the update is complete or the unit may be damaged.
- If power is lost during this update procedure, do not remove the USB flash drive. Turn the ignition switch to ON (II) and the H logo will appear for about **5 minutes**. The unit will restart the update procedure on its own.
