# F/CMVSS Noncompliance Recall

## N242447941 Blank Cluster Display

**Release Date:** August 2024

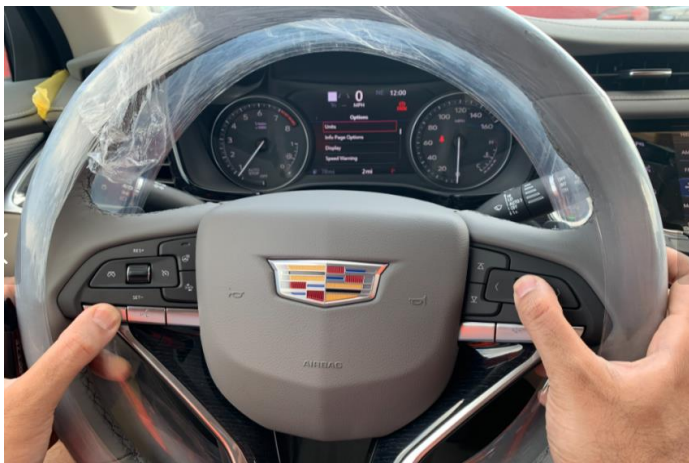
6719873

1. Vehicle ON, all systems ON.
2. Verify Instrument Cluster display functions as designed and DOES NOT have a blank screen condition.
  - If the Instrument Cluster display is **blank**, it will NOT accept USB programming. Part damage has already occurred, and the cluster will need to be replaced. Refer to *Instrument Cluster Replacement* in SI. Complete **ONLY** steps 5-9 to update the radio software. It is NOT necessary to USB program the Instrument Cluster if it is replaced.
  - If the Instrument Cluster is NOT blank, proceed to the next step.
3. Access the developer screen within the Cluster.
  - 3.1 Scroll right to the Options tab within the cluster, but do not make any selections.

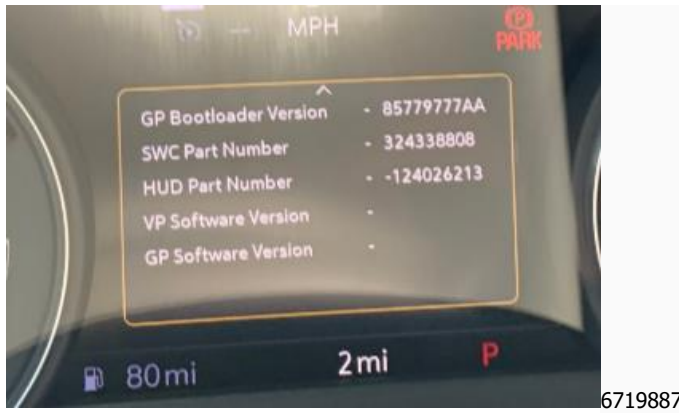
6719887

3.2 Simultaneously hold down the **End Call** button on the left side of the steering wheel and the **Select** button on the right for approximately 7 seconds.

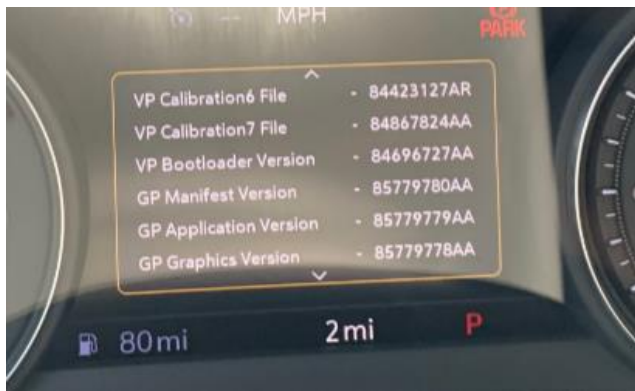
6719889

4. Verify GP Bootloader Version 85779777AA.

- If GP Bootloader Version 85779777AA, confirm GP Manifest, GP Application, AND GP Graphics version **ALL** match the above image.
  - If the version numbers **DO NOT** match:  
Replace the Instrument Panel Cluster. Refer to *Instrument Cluster Replacement* in SI. Complete **ONLY** steps 5-9 to update the radio software. It is NOT necessary to USB program the Instrument Cluster if it is replaced.
  - If **ALL THREE** version numbers match:  
The IPC is up to date and no further action is required.
- If GP Bootloader Version **IS NOT** 85779777AA, proceed to step 5.
