# F/CMVSS Noncompliance Recall

## N242447941 Blank Cluster Display

**Release Date:** July 2024

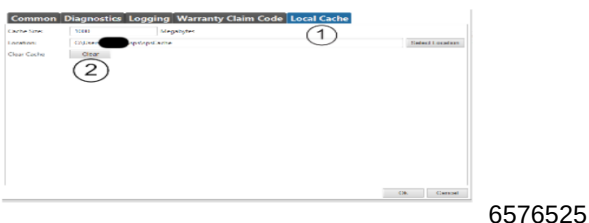
5. Select "Local Cache" (1) tab.
6. Select "Clear" tab (2) and then "OK".
