# Compliance Recall

## Code: 91US

### Subject Infotainment System Software

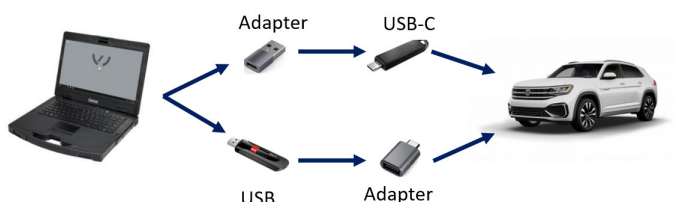
## Software Part Number

- The MIB3 system uses a USB-C input.
- If the software is downloaded onto a USB drive, a USB to USB-C adapter will be required.
- If the software is downloaded onto a USB-C drive, a USB-C to USB adapter will be required since the VAS tester does not have a USB-C drive.

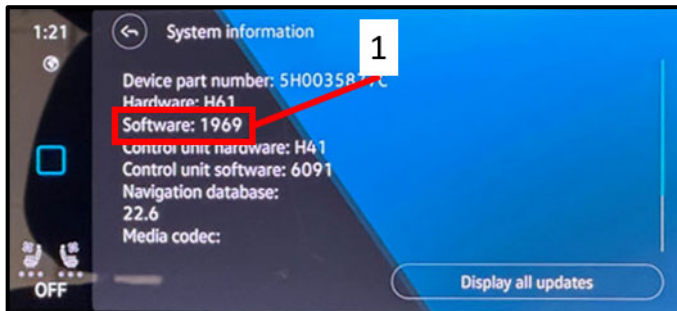
- Select the “Settings” option <1> from the home screen.

- Select the “System Information” option <1>.

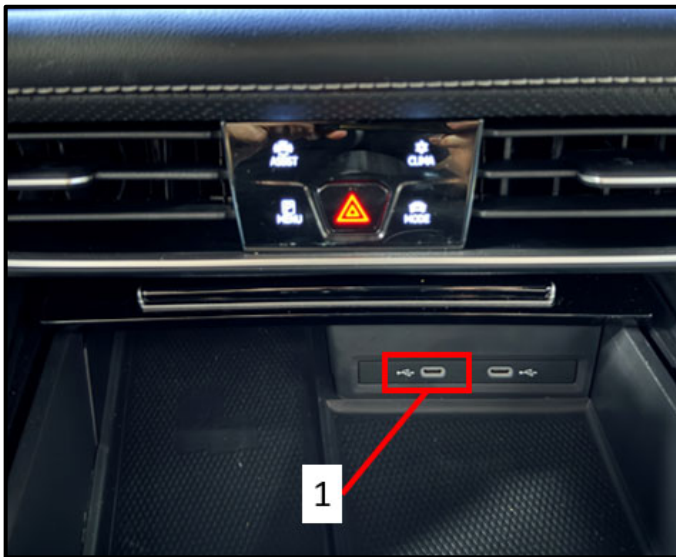
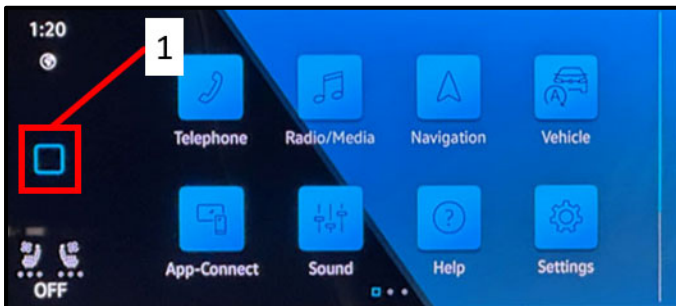
Atlas Cross Sport USB location shown. USB location is similar for other affected models.

- Enter service mode by pressing and holding the home button <1>.

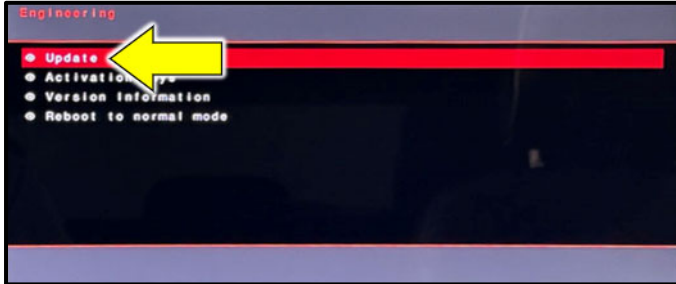
- Select the option for "Update" <arrow>.

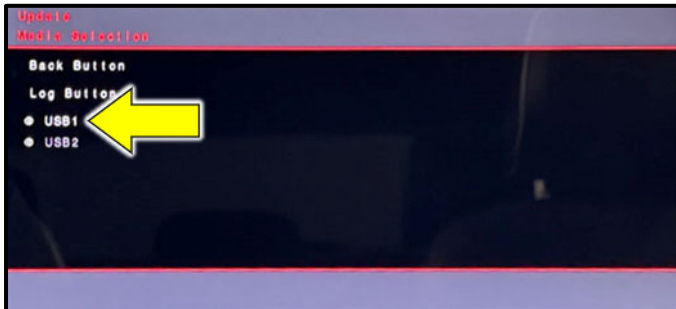
- Select the applicable USB port <arrow>.

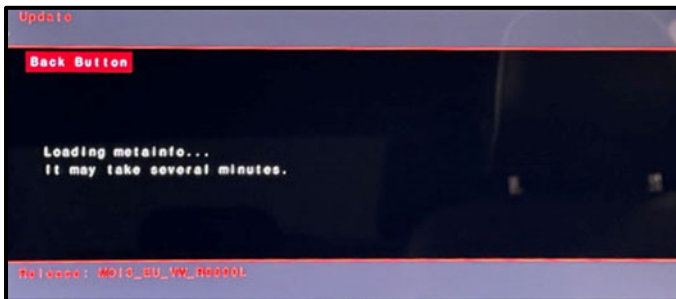
The software update may take several minutes to load.

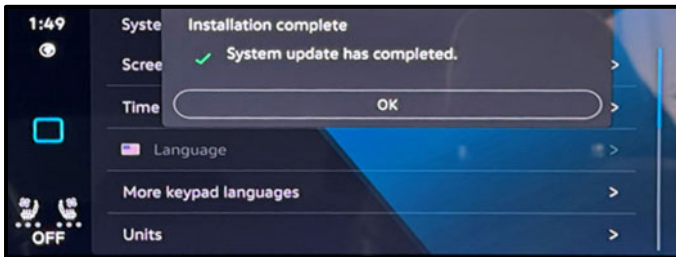
- When the “Installation complete” screen appears, select, “OK.”

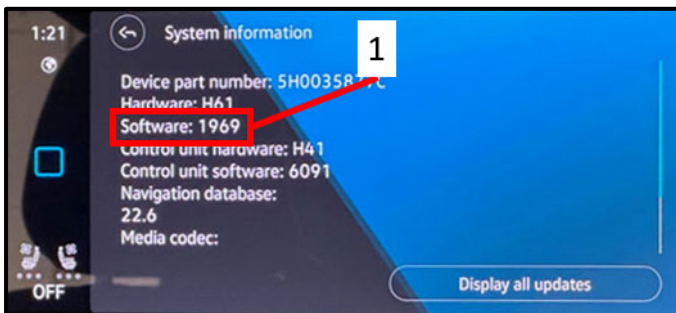
- Select the “System information” option again under the “Settings” menu according to the prior instructions.
- Confirm the software has updated to version “1969”.
- Switch off the ignition.
- Remove the USB drive.
- If erased, store the customer’s radio station presets.

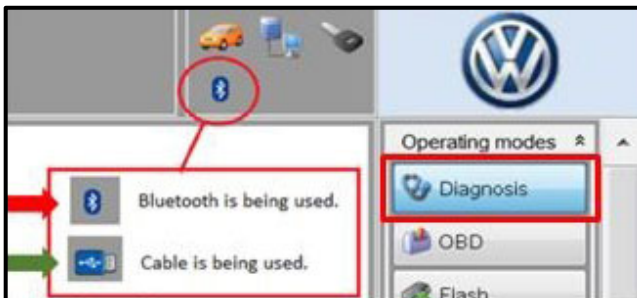
- Confirm that scan tool is communicating with the diagnostic head by USB <Green Arrow>.
  - If the Bluetooth symbol is shown <Red Arrow> then disconnect the diagnostic head from the vehicle and reconnect the USB cable to the diagnostic head and then reattach to the vehicle.
- Upon ODIS startup, verify the "Diagnosis" operating mode is selected <as shown>.
- Once the GFF scan is complete, select "Special functions" <arrow 1>, then "Adapting software" <arrow 2>, then select "Perform test" <arrow 3>.
