Compliance Recall

Code: 91US

Subject Infotainment System Software

On the affected vehicles, the rearview camera image may be delayed or deactivated after shifting into reverse. As a result, the rearview camera image may not meet the response time required by government regulations. A rearview camera with a delayed or deactivated image can reduce the information available to the driver of what is behind the vehicle, increasing the risk of a crash or injury to people outside the vehicle.

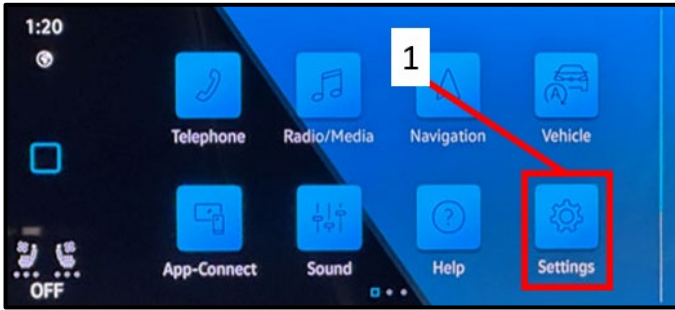
- Select the “Settings” option <1> from the home screen.

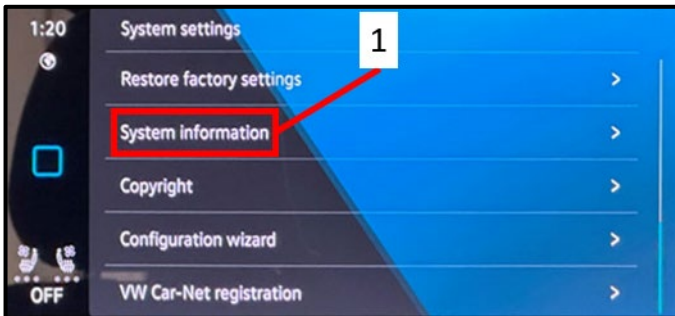
- Select the “System Information” option <1>.

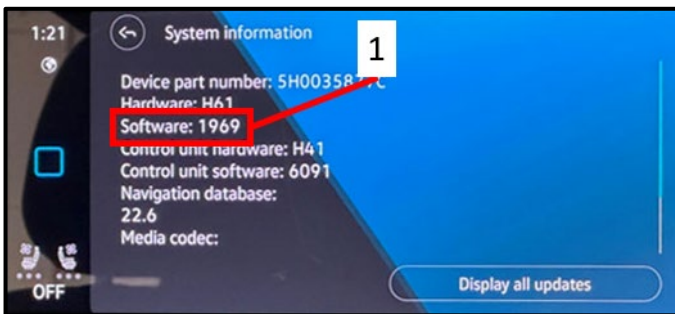
- Check the current software version of the MIB3 system <1>.
- If software version is **1969** or higher:
 - No further work is required.
 - **Proceed to Section E.**
- If software version is lower than **1969**:
 - Update the MIB3 system via USB.
 - **Proceed to Section C.**

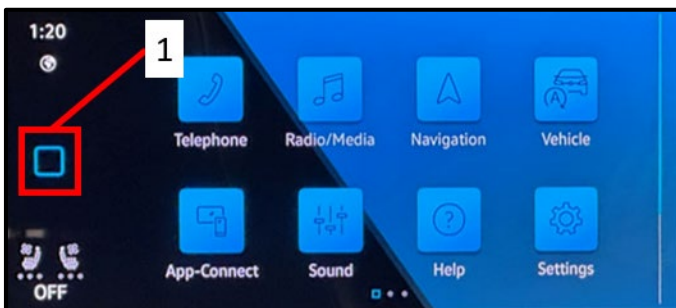
- Enter service mode by pressing and holding the home button <1>.

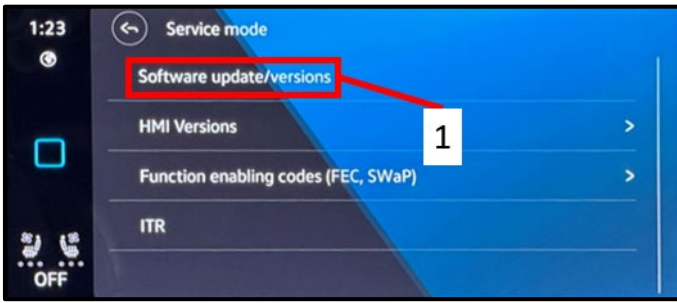
- Select the software update option <1>.
- Select the option to start the update when prompted.

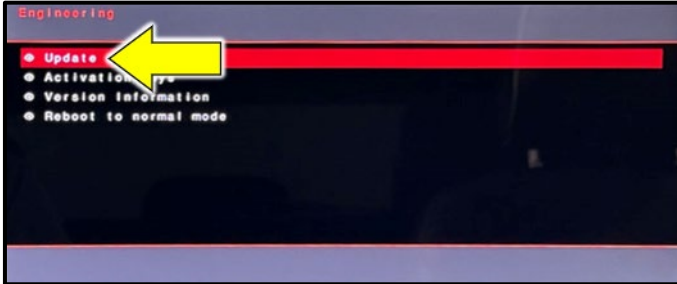
- Select the option for "Update" <arrow>.

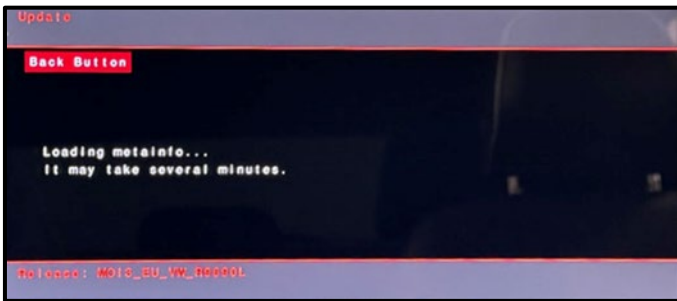
NOTE
The software update may take several minutes to load.

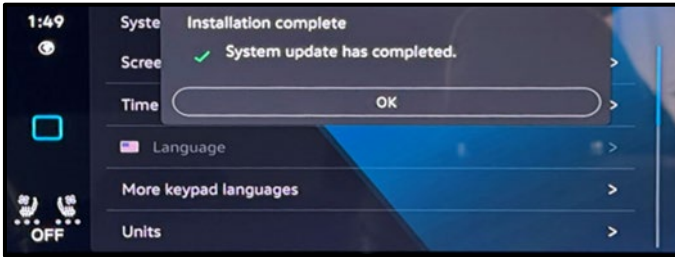
- When the “Installation complete” screen appears, select, “OK.”
