# Safety Recall

## N242443002 High Voltage Battery Fire Detection

Release Date: July 2024

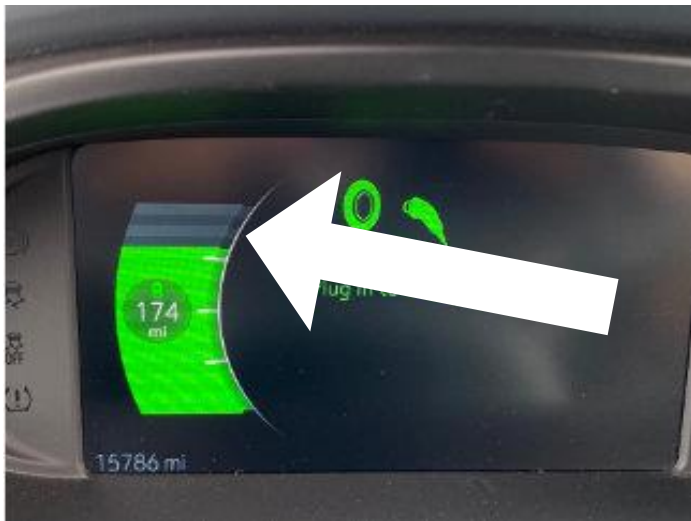
5924268

**Important:** Verify the vehicle SOC is less than 80%. This can be determined by looking at the bars on the power level indicator. If four or more empty bars (not showing green) are displayed, the SOC is at an acceptable level. If the power level indicator shows an SOC of greater than 80% The SOC must be adjusted before proceeding with the recalibration.
