VOLUNTARY RECALL CAMPAIGN

Classification: EL24-012	Reference: NTB24-039	Date: July 29, 2024
-----------------------------	-------------------------	------------------------

VOLUNTARY SAFETY RECALL CAMPAIGN 2023 ARIYA; BATTERY JUNCTION BOX

CAMPAIGN ID #: R24A8
APPLIED VEHICLES: 2023 ARIYA (FE0)

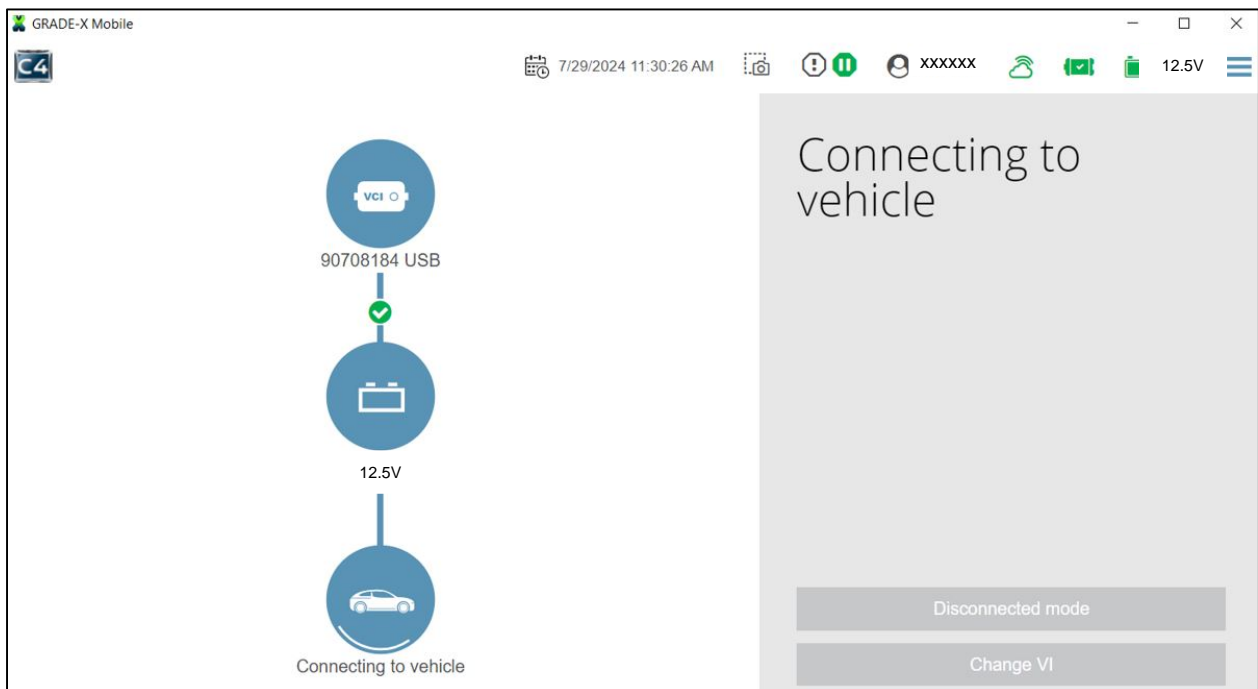
Figure 3

9. Allow the CONSULT 4 to connect to the vehicle and complete system call.

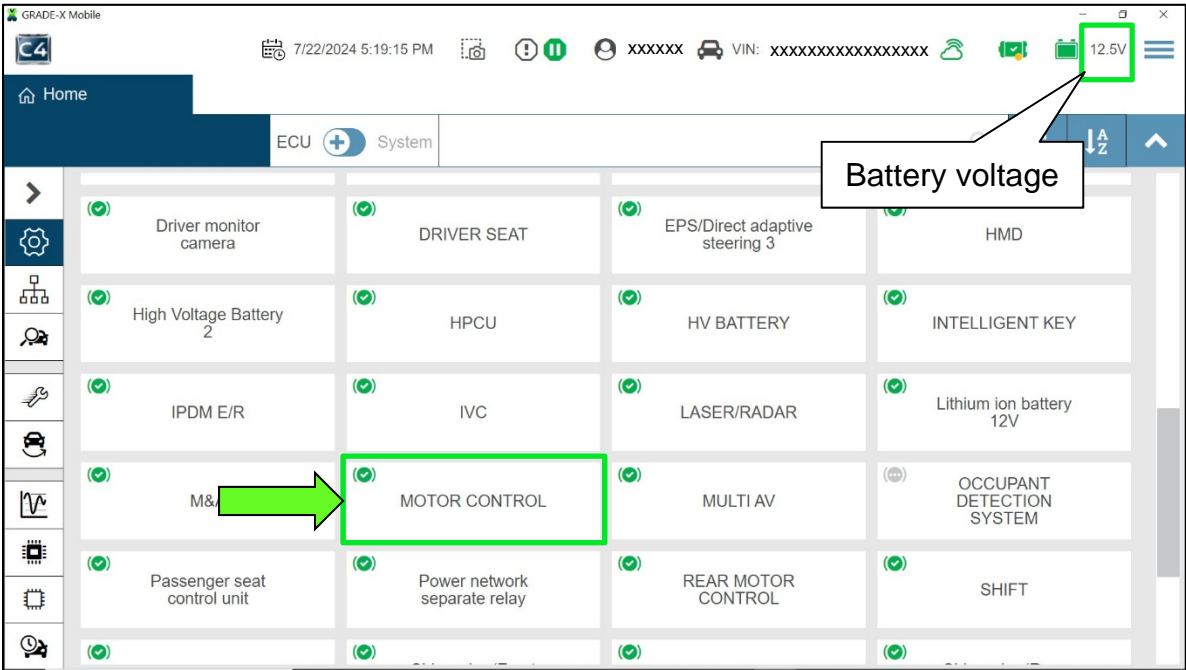
Figure 4

- 10. Ensure that the vehicle's 12 volt battery voltage stays between 12.0-13.5V.
- 11. Allow CONSULT 4 to access all the control units in the vehicle. Once complete, select **MOTOR CONTROL**.
 - This process may take several minutes.

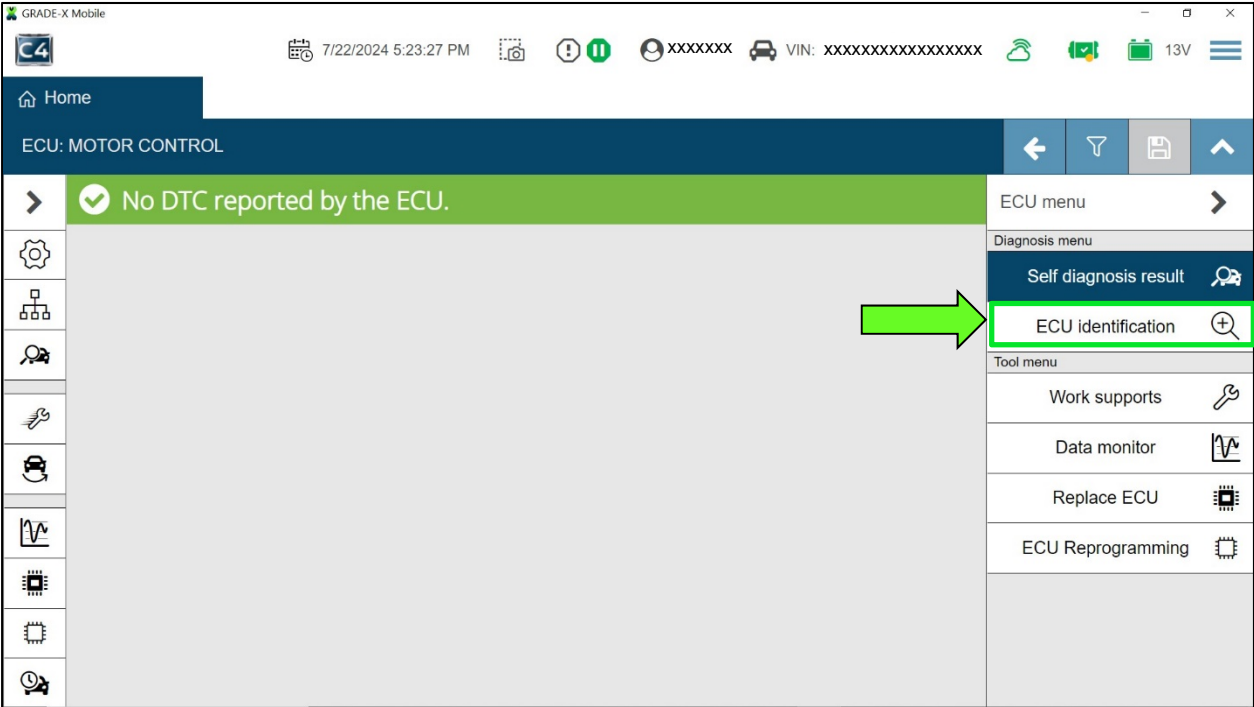
Figure 5

- 12. Select **ECU identification**.

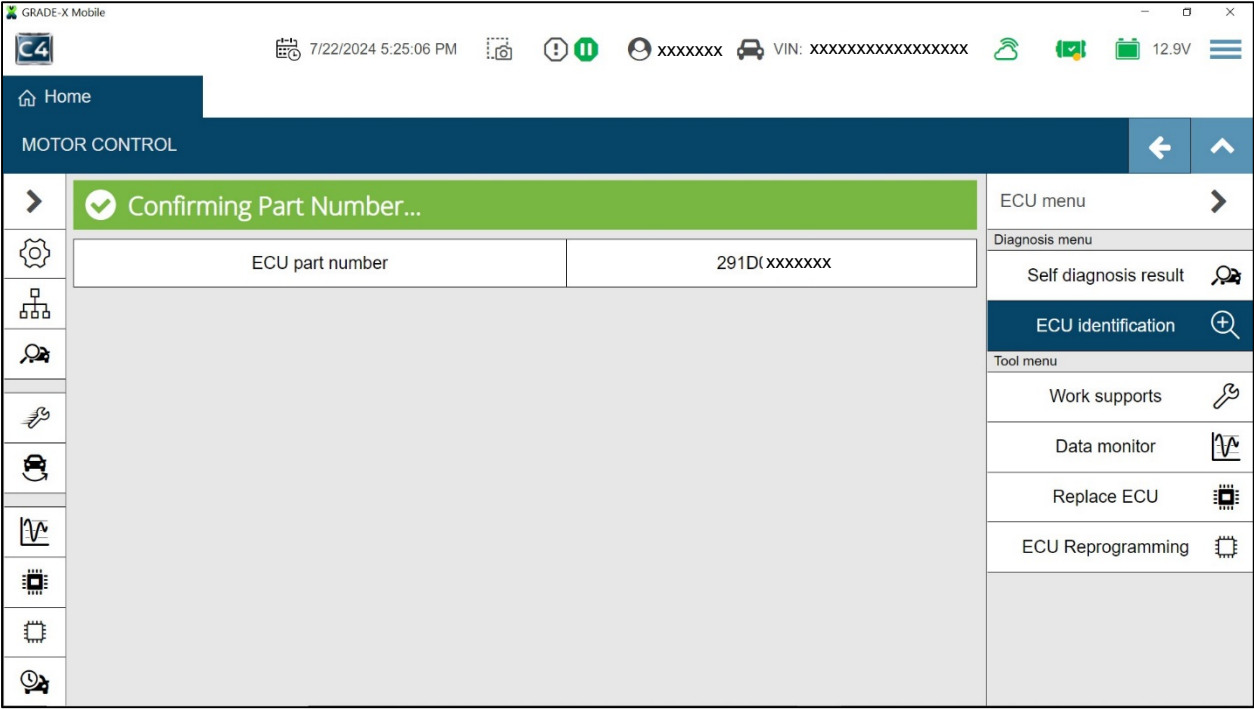
Figure 6

13. Print the screen showing the **MOTOR CONTROL ECU part number** and attach it to the repair order.

- If the vehicle is FWD, continue to step 14 on page 7.
- If the vehicle is AWD, repeat steps 11-13 on pages 5-6 by selecting **REAR MOTOR CONTROL**.
 - Continue to step 14 on page 7.
