**HYUNDAI**  
**Technical Service Bulletin**

GROUP <b>RECALL</b>	NUMBER <b>24-01-065H</b>
DATE <b>AUGUST 2024</b>	MODEL(S) <b>SONATA (DN8)</b>

**SUBJECT:** ESC SOFTWARE UPDATE FOR EMERGENCY STOP SIGNAL (ESS) FEATURE DEACTIVATION (RECALL 267)

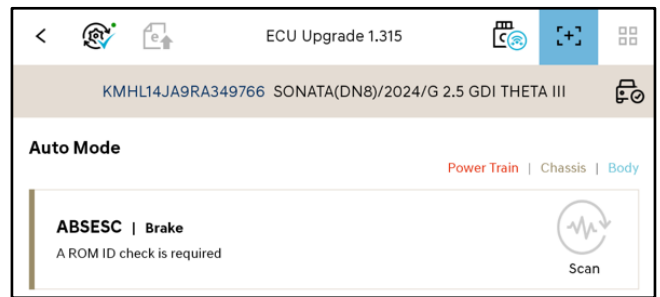
Check the current ROM ID version and compare it to the ROM ID Information table before attempting to perform the software update.

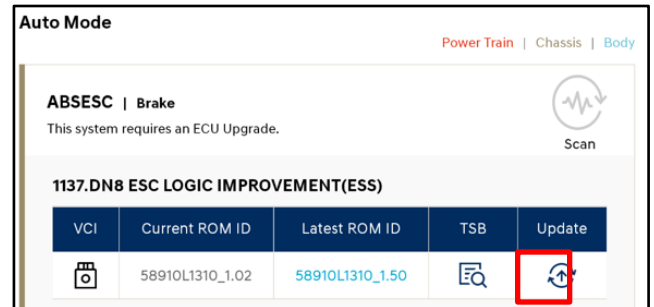
3. Under Event #1137. **DN8 ESC Logic Improvement (ESS)**, verify the current ROM ID and latest ROM ID. Refer to the **ROM ID Information** table for applicable ROM IDs.

Select the icon under “Update” to start update.

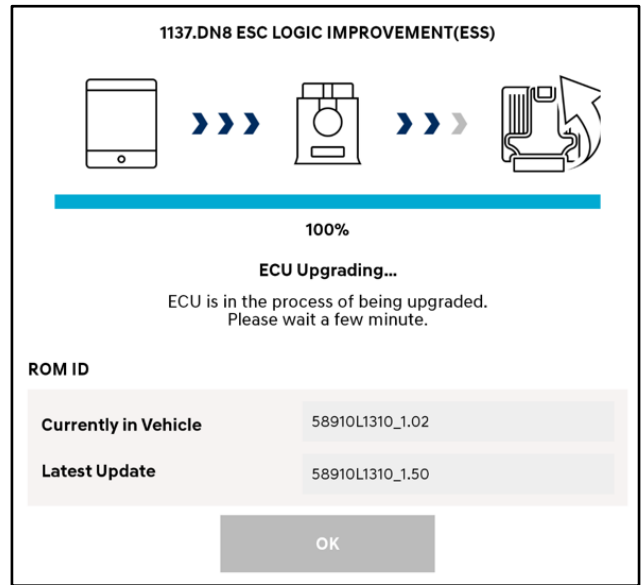
- 4. ECU update will start and progress to 100%.

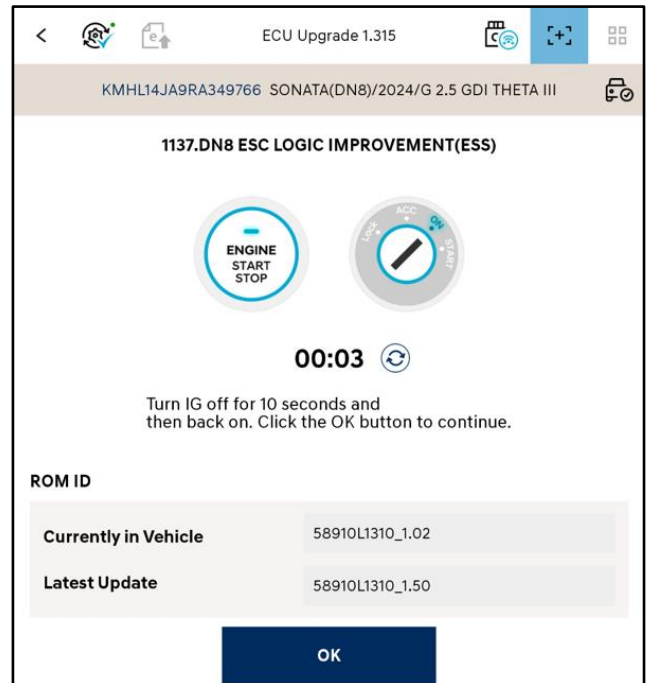
- 3. After the ECU update process shows 100% complete, follow the prompts on the screen to cycle the ignition **OFF** for at least **10 seconds** to reset the control unit.

Use the **Refresh** button to reset the timer.
