### N242453471 Reduction or Loss of Braking at Low Speeds

Release Date: August 2024 Revision: 00

Condition	General Motors has decided that a defect which relates to motor vehicle safety may exist in certain 2023 – 2024 model year Cadillac LYRIQ all-wheel drive vehicles. In rare circumstances, during certain braking events on dry surfaces at speeds below 25 mph, the vehicle may exhibit overly sensitive anti-lock braking system (ABS) control. In these conditions, if ABS falsely activates and a specific sequence of wheel movements occurs, the vehicle's ABS system will continue to release the braking pressure in the vehicle's service brake system. A release of braking pressure can cause the service brakes to have reduced stopping performance or become inoperative, increasing the risk of a crash.				
Correction	General Motors will update the software in the vehicles' Electronic Brake Control Module (EBCM) to correct the condition. Owners who have accepted applicable terms and conditions will have the opportunity to accept these software changes using wireless over-the-air (OTA) technology without having to bring their vehicle to a dealership. Alternatively, owners may schedule to have

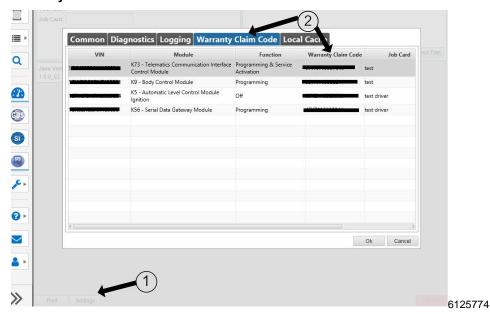
#### **Warranty Claim Code Information Retrieval**

If the Warranty Claim Code was not recorded on the Job Card, the code can be retrieved in the SPS2 system as follows:

- 1. Open TLC on the computer used to program the vehicle.
- 2. Select and start SPS2.
- 3. Select Settings (1).
- 4. Select the Warranty Claim Code tab (2).

The VIN, Warranty Claim Code and Date/Time will be listed on a roster of recent programming events. If the code is retrievable, dealers should resubmit the transaction making sure to include the code in the SPS Warranty Claim Code field.

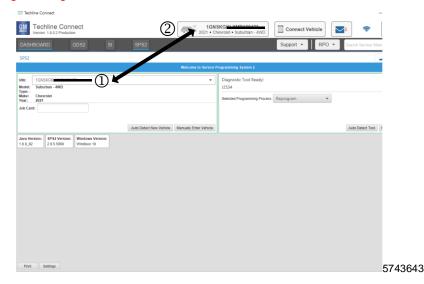
**Caution:** Be sure the VIN selected in the drop down menu (1) is the same as the vehicle connected (2) before beginning programming.

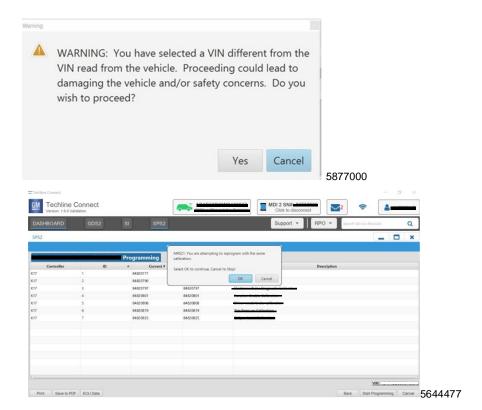
Important: If the vehicle VIN DOES NOT match, the message below will be shown.

Important: Techline Connect screens shown above.
