**SAFETY RECALL**  
 NORTH AMERICA  
**Instrument Panel Cluster**

Reference: 30B / NHTSA 24V-652

Remedy available for  
 2024 (JL) Jeep Wrangler  
 2024 (JT) Jeep Gladiator

This recall applies only to the above vehicles equipped with a 3.5" Instrument Panel Cluster (IPC).

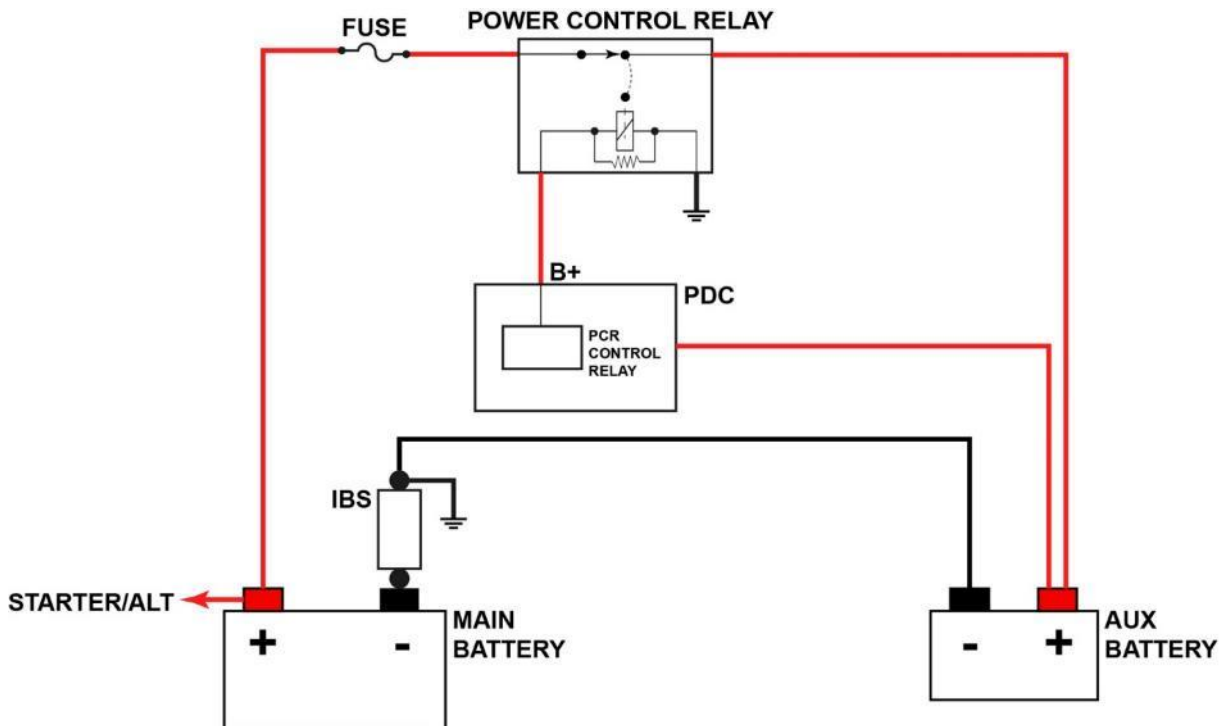
**Figure 9 – Battery System**

**NOTE:** On this dual battery system the auxiliary battery ground cable connects to the main battery cable end (shown in generic graphic above) and grounds through the main battery ground cable connection to the body, chassis, or engine (depending on vehicle). Therefore, simply disconnecting and isolating the main battery negative cable clamp from the main battery post will not isolate the auxiliary from the vehicle's electrical system. The auxiliary battery will still be grounded through its connection to the main battery negative cable end. If both battery negative cables are not isolated, it will result in the vehicle electrical system and Power Distribution Center (PDC) still having battery connection which can cause vehicle wiring damage or deployment of air bags on re-connection. (Figure 9).

1. Open the hood and turn the ignition off. Wait five minutes to allow the main modules to go to sleep.
2. Disconnect and isolate the supplemental (auxiliary) battery negative cable from the main battery negative cable end. This will disconnect and isolate the auxiliary battery ground.
3. The main battery ground can be disconnected by removing the main battery negative cable from the negative battery cable end, or by disconnecting the IBS connector, loosening the negative battery clamp nut and removing the negative battery cable end from the battery post. Either method will disconnect the main battery. Both batteries should be disconnected from the vehicle electrical system.

51. Connect the main battery clamp to the negative post and tighten to 7 N·m (62 In. Lbs.), or connect the main battery negative cable To Intelligent Battery Sensor (IBS) with a nut and tighten to 12 N·m (9 Ft. Lbs.) (Figure 9).
52. Connect the IBS harness connector if disconnected (Figure 9).
53. Connect the auxiliary battery negative cable to the main battery negative cable clamp. If connected by a nut, install the nut and tighten to 5 N·m (44 In. Lbs.) (Figure 9).

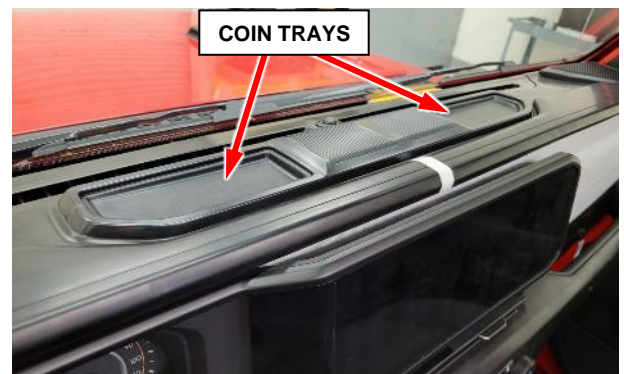
**Figure 10 – Coin Trays**

5. Remove both rubber coin trays from the coin tray bezel (Figure 10).

50. Install both rubber coin trays to the coin tray bezel (Figure 10).

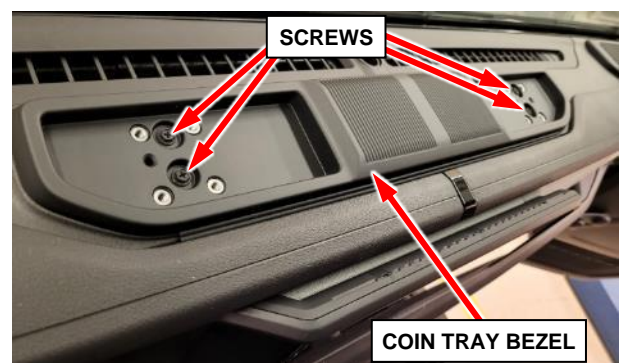
**Figure 11 – Coin Tray Bezel**

6. Remove the screws securing the coin tray bezel to instrument panel (Figure 11).

7. Remove the coin tray bezel from instrument panel (Figure 11).

48. Install the coin tray bezel to the instrument panel (Figure 11).
49. Install and tighten securely the screws securing the coin tray bezel to instrument panel (Figure 11).

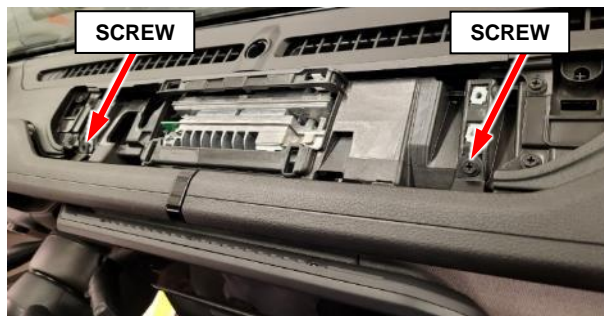
**Figure 12 – Instrument Panel Pad**

- 8. From under the coin tray bezel, remove the two screws securing the instrument panel pad (Figure 12).

45. Install the right side instrument panel end cap (Figure 14).
46. Install the instrument panel pad (Figure 13).
47. Install and tighten securely the two screws securing the instrument panel pad (Figure 11).

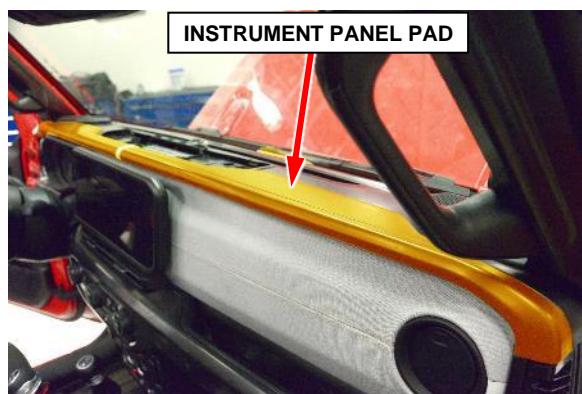
**Figure 13 – Instrument Panel Pad**

- 9. Use a trim stick or equivalent to release the retaining clips then remove the instrument panel pad (Figure 13).

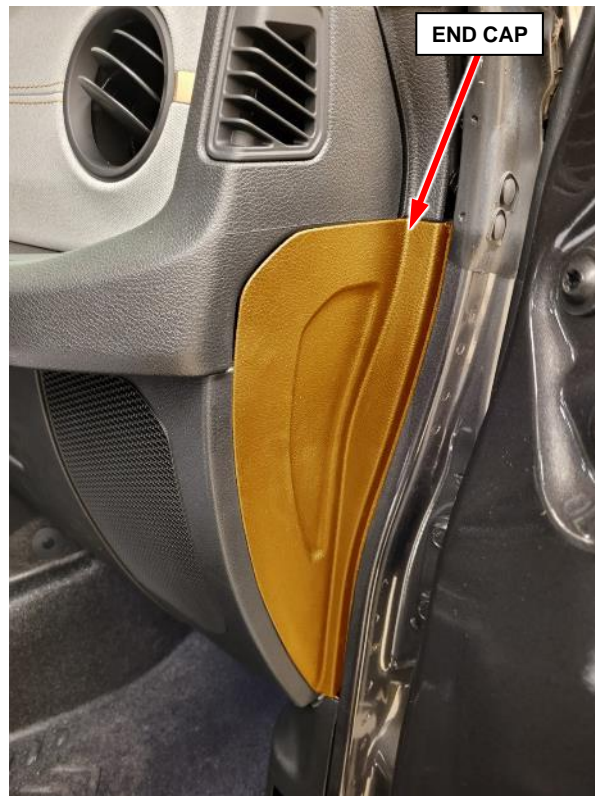
**Figure 14 – Instrument Panel End Cap**

10. Using a trim stick or equivalent, remove the right side instrument panel end cap (Figure 14).

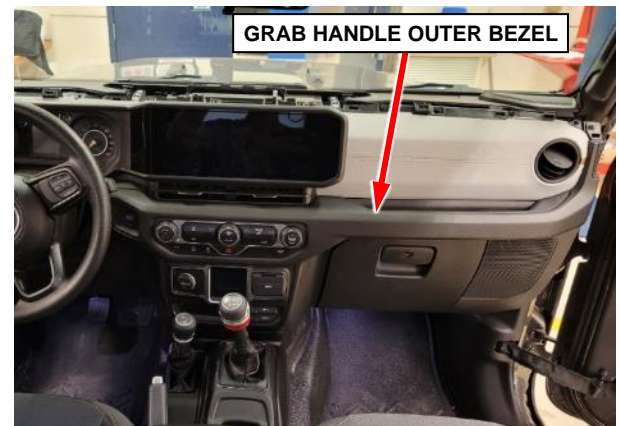
**Figure 17 – Grab Handle Outer Bezel**

14. Using a trim stick or equivalent, release the grab handle outer bezel including integrated center stack module from the instrument panel (Figure 17).

41. Install the grab handle outer bezel to the instrument panel (Figure 17).
42. Install and tighten securely the three screws (2) securing the grab handle outer bezel (3) to the grab handle bracket (Figure 16).

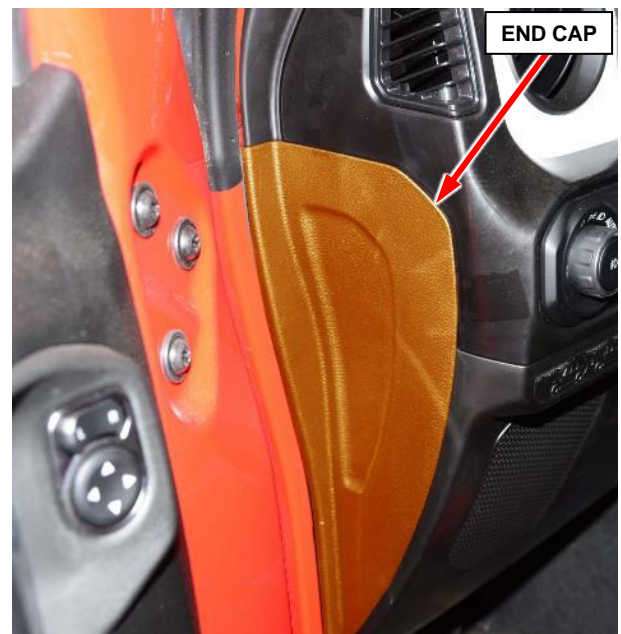
**Figure 23 – Instrument Panel End Cap**

22. Using a trim stick or equivalent, remove the left side instrument panel end cap (Figure 23).

34. Install the left side instrument panel end cap (Figure 23).

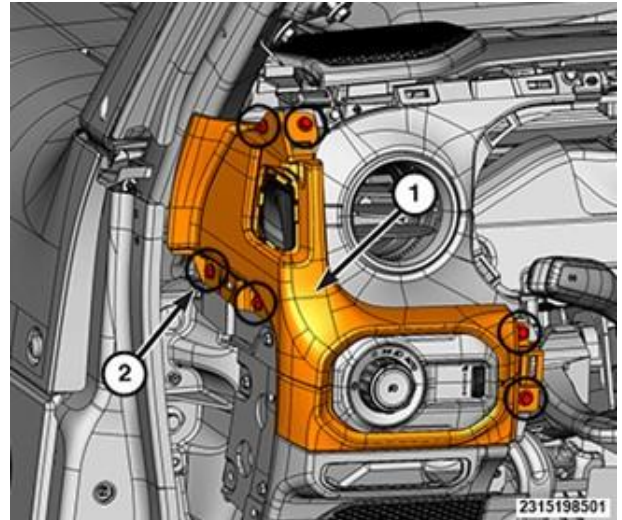
Figure 24 – Headlamp Switch Bezel

23. Remove the screws (2) securing the headlamp switch bezel (1) to the instrument panel reinforcement (Figure 24).
24. Disconnect the wire harness connector from the headlamp switch and remove the bezel (Figure 24).

33. Connect the wire harness connector to the headlamp switch then install the bezel (1) and tighten the screws (2) securely (Figure 24).

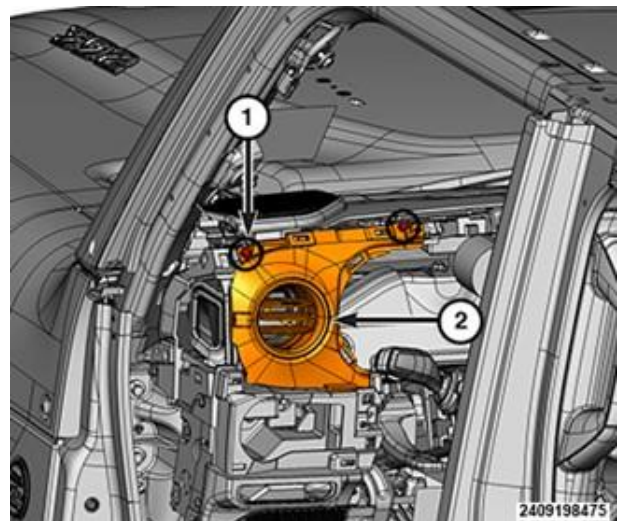
Figure 25 – Driver's Vent Assembly

25. Remove the fasteners securing the driver front outboard air outlet assembly to the instrument panel, then remove the driver's vent assembly from the vehicle (Figure 25).

28. Remove the IPC from the instrument panel.
29. Exchange the IPC for replacement pre-programmed with the correct mileage.
30. Connect the instrument panel wire harness connectors to the back of the **NEW** IPC (Figure 27).
31. Install the **NEW** IPC to the instrument panel and tighten the fasteners securely (Figure 26).
32. Install the driver front outboard air outlet assembly to the instrument panel and tighten the fasteners securely (Figure 25).

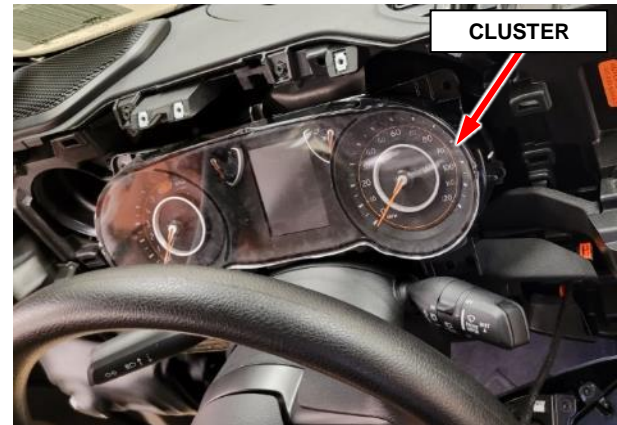
Figure 26 – Instrument Panel Cluster

26. Remove the four fasteners that secure the Instrument Panel Cluster (IPC) to the instrument panel (Figure 26).
