Remedy available for

2022-2024 (JL) Jeep Wrangler

2022-2024 (JT) Jeep Gladiator

SAFETY RECALL
NORTH AMERICA
Instrument Panel Cluster

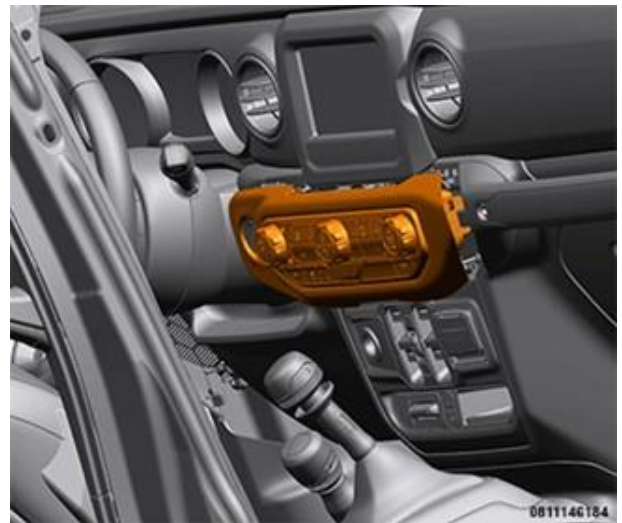
Figure 2 – Integrated Center Stack

5. Using trim stick C-4755 or equivalent, remove the Integrated Center Stack (ICS) and upper instrument panel center trim from the instrument panel (Figure 2).

19. Engage the retaining clips for the steering column shroud gap hider (1) (Figure 7).
20. Position the instrument cluster bezel (2), engage the lower retaining clips, then install the screws (1) and tighten securely (Figure 6).
21. Position the instrument panel pad (2) and engage the retaining clips, then install the screw (1) and tighten securely (Figure 5).
22. Position the radio bezel (2), engage the retaining clips then install two screws (1) and tighten securely (Figure 4).
23. Position the ICS to the vehicle (Figure 3).
24. Connect the wire harness connector to the KIN (Figure 3).
25. Connect the wire harness connector to the ICS (Figure 3).
26. Install the ICS and upper instrument panel center trim to the instrument panel (Figure 2).

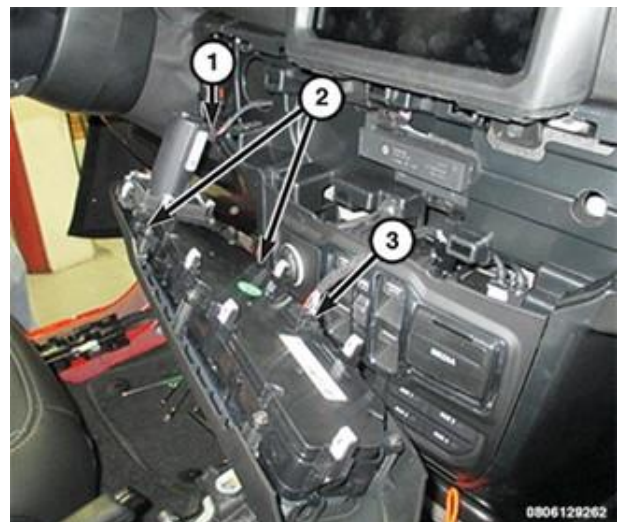
Figure 3 – Integrated Center Stack

6. Disconnect the wire harness connector from the ICS (Figure 3).
7. Disconnect the wire harness connector from the Keyless Ignition Node (KIN) (Figure 3).
8. Remove the ICS from the vehicle (Figure 3).

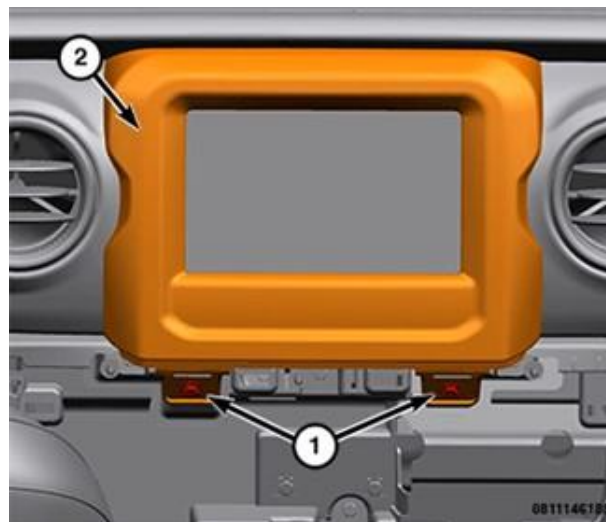
Figure 4 – Radio Bezel

9. Remove the two screws (1) then use a trim stick or equivalent to release the radio bezel (2) and remove (Figure 4).

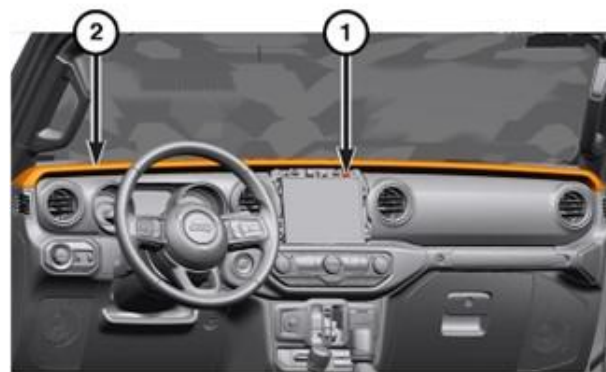
Figure 5 – Instrument Panel Pad

10. Remove the screw (1) then use a trim stick or equivalent to release the retaining clips for the instrument panel pad (2) then pull forward and out (Figure 5).

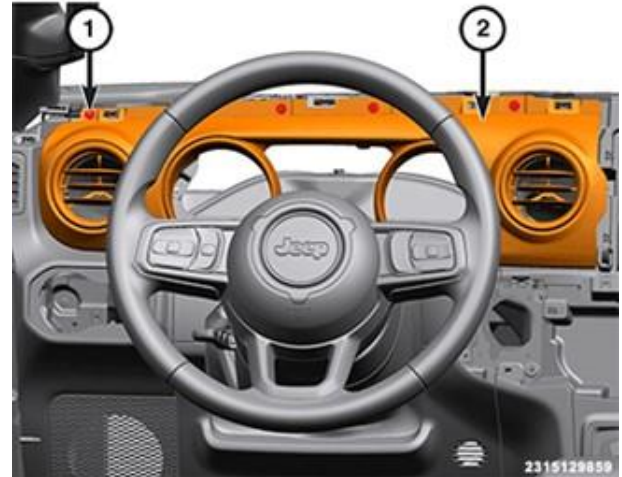
Figure 6 – Instrument Cluster Bezel

11. Remove the four screws (1) along the top of instrument cluster bezel (2) (Figure 6).

12. Using a trim stick or equivalent, disengage instrument cluster bezel from lower retaining clips and remove (Figure 6).

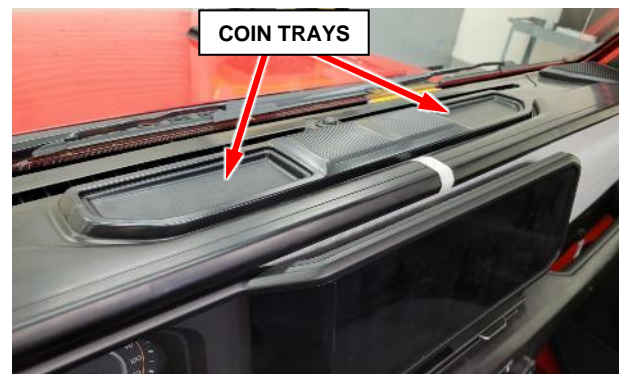
Figure 10 – Coin Trays

5. Remove both rubber coin trays from the coin tray bezel (Figure 10).

50. Install both rubber coin trays to the coin tray bezel (Figure 10).

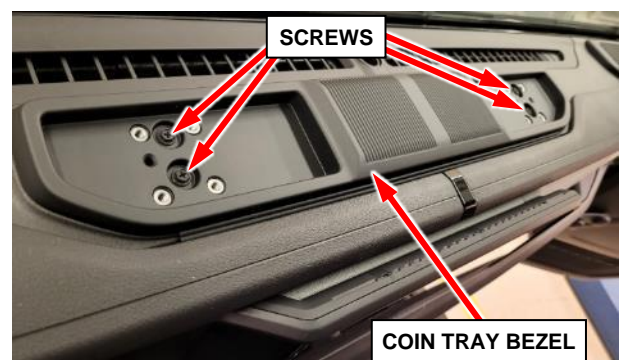
Figure 11 – Coin Tray Bezel

6. Remove the screws securing the coin tray bezel to instrument panel (Figure 11).

7. Remove the coin tray bezel from instrument panel (Figure 11).

48. Install the coin tray bezel to the instrument panel (Figure 11).
49. Install and tighten securely the screws securing the coin tray bezel to instrument panel (Figure 11).

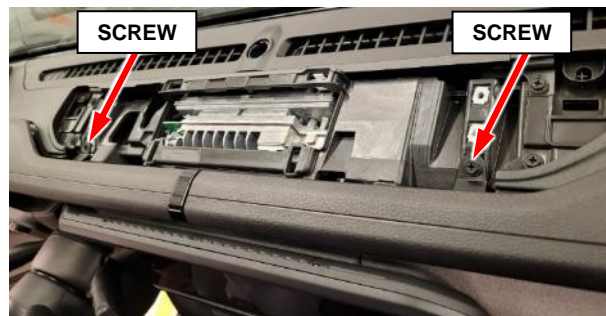
Figure 12 – Instrument Panel Pad

- 8. From under the coin tray bezel, remove the two screws securing the instrument panel pad (Figure 12).

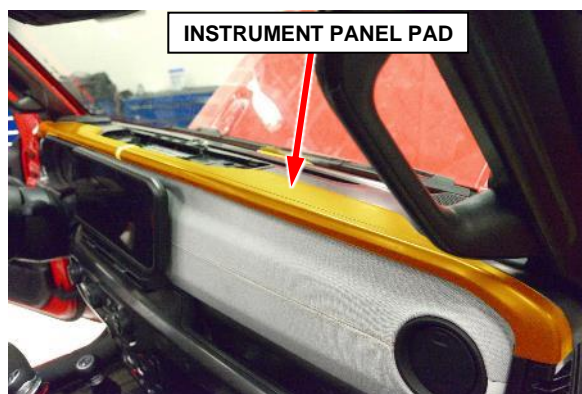
Figure 13 – Instrument Panel Pad

- 9. Use a trim stick or equivalent to release the retaining clips then remove the instrument panel pad (Figure 13).

45. Install the right side instrument panel end cap (Figure 14).
46. Install the instrument panel pad (Figure 13).
47. Install and tighten securely the two screws securing the instrument panel pad (Figure 11).

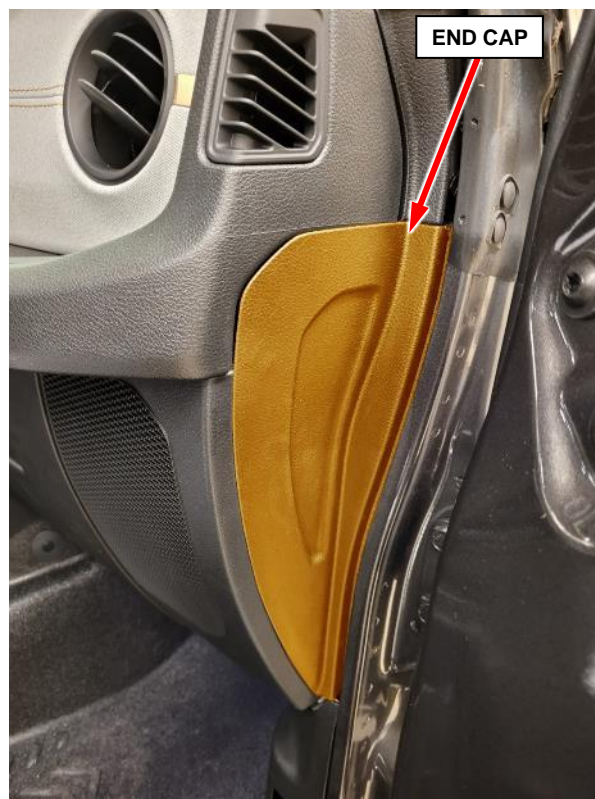
Figure 14 – Instrument Panel End Cap

10. Using a trim stick or equivalent, remove the right side instrument panel end cap (Figure 14).

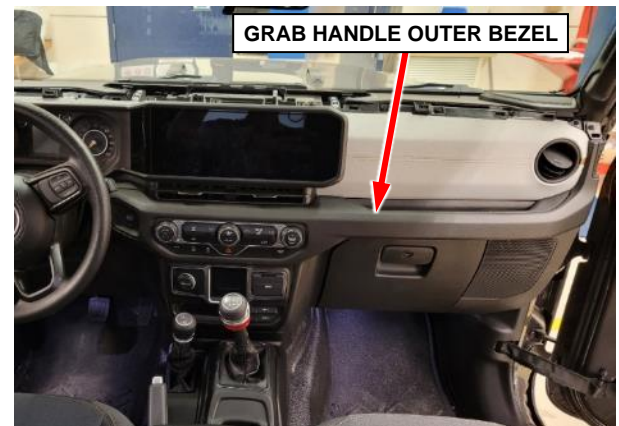
Figure 17 – Grab Handle Outer Bezel

14. Using a trim stick or equivalent, release the grab handle outer bezel including integrated center stack module from the instrument panel (Figure 17).

41. Install the grab handle outer bezel to the instrument panel (Figure 17).
42. Install and tighten securely the three screws (2) securing the grab handle outer bezel (3) to the grab handle bracket (Figure 16).

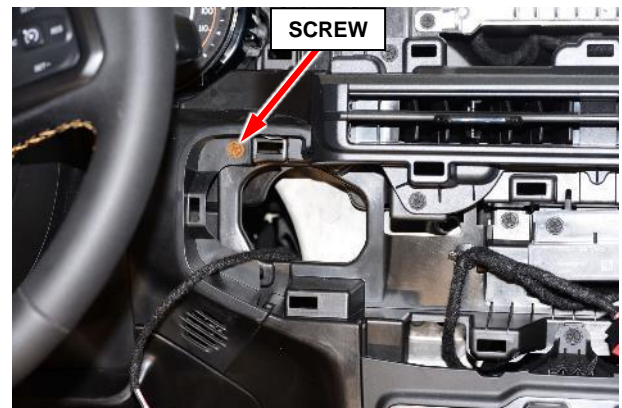
Figure 21 – Steering Column Shroud Gap Hider Screw

- 20. Remove the screw securing the steering column shroud gap hider (Figure 21).

35. Engage the retaining clips securing the steering column gap hider (Figure 22).
36. Install and tighten securely the screw securing the steering column gap hider (Figure 21).

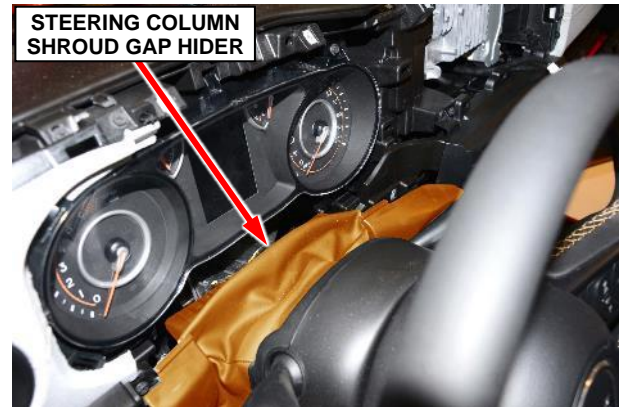
Figure 22 – Steering Column Shroud Gap Hider

21. Using a trim stick or equivalent, disengage the retaining clips to release the steering column gap hider (1) (Figure 22).

NOTE: Gap hider does not need to be fully removed to access the headlamp switch bezel retaining screws.

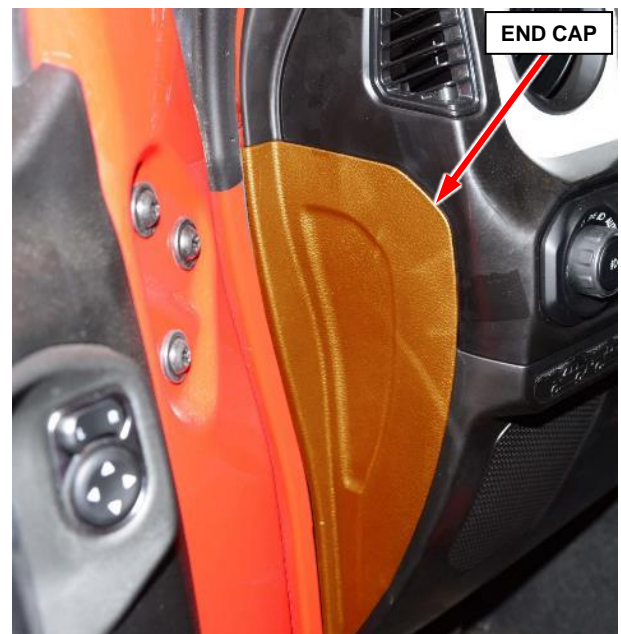
Figure 23 – Instrument Panel End Cap

22. Using a trim stick or equivalent, remove the left side instrument panel end cap (Figure 23).

34. Install the left side instrument panel end cap (Figure 23).

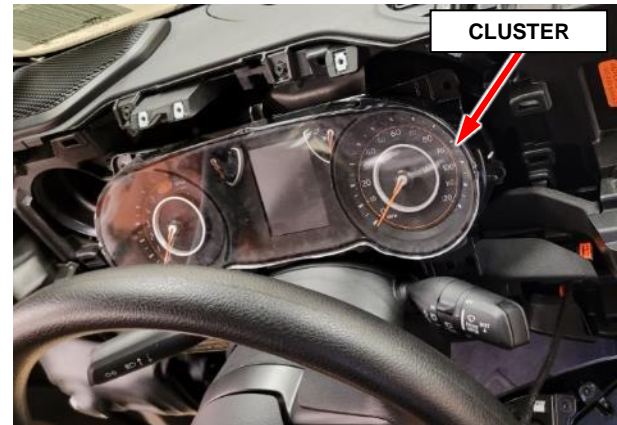
Figure 26 – Instrument Panel Cluster

26. Remove the four fasteners that secure the Instrument Panel Cluster (IPC) to the instrument panel (Figure 26).

28. Remove the IPC from the instrument panel.
29. Exchange the IPC for replacement pre-programmed with the correct mileage.
30. Connect the instrument panel wire harness connectors to the back of the **NEW** IPC (Figure 27).
31. Install the **NEW** IPC to the instrument panel and tighten the fasteners securely (Figure 26).
32. Install the driver front outboard air outlet assembly to the instrument panel and tighten the fasteners securely (Figure 25).

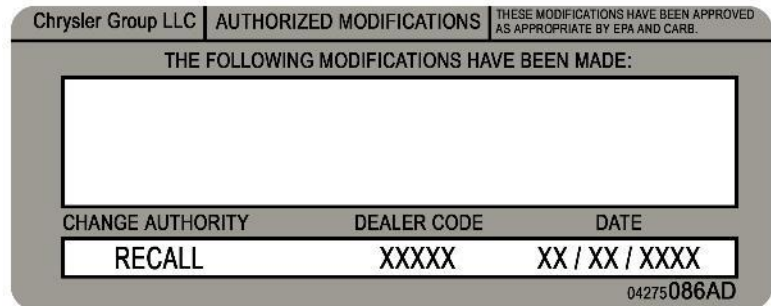
Figure 28 – Authorized Modifications Label

Type or print (with a ballpoint pen) the necessary information shown in (Figure 28) onto the Authorized Modifications Label. Then attach the label near the VECI label.

The image shows a rectangular label with a grey border. At the top left, it says "Chrysler Group LLC". To its right, in a larger font, is "AUTHORIZED MODIFICATIONS". Further right, in a smaller font, is "THESE MODIFICATIONS HAVE BEEN APPROVED AS APPROPRIATE BY EPA AND CARB.". Below this header, it says "THE FOLLOWING MODIFICATIONS HAVE BEEN MADE:" followed by a large empty rectangular box. Below the box is a table with three columns: "CHANGE AUTHORITY", "DEALER CODE", and "DATE". The first row of the table contains the text "RECALL", "XXXXX", and "XX / XX / XXXX". At the bottom right of the label, the number "04275086AD" is printed.
