N242447990 Failed Brake Fluid Leak Detection

Release Date: September 2024 Revision: 01

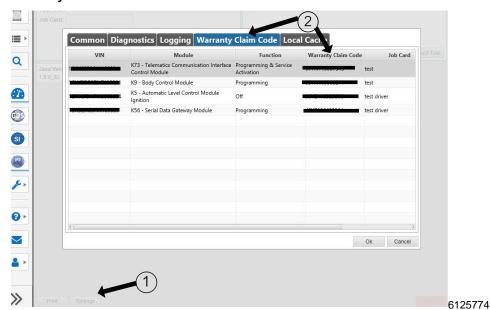
If the Warranty Claim Code was not recorded on the Job Card, the code can be retrieved in the SPS2 system as follows:

- 1. Open TLC on the computer used to program the vehicle.
- 2. Select and start SPS2.
- 3. Select Settings (1).
- 4. Select the Warranty Claim Code tab (2).

The VIN, Warranty Claim Code and Date/Time will be listed on a roster of recent programming events. If the code is retrievable, dealers should resubmit the transaction making sure to include the code in the SPS Warranty Claim Code field.

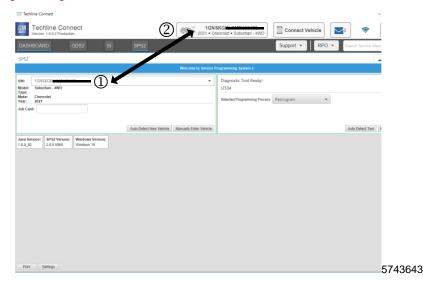
Caution: Be sure the VIN selected in the drop down menu (1) is the same as the vehicle connected (2) before beginning programming.

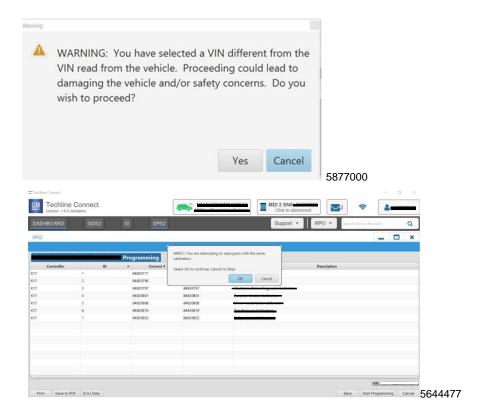
Important: If the vehicle VIN DOES NOT match, the message below will be shown.

Important: Techline Connect screens shown above.

Important: If the same calibration/software warning is noted on the TLC Summary screen, select OK and follow screen instructions. After a successful programming event, the WCC is located in the Service Programming System dialogue box of the SPS Summary screen. No further action is required. Refer to the Warranty section of the bulletin.
