VOLUNTARY RECALL CAMPAIGN

VOLUNTARY SAFETY RECALL CAMPAIGN 2019-2022 LEAF; HV BATTERY

CAMPAIGN ID #: P5A22
APPLIED VEHICLES: Specific 2019-2022 LEAF (ZE1)

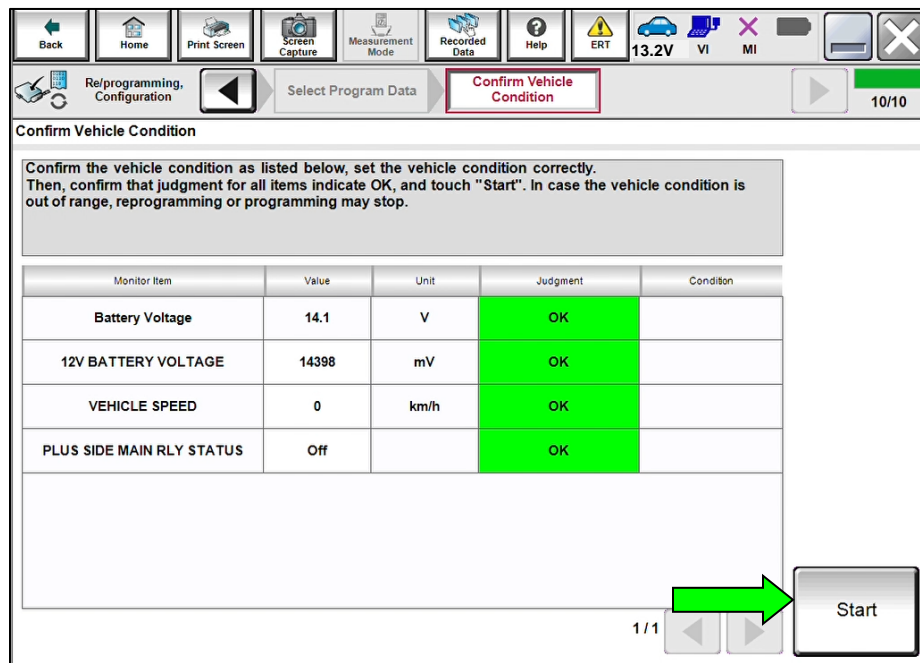
25. Confirm all Items listed have a judgement of “OK”, and then select **Start**.

- The reprogramming process will take approximately 10 minutes.

HINT: If any of the items shown in Figure 15 have a status of “NG”, verify the battery charger/maintainer is connected correctly and the vehicle is NOT in ready mode.

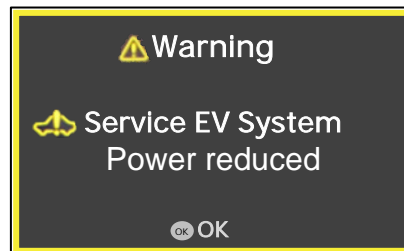
- Be sure to review and understand the drive pattern before beginning.
- If one of the warning messages shown in Figure 32 and Figure 33 sets during the drive pattern, return to the dealership without turning the vehicle OFF.
 - Do NOT turn the vehicle OFF until the vehicle has been returned to the dealership as the vehicle may not restart (Enter Ready mode) until DTCs are checked/erased. Skip to step 49 on page 26.
