VOLUNTARY RECALL CAMPAIGN

Classification: EL25-008A	Reference: NTB25-043A	Date: October 15, 2025
------------------------------	--------------------------	---------------------------

VOLUNTARY SAFETY RECALL CAMPAIGN 2019-2020 LEAF; HV BATTERY

CAMPAIGN ID #: P5A22
APPLIED VEHICLES: Specific 2019-2020 LEAF (ZE1)

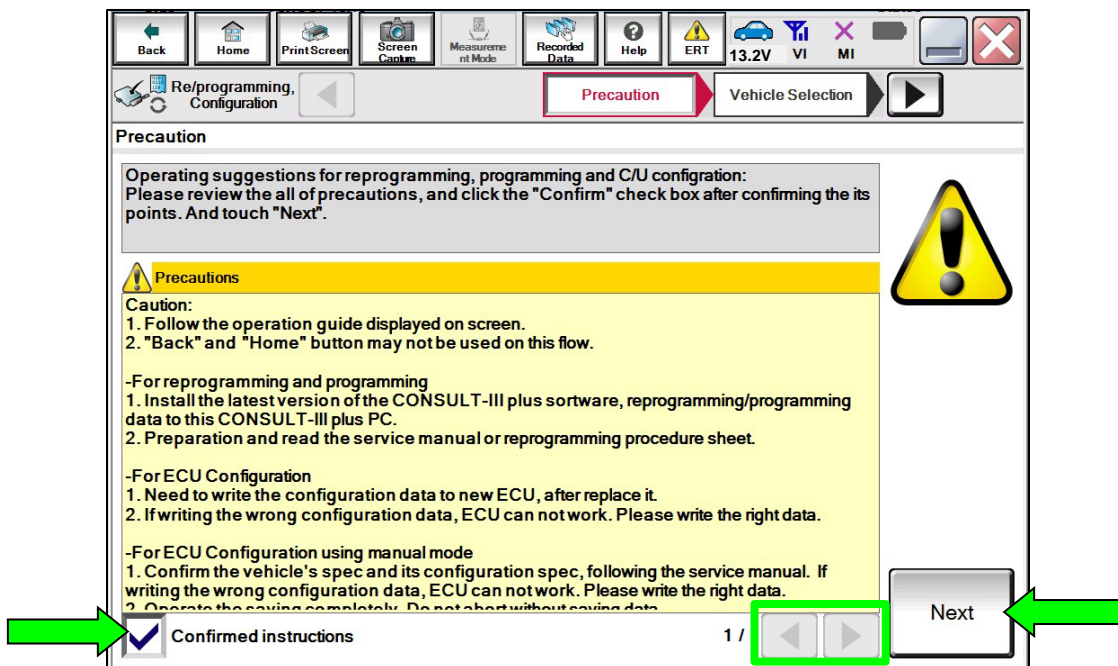
Figure 24

35. Use the arrows (if needed) to view and read all precautions.

36. Check the box confirming the precautions have been read, and then select **Next**.
