## **UPDATE: Recall 24V-716 Delivery Stop R18 Model's Control Unit Reverser**

Recall 24V-716 with final repair has been posted for R 18 reverser

[RECALL 24V-716: 61 03 25 R 18 Reverser](#) Bulletin has been released today Feb 24th 2025.

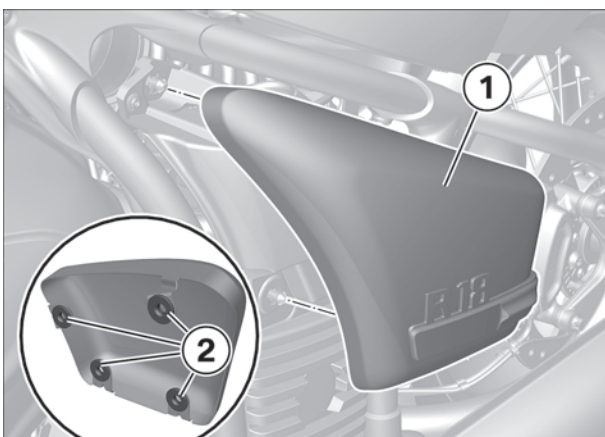
**2**

**► Removing left side cap**

- Pull off side cover **(1)** with rubber grommets **(2)** and remove.

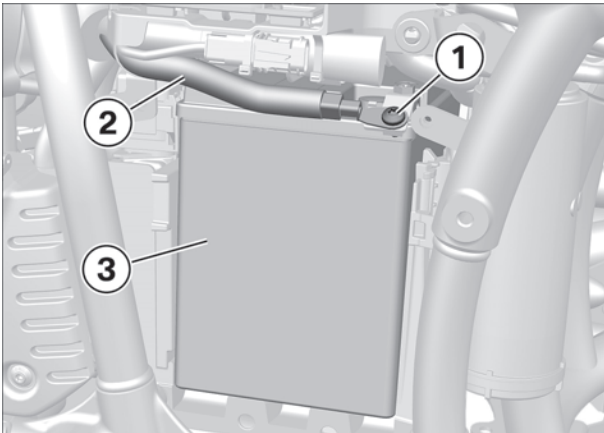
4

► **Disconnect battery from vehicle**

Ignition is switched OFF.

- Remove screw (1) and loosen negative wire (2) from battery (3).
- Insulate negative wire (2) with adhesive tape or similar.
