High Voltage Battery

Reference: 95B / NHTSA 24V-720 FCA US LLC

2020 - 2024 (JL) Jeep Wrangler

C. (JL) Jeep Wrangler - High Voltage Battery Pack Replacement

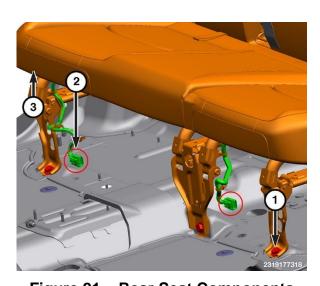
Figure 21 – Rear Seat Components

- 1 Rear Seat Bolts
- 2 Wire Harness Connectors
- 3 Rear Seat

- 33. Disconnect the wire harness connectors (2), if equipped (Figure 21).
- 34. Remove the bolts (1) at the front of the rear seat (Figure 21).
