GROUP	MODEL
Noncompliance Safety Recall Campaign	2024-2025MY EV9 (MV1)
NUMBER	DATE
SC326 (Rev 3, 01/09/2025)	October 2024

### CLUSTER DISPLAY LOGIC IMPROVEMENT (SC326)

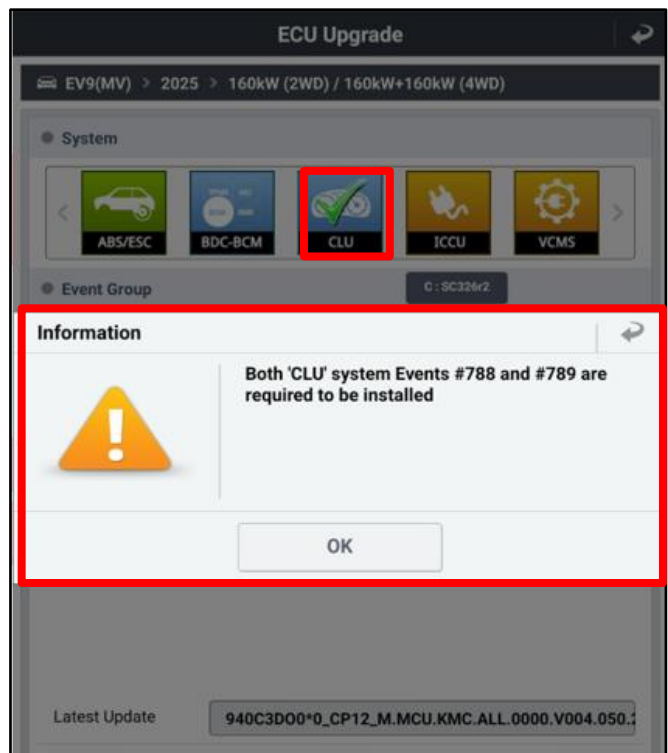
### 2. **UPGRADE BOTH EVENTS:**

- 788.MV CLU (12 inch) Operation Logic Improvement (AP)

### **AND THEN**

- 789.MV CLU (12 inch) Operation Logic Improvement (MPU)

**Note:** After SW Event #788 has completed installation, an audible 'beep' may be heard until SW Event #789 begins to be installed.
