GROUP	MODEL
Noncompliance Safety Recall Campaign	2024-2025MY EV9 (MV1)
NUMBER	DATE
SC326	October 2024

SUBJECT: **CLUSTER DISPLAY LOGIC IMPROVEMENT (SC326)**

This bulletin provides the procedure to update the software logic of the Cluster 'CLU' system on certain 2024MY EV9 (MV1) vehicles produced from September 25, 2023 through May 27, 2024 and one (1) 2025MY EV9 (MV1) in a US Territory produced on August 6, 2024. Due to a software logic error, the instrument cluster screen may become intermittently blank at vehicle start up, resulting in the driver's inability to see certain telltales and indicators required by the Federal Motor Vehicle Safety Standard (FMVSS) 101 such as the odometer, speedometer, and turn signal indicator. As a result, the subject vehicles do not comply with the visibility and illumination requirements of FMVSS 101. A blank instrument cluster screen cannot show certain information such as the speedometer or other telltales and indicators, thereby increasing the risk of a crash. Follow the procedure outlined in this publication to apply the improved logic to the 'CLU' system using the KDS ECU Upgrade function in Manual Mode only as described in this bulletin. Fo

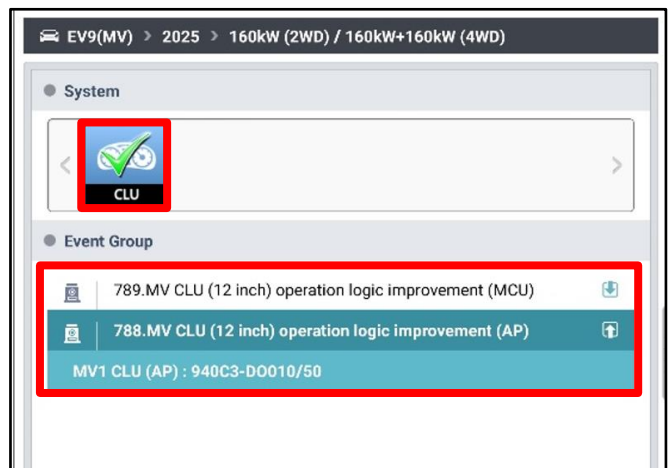
2. **UPGRADE BOTH EVENTS:**

- 788.MV CLU (12 inch) Operation Logic Improvement (AP)
- 789.MV CLU (12 inch) Operation Logic Improvement (MPU)

Note: After SW Event #788 has completed installation, an audible 'beep' may be heard until SW Event #789 begins to be installed.

The audible 'beep' is normal.
