GROUP	MODEL
Noncompliance Safety Recall Campaign	2024-2025MY EV9 (MV1)
NUMBER	DATE
SC326 (Rev 2, 12/20/2024)	October 2024

NONCOMPLIANCE SAFETY RECALL CAMPAIGN

CLUSTER DISPLAY LOGIC IMPROVEMENT (SC326)

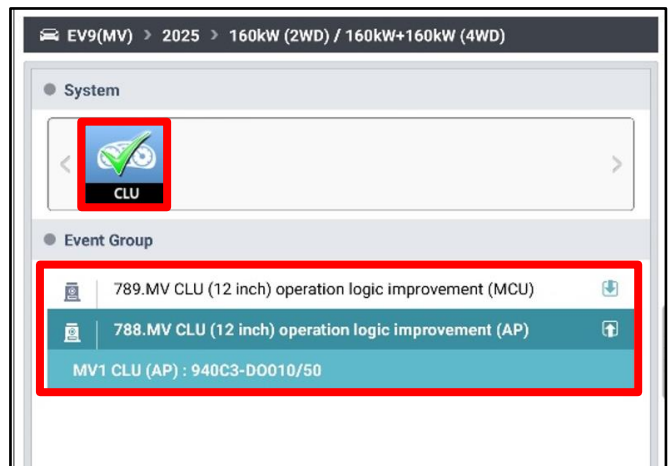
2. **UPGRADE BOTH EVENTS:**

- 788.MV CLU (12 inch) Operation Logic Improvement (AP)

AND

- 789.MV CLU (12 inch) Operation Logic Improvement (MPU)

Note: After SW Event #788 has completed installation, an audible 'beep' may be heard until SW Event #789 begins to be installed.
