# SAFETY RECALL

Volvo Trucks North America

**Bendix ABS ECU  
VAH, VHD, VN, VNRE**

Volvo Trucks has determined that certain VAH, VHD, VN, and VNRE model vehicles equipped with Bendix EC-80 ABS and towing capability may get an ABS fault due to miscommunication with the trailer. This could impact the ABS/ESP/AEB performance which could result in improper responses from the ABS system. The system may respond incorrectly to the event which could increase the likelihood of a crash.

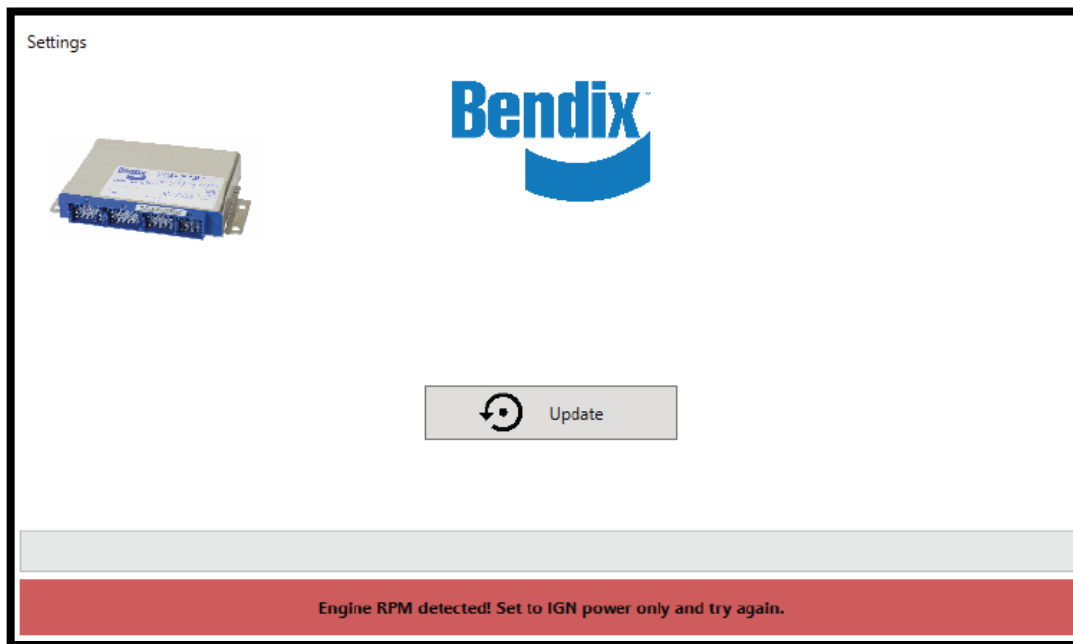
2. If engine RPM is detected during the procedure, power cycle to ignition only and restart the update procedure from Step 11.
