# SAFETY RECALL

Mack Trucks Inc.  
Greensboro, NC USA

**Bendix ABS ECU  
AN, GR, PI, TE**

**Rev. 4 date: 12/19/2024**

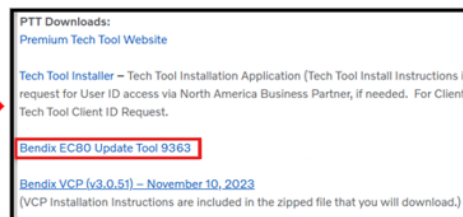
2. Select Bendix EC80 Update tool under PTT downloads.

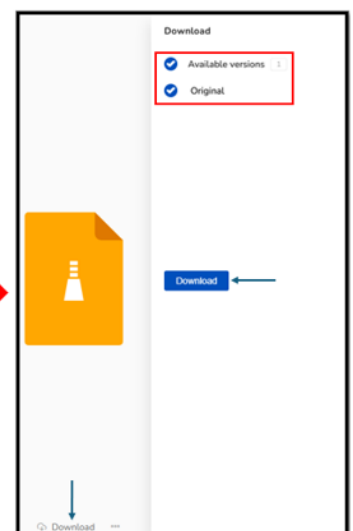
4. Select download, check **original**, click **blue download** option.

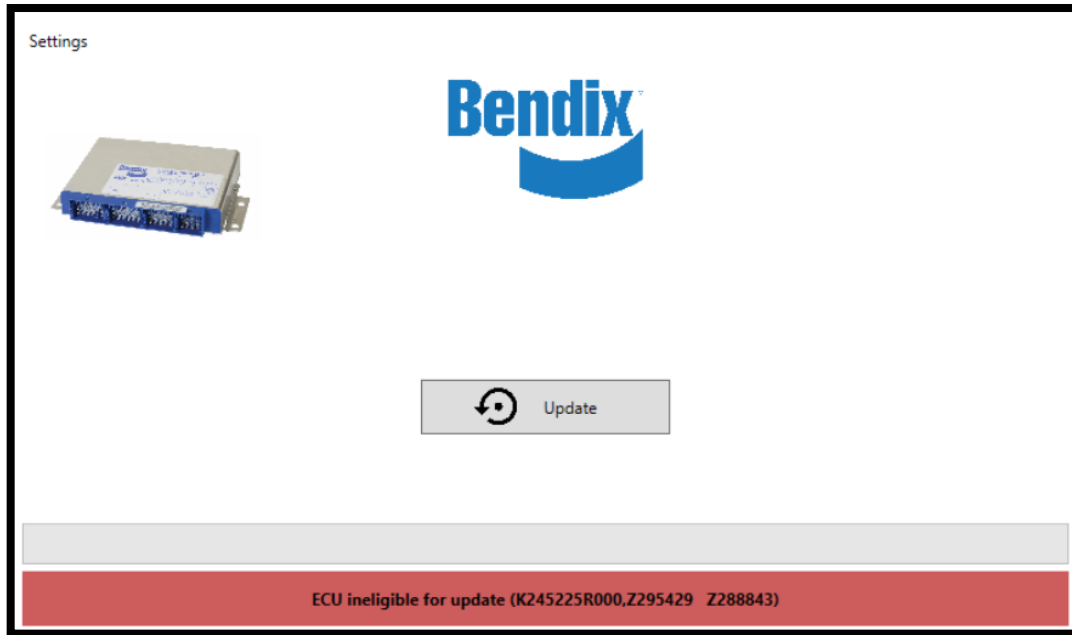
1. If the detected ECU is not eligible for an update, truck can be released for service.

16. If the update ***fails or errors or ends in an errored state (examples of errors below)***, the screen will show the software was not able to update. Power cycle the vehicle and restart the update procedure from Step 11.
