# SAFETY RECALL

Mack Trucks Inc.  
Greensboro, NC USA

**Bendix ABS ECU  
AN, GR, PI, TE**

Mack trucks has determined that certain AN, GR, PI, and TE model vehicles equipped with Bendix EC-80 ABS and towing capability may get an ABS fault due to miscommunication with the trailer. This could impact the ABS/ESP/AEB performance which could result in improper responses from the ABS system. The system may respond incorrectly to the event which could increase the likelihood of a crash.

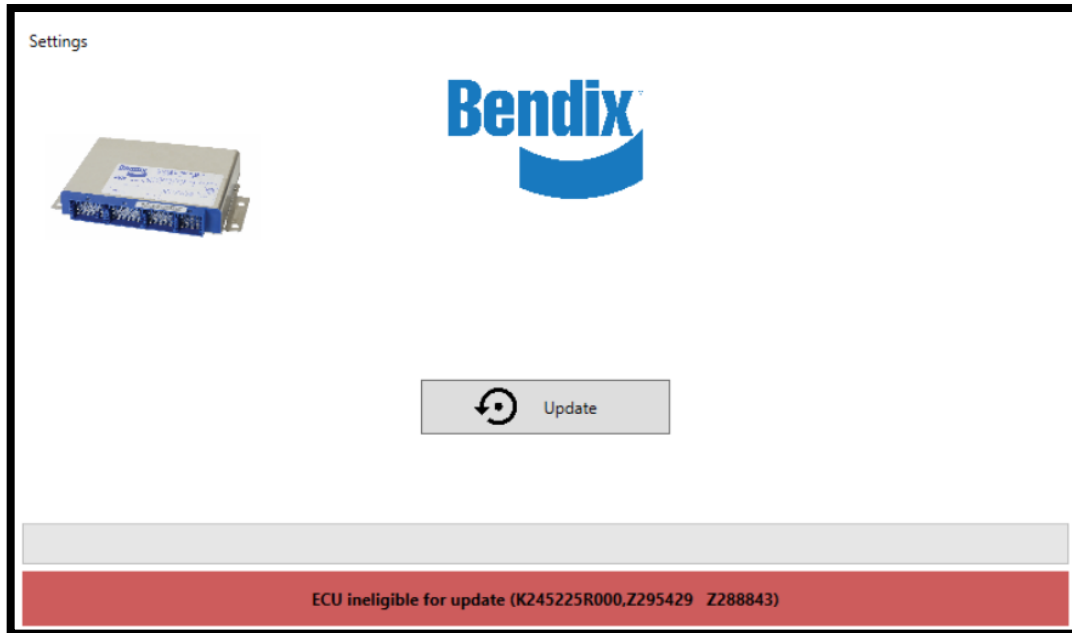
16. If the update ***fails or errors or ends in an errored state (examples of errors below)***, the screen will show the software was not able to update. Power cycle the vehicle and restart the update procedure from Step 11.

1. If the detected ECU is not eligible for an update, truck can be released for service.

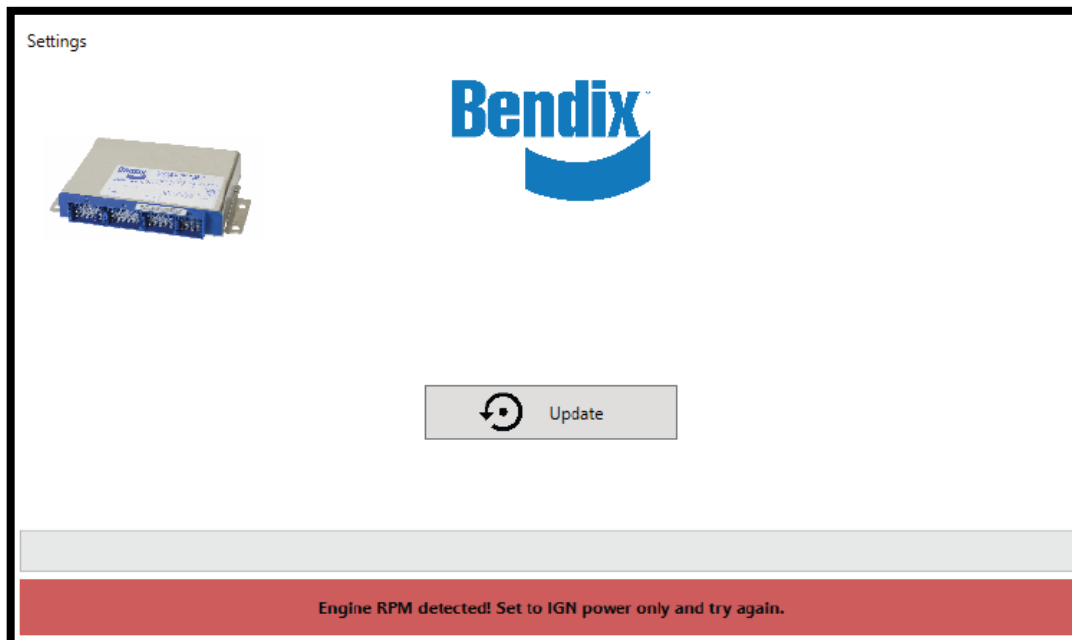
2. If engine RPM is detected during the procedure, power cycle to ignition only and restart the update procedure from Step 11.
