SAFETY RECALL

Date	Number	Release	Page
11.2024	SC0472	03	1(9)

**Bendix ABS ECU
AN, GR, PI, TE**

Mack trucks has determined that certain AN, GR, PI, and TE model vehicles equipped with Bendix EC-80 ABS and towing capability may get an ABS fault due to miscommunication with the trailer. This could impact the ABS/ESP/AEB performance which could result in improper responses from the ABS system. The system may respond incorrectly to the event which could increase the likelihood of a crash.

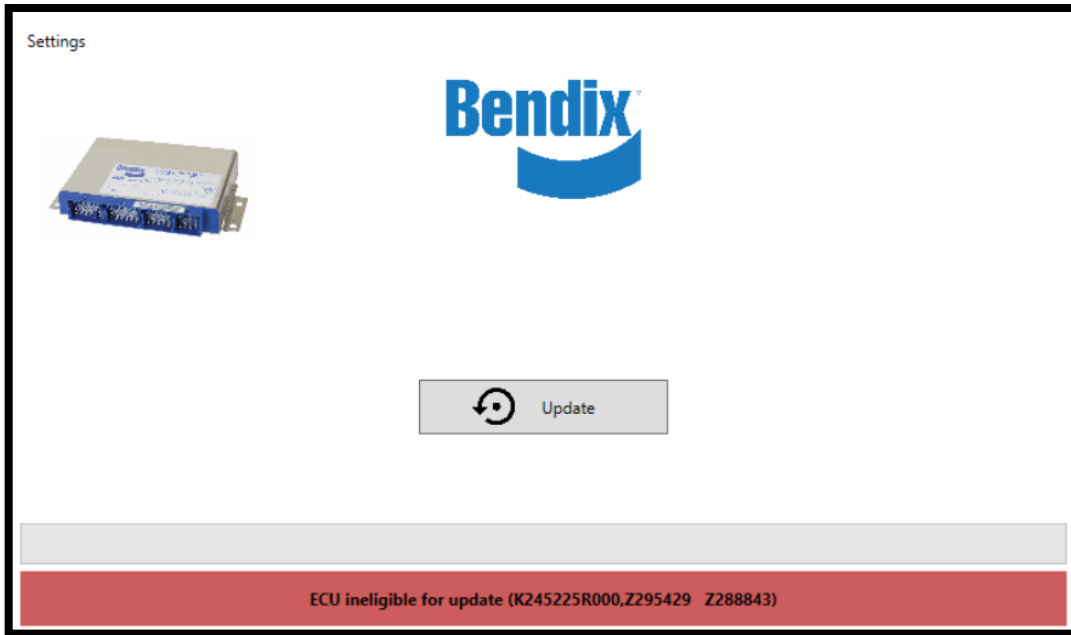
15. If the update ***fails or errors or ends in an errored state (examples of errors below)***, the screen will show the software was not able to update. Power cycle the vehicle and restart the update procedure from Step 11.

1. If the detected ECU is not eligible for an update, truck can be released for service.

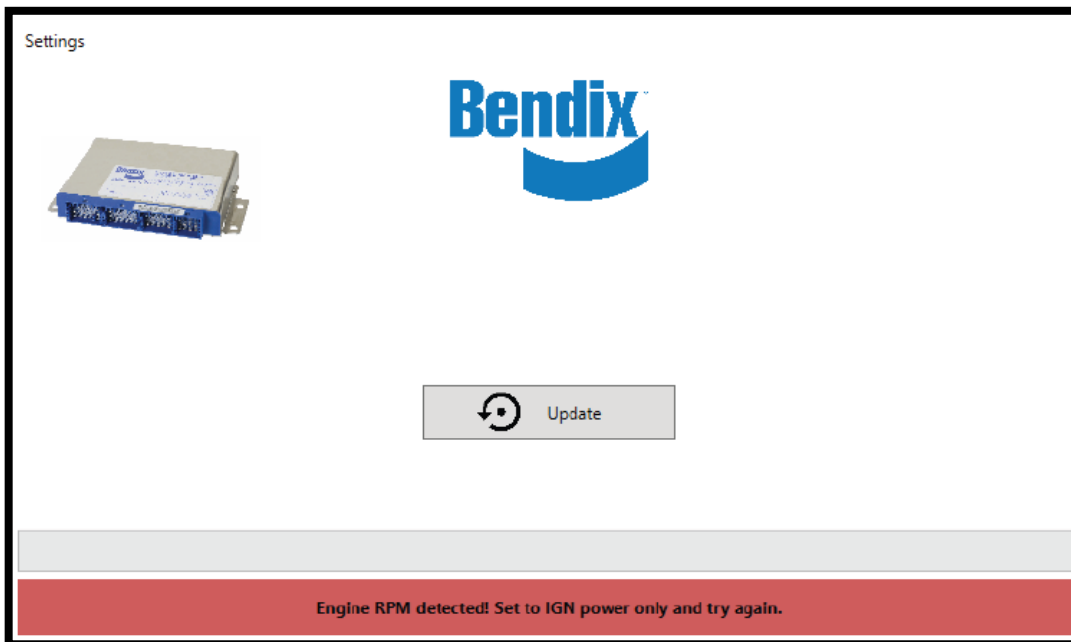
2. If engine RPM is detected during the procedure, power cycle to ignition only and restart the update procedure from Step 11.
