Safety Recall

N242454440 Momentary Rear Wheel Lock-Up

Release Date: January 2025

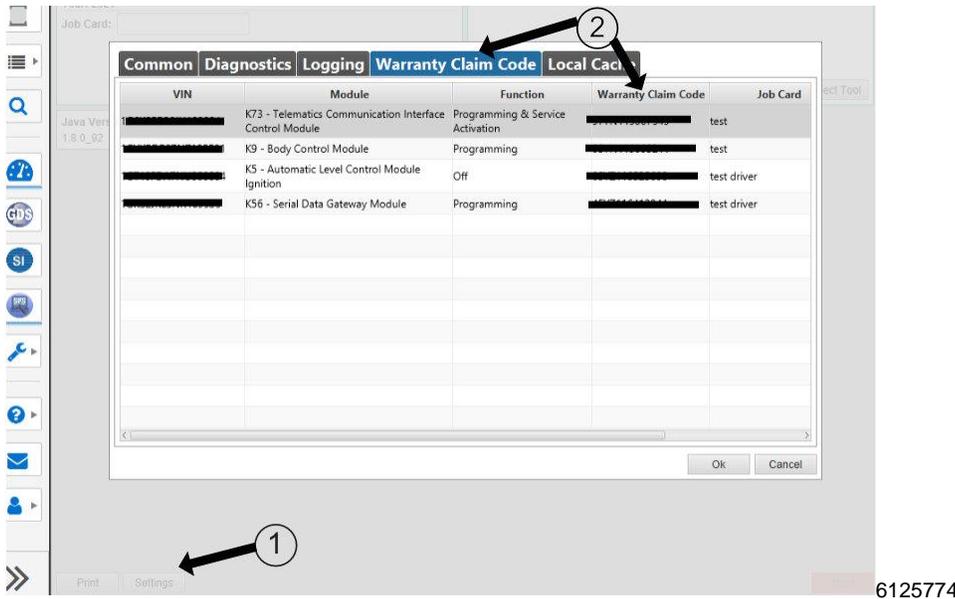
If the Warranty Claim Code was not recorded on the Job Card, the code can be retrieved in the SPS2 system as follows:

1. Open TLC on the computer used to program the vehicle.
2. Select and start SPS2.
3. Select Settings (1).
4. Select the Warranty Claim Code tab (2).

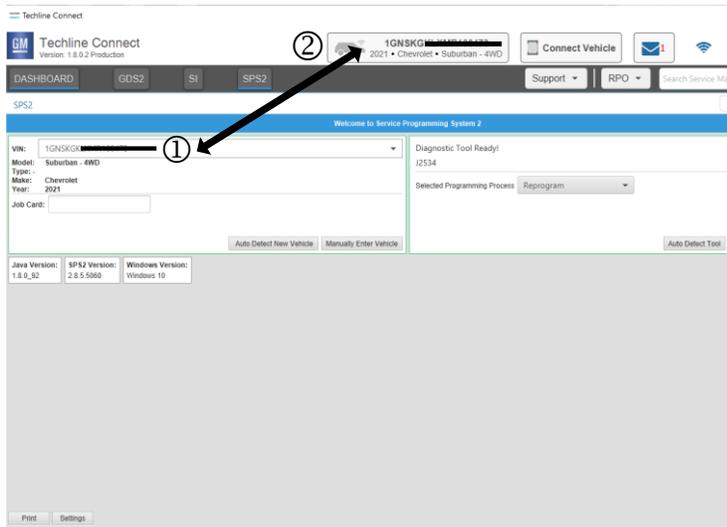
5743643

Important: Techline Connect screens shown above.

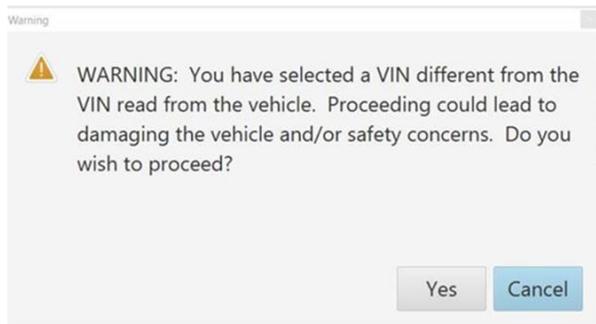
5877000

Important: If the vehicle VIN DOES NOT match, the message below will be shown.

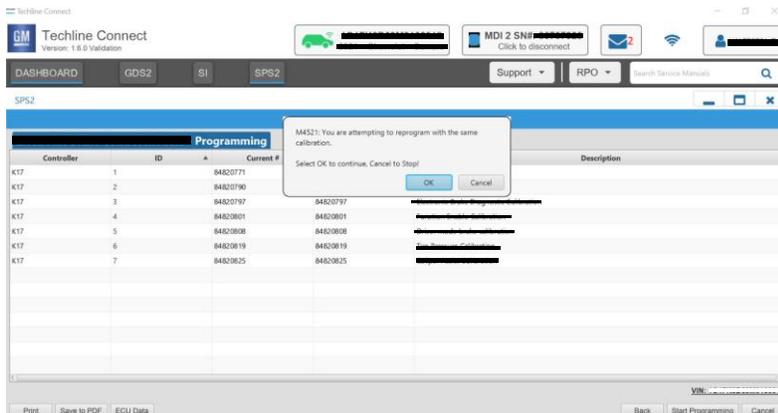
5644477

Important: If the same calibration/software warning is noted on the TLC Summary screen, select OK and follow screen instructions. After a successful programming event, the WCC is located in the Service Programming System dialogue box of the SPS Summary screen. No further action is required. Refer to the Warranty section of the bulletin.

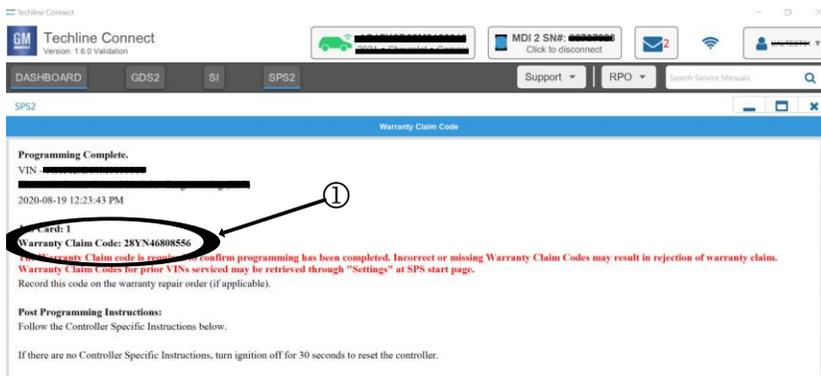
5644478

Note: The screenshot above is an example of module programming and may not be indicative of the specific module that is being programmed. Module selection and VIN information have been blacked out.
