Safety Recall

N242454440 Momentary Rear Wheel Lock-Up

Release Date: December 2024

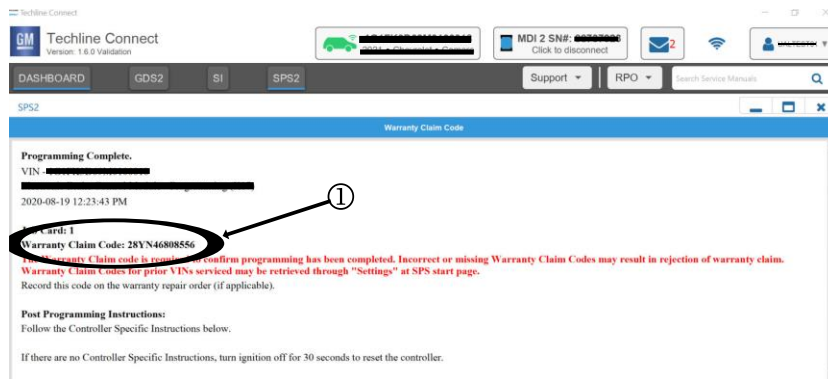
5644478

Note: The screenshot above is an example of module programming and may not be indicative of the specific module that is being programmed. Module selection and VIN information have been blacked out.
