# Safety Recall

## N242470160 High Voltage Battery Fire Detection

<b>Condition</b>	General Motors has decided that a defect which relates to motor vehicle safety may exist in certain 2020 – 2022 model year Chevrolet Bolt EV and 2022 model year Chevrolet Bolt EUV vehicles. GM's service records indicate that the advanced diagnostic software remedy in a previous recall may not have been correctly installed in this vehicle population. The vehicle may fail to identify defective battery modules that require replacement, increasing the risk that the batteries in some vehicles may pose a risk of fire when charged to full, or very close to full, capacity. A battery fire increases the risk of injury.
<b>Correction</b>	Dealers will reprogram the Hybrid Powertrain Control Module 2, Battery Energy Control Module, and the Body Control module.

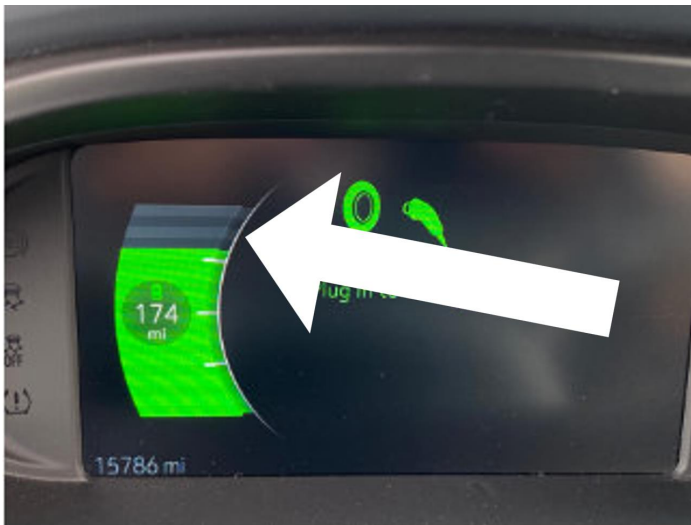
5924268

**Important:** Verify the vehicle SOC is less than 80%. This can be determined by looking at the bars on the power level indicator. If four or more empty bars (not showing green) are displayed, the SOC is at an acceptable level. If the power level indicator shows an SOC of greater than 80% The SOC must be adjusted before proceeding with the recalibration.
