# Safety Recall

## N242470161 High Voltage Battery Fire Detection

Release Date: October 2024

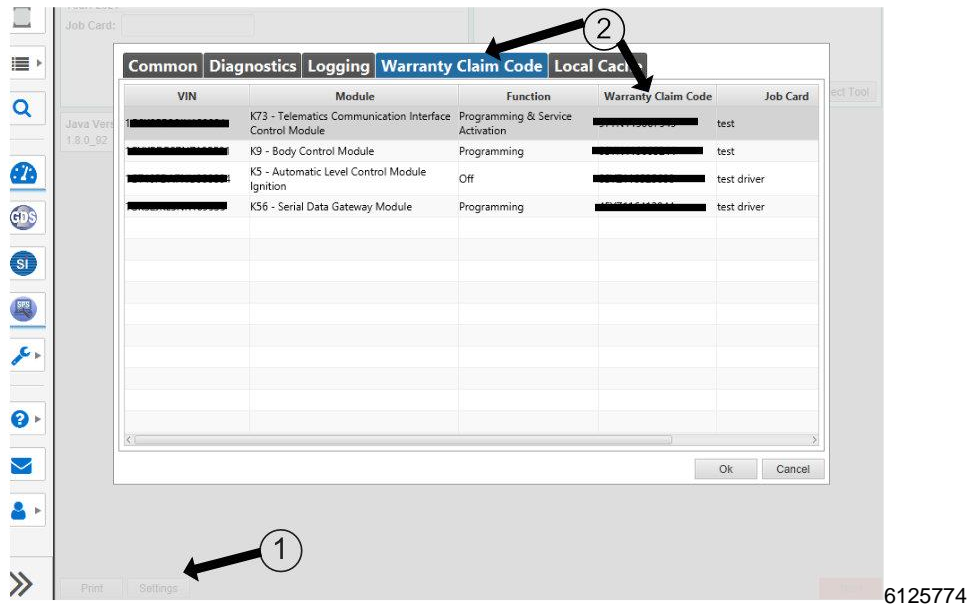
If the Warranty Claim Code was not recorded on the Job Card, the code can be retrieved in the SPS2 system as follows:

1. Open TLC on the computer used to program the vehicle.
2. Select and start SPS2.
3. Select Settings (1).
4. Select the Warranty Claim Code tab (2).

The VIN, Warranty Claim Code and Date/Time will be listed on a roster of recent programming events. If the code is retrievable, dealers should resubmit the transaction making sure to include the code in the SPS Warranty Claim Code field.

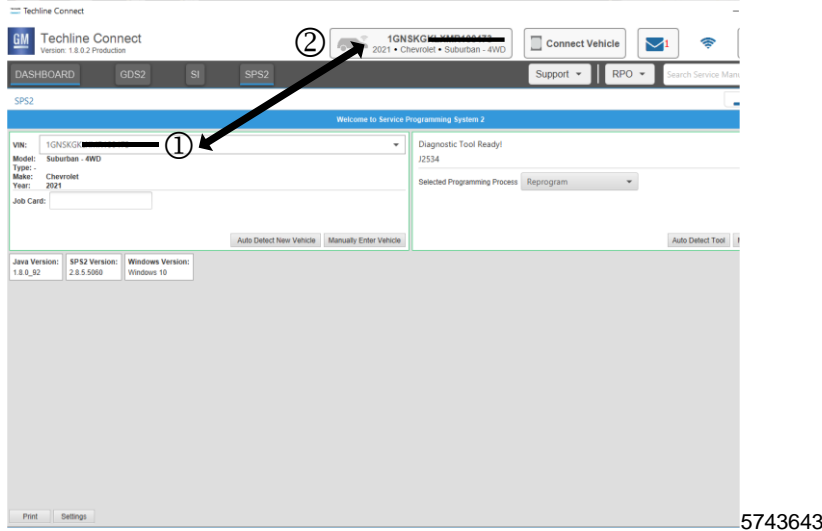
**Caution:** Be sure the VIN selected in the drop down menu (1) is the same as the vehicle connected (2) before beginning programming.

**Important:** Techline Connect screens shown above.

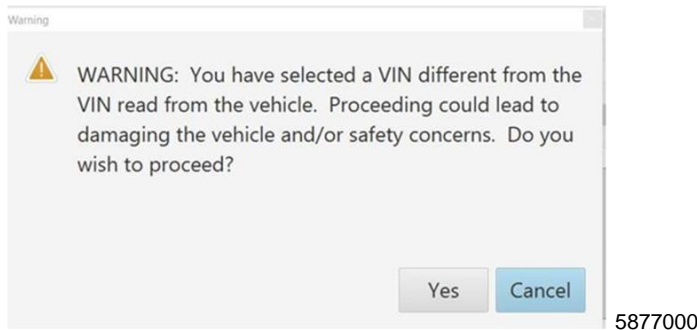
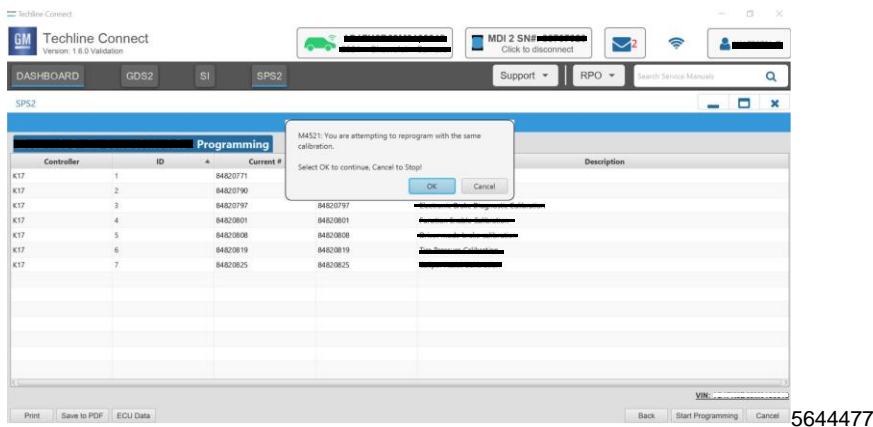
**Important:** If the vehicle VIN DOES NOT match, the message below will be shown.

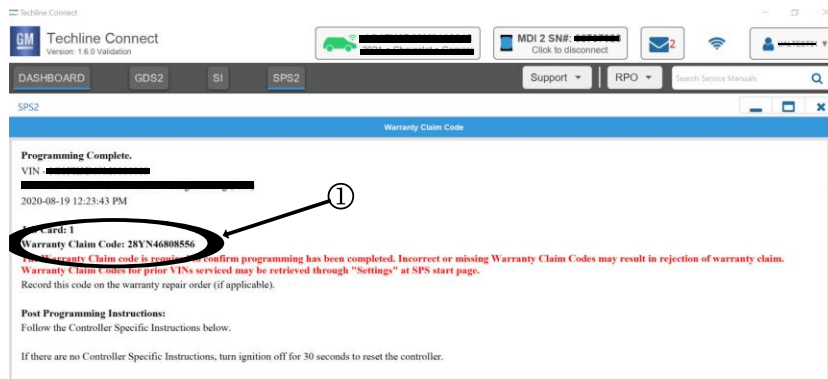
5644478

**Note:** The screenshot above is an example of module programming and may not be indicative of the specific module that is being programmed. Module selection and VIN information have been blacked out.
