**SAFETY AND EMISSIONS RECALL 7124J
REPAIR PROCEDURE**

Section B : Repair Procedure Recall 7124J

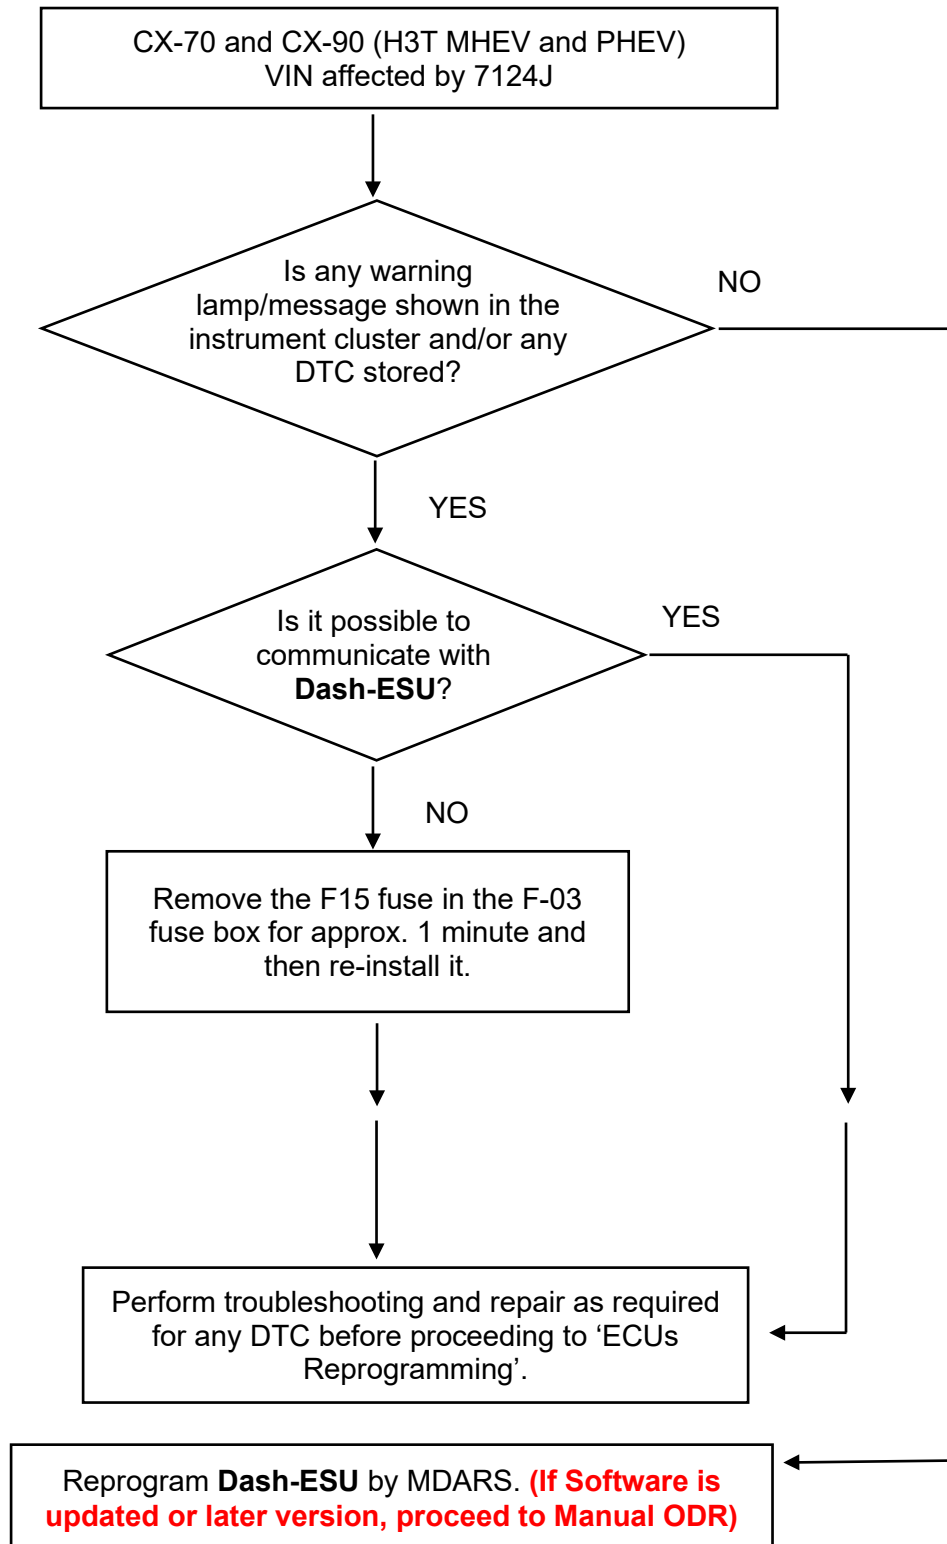
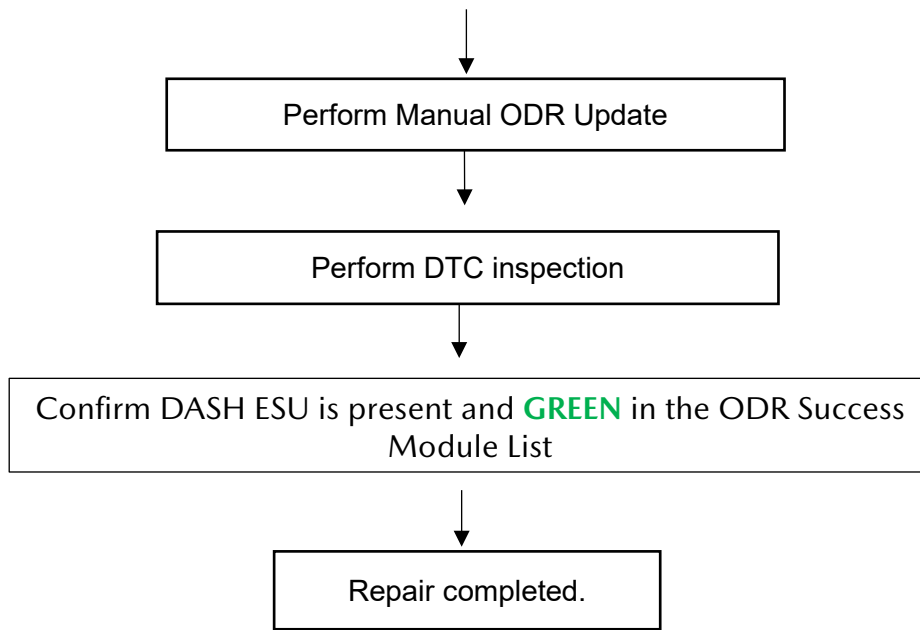
Section A: Flow Chart

NOTE: This recall repair may only fix/clear a DTC issue related to the DASH-ESU. DTC's unrelated to the campaign may need to be cleared before performing this recall. Once cleared/repaired, then start the repair process for 7124J.

NOTE: This Flow Chart needs to be followed strictly

****NOTE: All vehicles require the upload of ODR (Manual) after the technician has completed all software updates. If ODR is not uploaded successfully, or if one or more software updates are missed, the applicable campaign(s) will remain open, the warranty claim will not accept, and your dealer will have to contact the customer to bring back the car to correct the concern. You must do a ODR Update (Manual) even if the module software is up to date.**

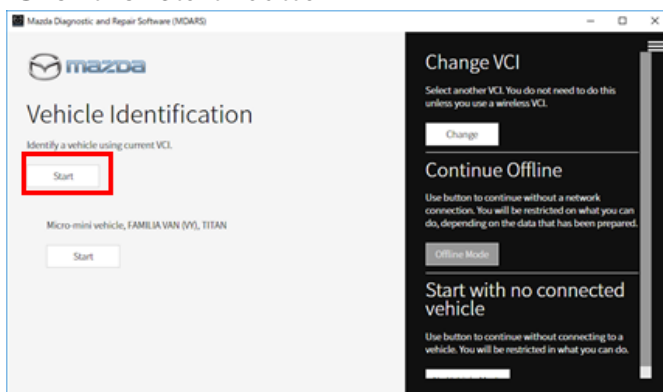
1. Click the "Start" button.

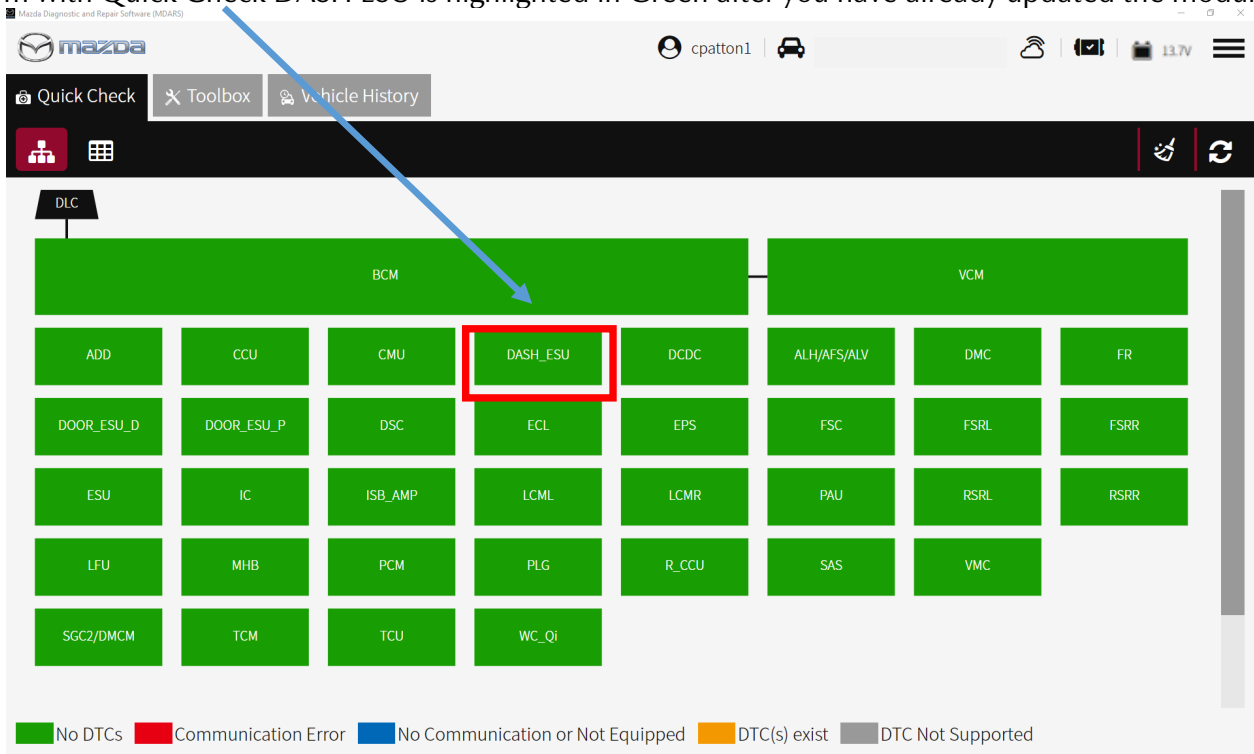
Confirm with Quick Check DASH ESU is highlighted in Green after you have already updated the module.

※If the status is 'FAILURE', the ODR (latest vehicle information) has not been submitted to the server.

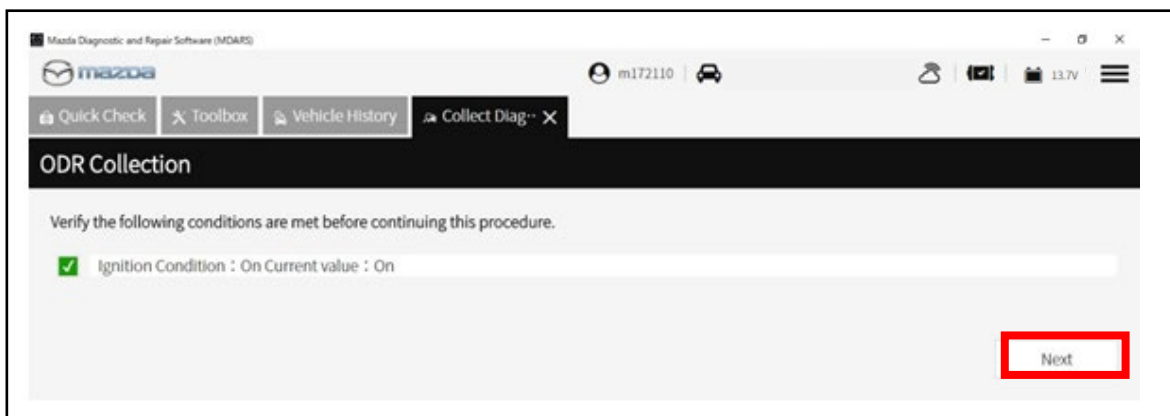
(2) Click 'Next'.

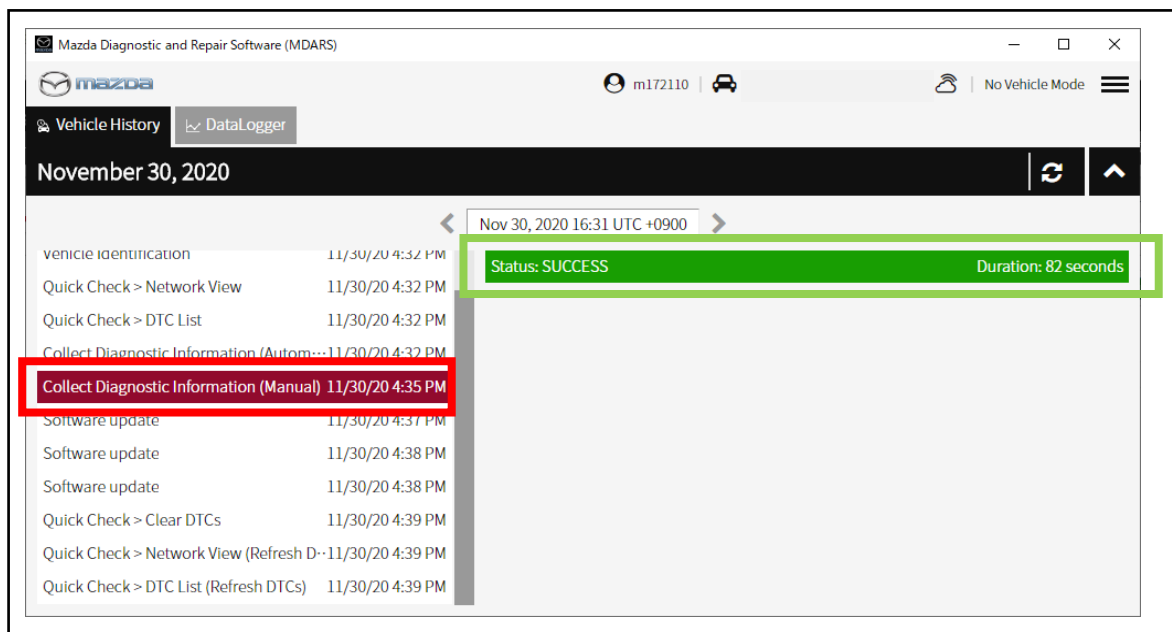
(5) Go back to step 14 and 15 to confirm the 'Collect Diagnostic Information (Manual)' status shows "SUCCESS" on green.
