**SAFETY AND EMISSIONS RECALL 7024J
PHEV VEHICLE REPAIR PROCEDURE**

Section B : Repair Procedure Recall 7024J

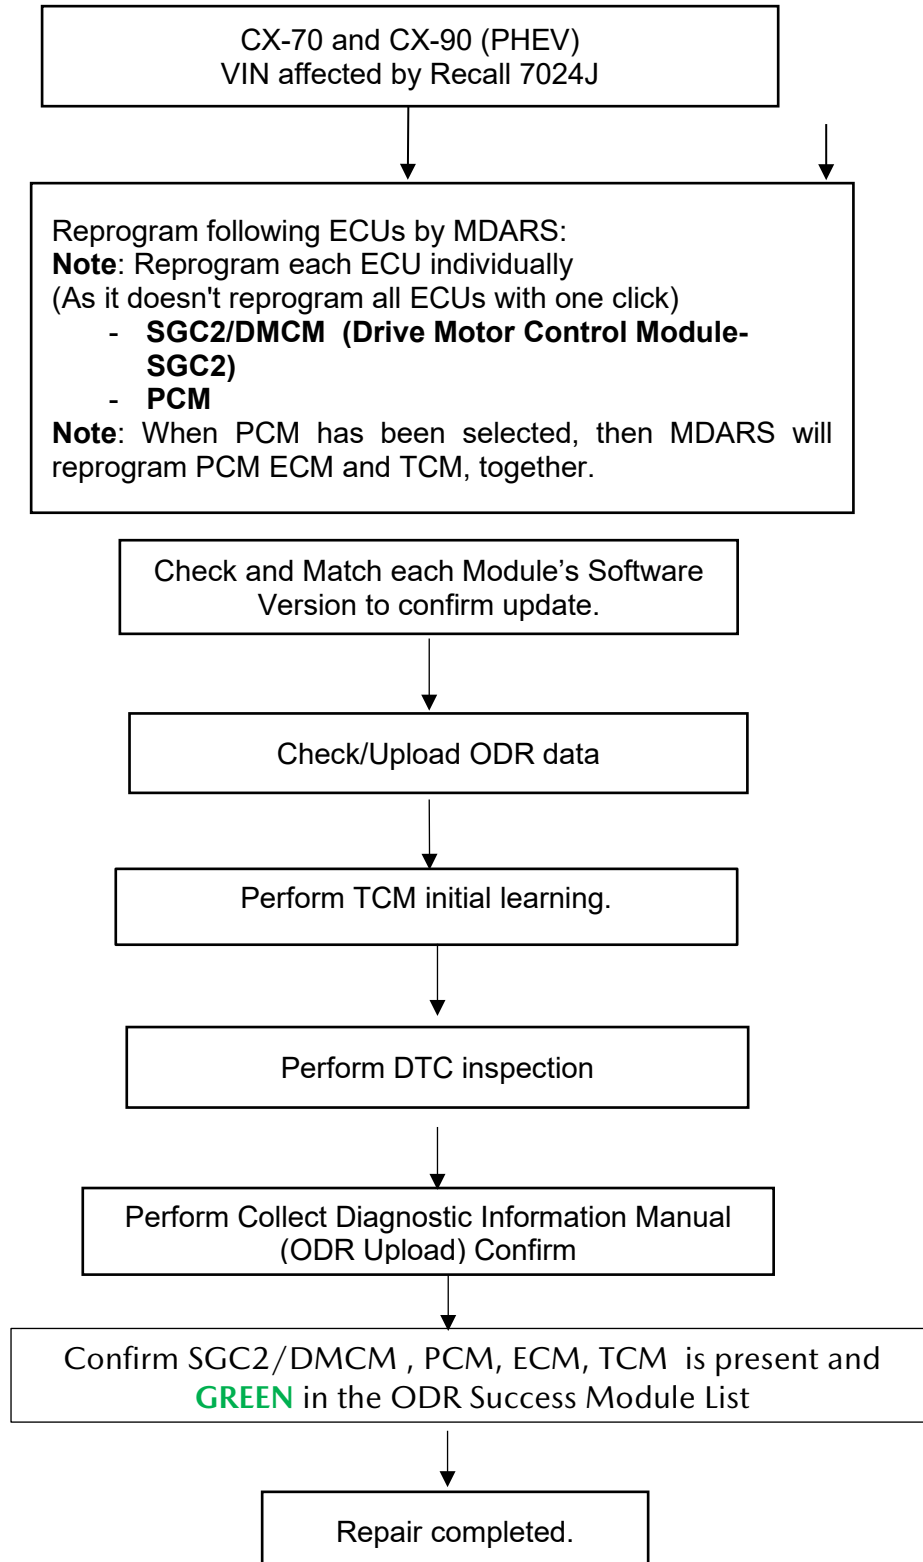
Section A: Flow Chart

NOTE: You must clear any DTC's (diagnose and repair) before performing any of these campaigns. The recall repairs will NOT fix/clear a DTC issue. Once repaired, then start the repair process for campaigns.

NOTE: This Flow Chart needs to be followed strictly

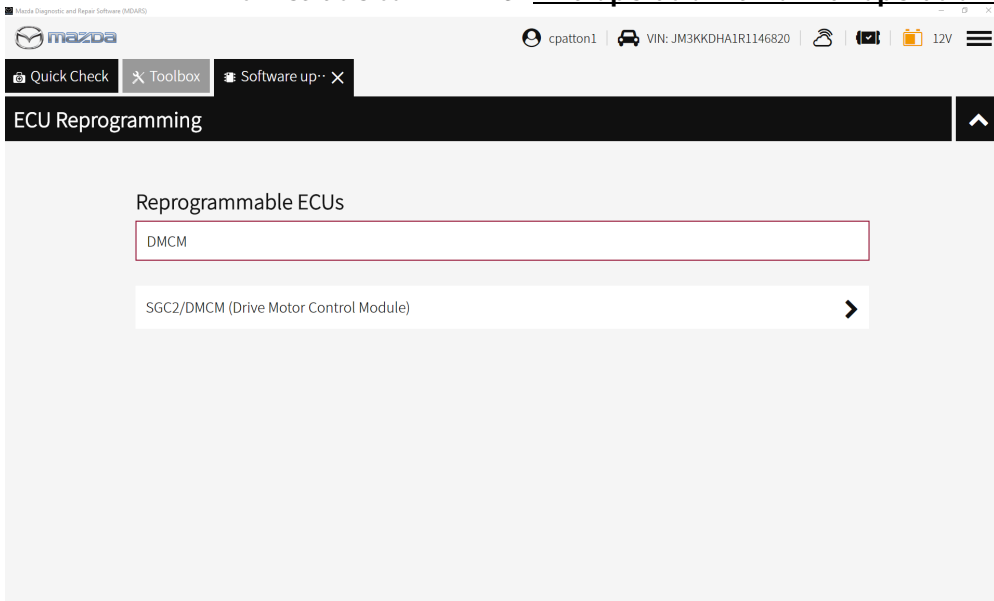
- Select **SGC2/DMCM** on the 'ECU Reprogramming' screen. Start Reprogramming. Once you are finished you will need to update the PCM module.

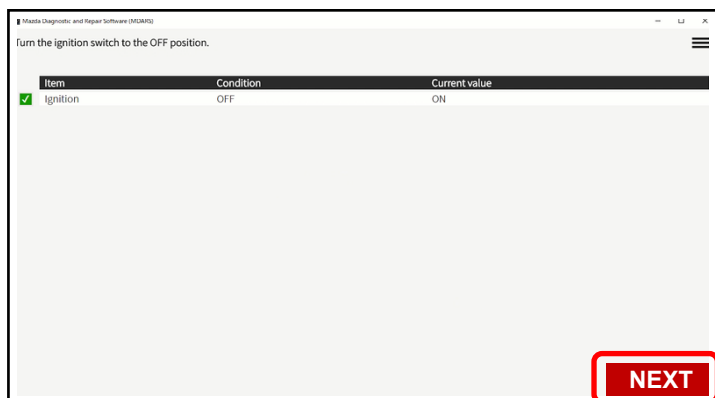
- (3) During reprogramming, "Turn Ignition Switch to the OFF Position" may display on the MDARS several times. Turn the ignition switch OFF, check the box, and select "Next".

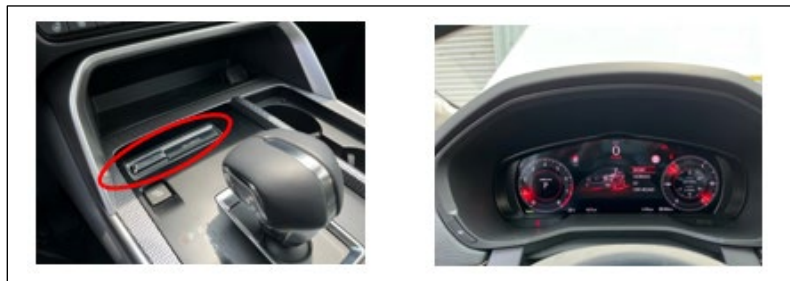
1. Start the engine.
2. Switch to 'Sport Mode'
