**SAFETY AND EMISSIONS RECALL 7024J
MHEV VEHICLE REPAIR PROCEDURE**

Section B : Repair Procedure Recall 7024J

Reprogram ECUs by MDARS (each car updates MHB module AND PCM with TCM relearn)

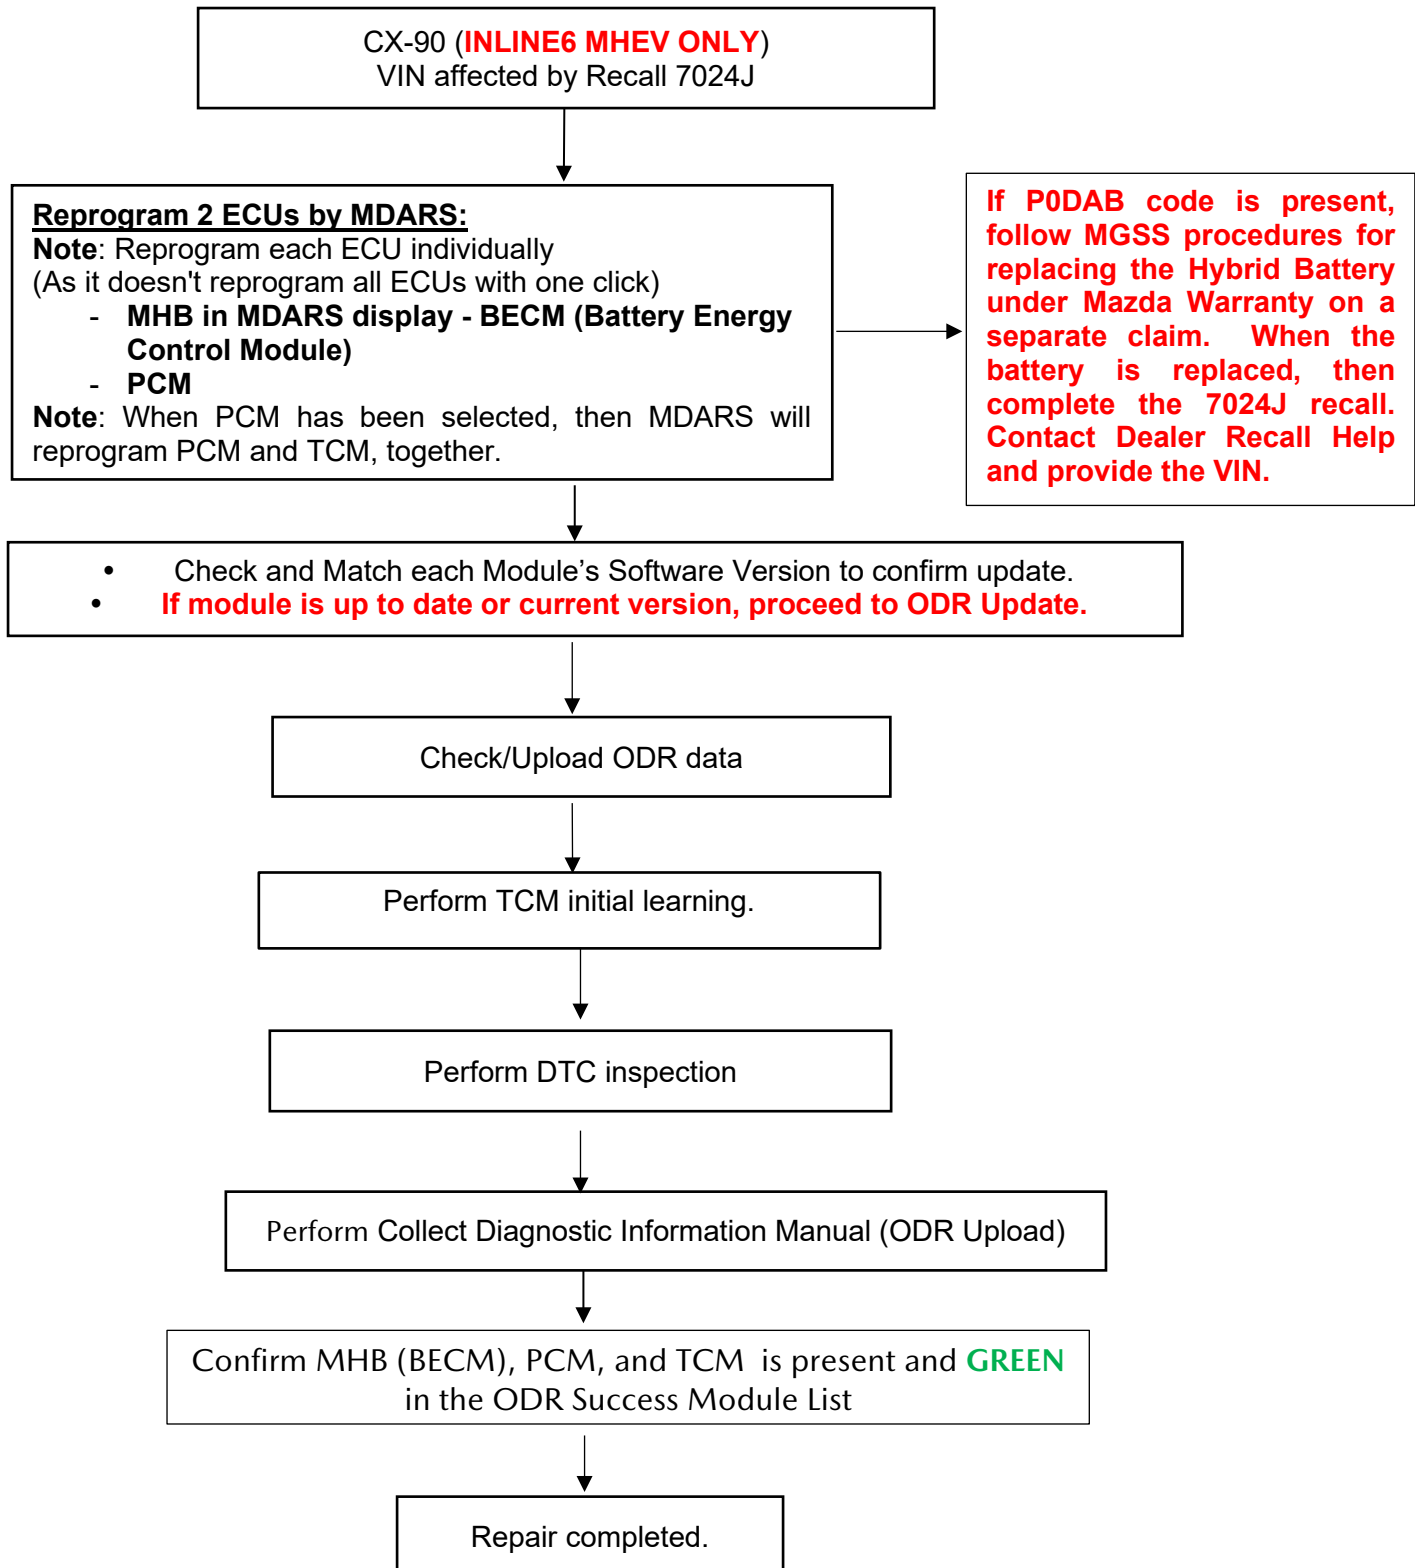
Section A: Flow Chart – MHEV vehicle model ONLY

NOTE: This campaign may only resolve DTC's related to modules affected by this campaign for MHEV vehicles. If DTC's unrelated to the campaign exist please clear or repair those concerns before performing the recall 7024J.

NOTE: This Flow Chart needs to be followed strictly

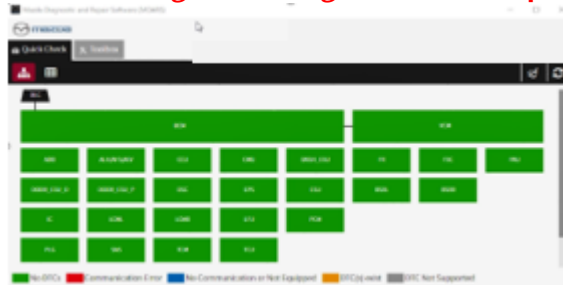
4. Verify the DTC according to the directions on the quick check screen. **If any DTCs are displayed, perform troubleshooting according to the corresponding DTC inspection.**

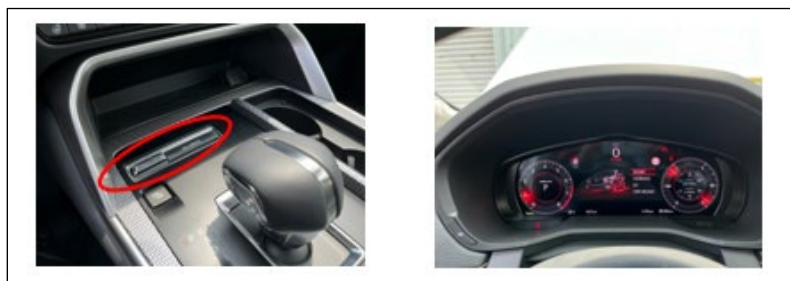
Shift range learning.

1. Start the engine.
2. Switch to 'Sport Mode'

3. While idling, depress the brake and perform the following steps.
 - i) Move the shift lever in "D".
 - ii) Move the shift lever from "D" to "R" and wait 5 seconds *
 - iii) Move the shift lever from "R" to "D" and wait 5 seconds *
 - * Do not stop in N range while moving the shift lever.
 - iv) Repeat steps from i) to iii) 5 times.
