**SAFETY AND EMISSIONS RECALL 7024J  
MHEV VEHICLE REPAIR PROCEDURE**

## Section B : Repair Procedure Recall 7024J

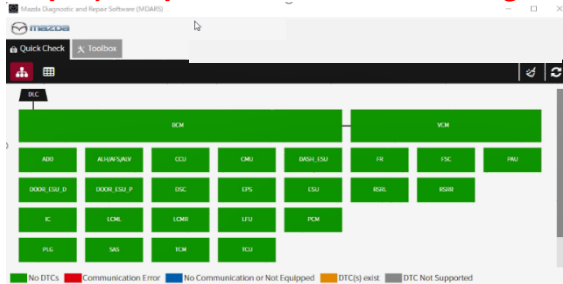
- Verify the DTC according to the directions on the quick check screen. **If any DTCs are displayed, perform troubleshooting according to the corresponding DTC inspection.**

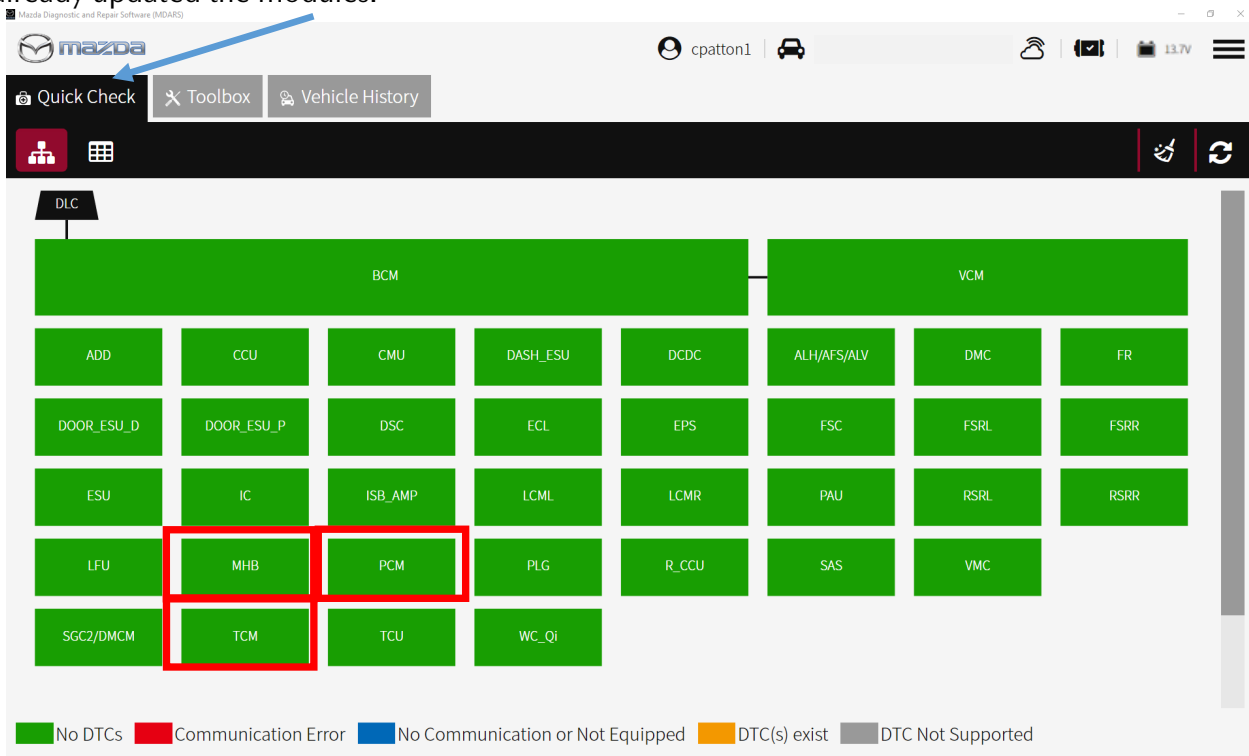
Confirm with Quick Check the following Modules MHB, PCM, TCM are highlighted in Green after you have already updated the modules.

※If the status is 'FAILURE', the ODR (latest vehicle information ) has not been submitted to the server.
