**SAFETY AND EMISSIONS RECALL 7024J
MHEV VEHICLE REPAIR PROCEDURE**

Section B : Repair Procedure Recall 7024J

Reprogram ECUs by MDARS

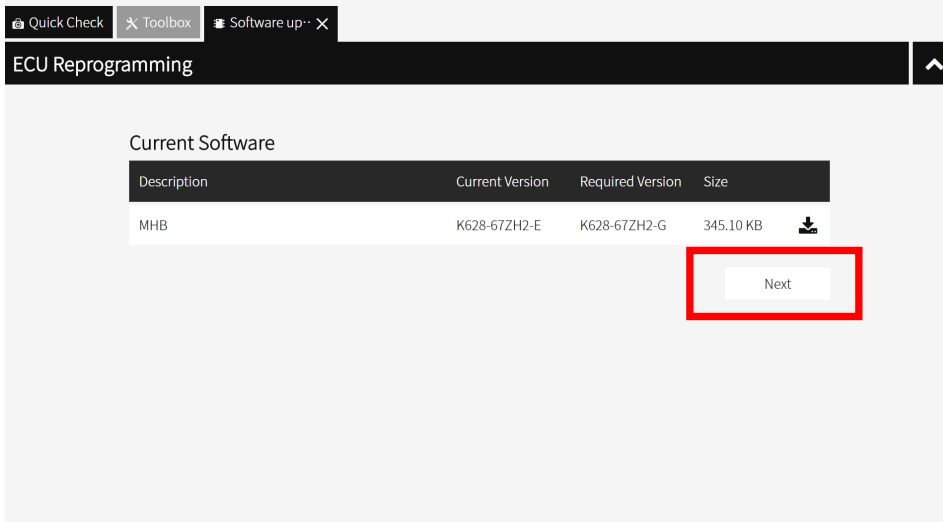
- Select **MHB (BECM)** on the 'ECU Reprogramming' screen. Start Reprogramming. Once you are finished you will need to update the PCM module.

- Reprogram each ECU individually (as it doesn't reprogram all ECUs with one click).
- When PCM is selected, then MDARS will reprogram PCM and TCM together as one software package. **Be sure to perform initial TCM learning after TCM reprogramming.**
- If current calibration file name in the ECU FILENAME screen is the same as shown in Calibration Files Information or with a later suffix, reprogramming is not necessary.
- MDARS reads the current file name of the modules to be reprogrammed and then reprograms the required modules only. (MDARS does not reprogram modules that are not needed)

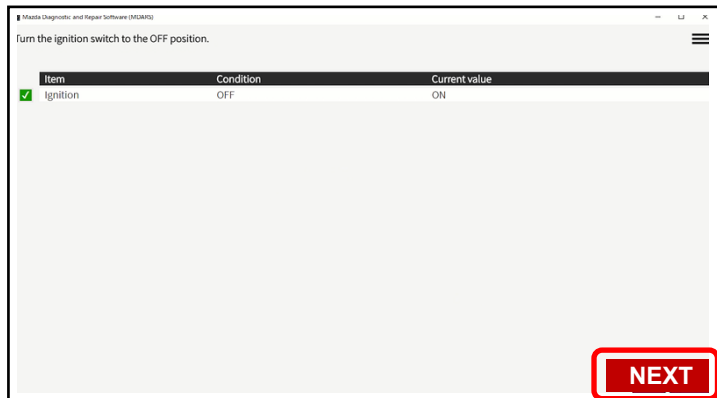
- (3) During reprogramming, "Turn Ignition Switch to the OFF Position" may display on the MDARS several times. Turn the ignition switch OFF, check the box, and select "Next".

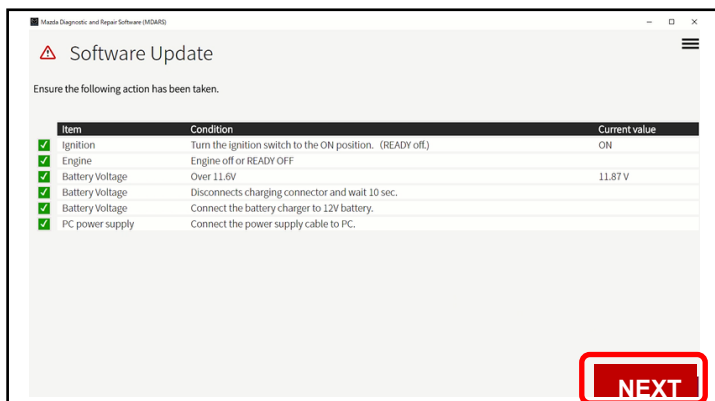
- (4) MDARS may return to screen shown in step (1) multiple times (this is normal operation.). Then each time turn the ignition switch to the ON position and then click 'next'.
