PHEV - Vehicle Inspection Procedure and Preparation for Repair

**SAFETY AND EMISSIONS RECALL 7024J
PHEV VEHICLE REPAIR PROCEDURE**

Section B : Repair Procedure Recall 7024J

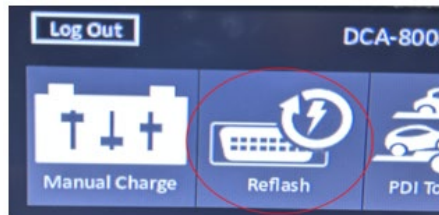
During reprogramming, connect battery charger to the vehicle to stabilize voltage fluctuation. If missing, it may cause damage to ECUs due to decreasing voltage.

7th generation vehicle will control to turn on headlight forcibly during reprogramming due to change CAN communication. **Please use the “Reflash” setting in the charger, which will keep the voltage stable. The setting voltage must be between 12 -13V.**

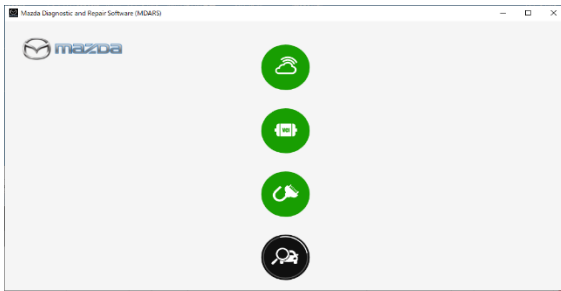
- The Vehicle Identification process will start and automatically inspect every connection and then collect the vehicle information.

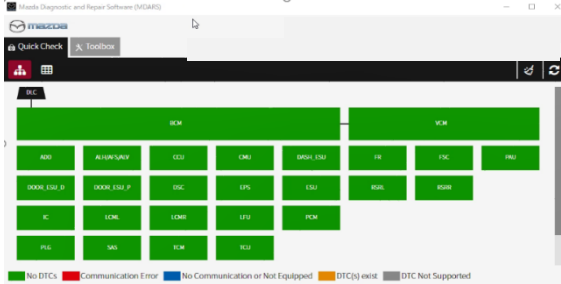
- Verify the DTC according to the directions on the quick check screen. **If any DTCs are displayed, perform troubleshooting according to the corresponding DTC inspection.**

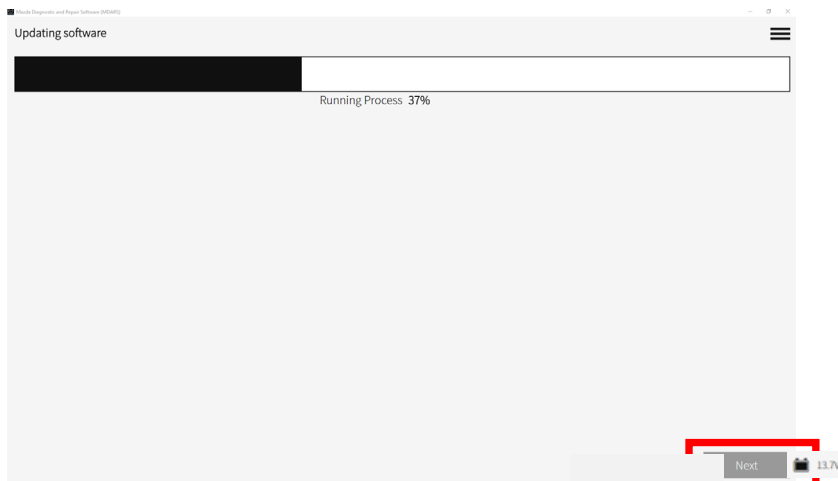
- (2) This is the screen while the software is being updated. The progress bar does not change for about 60 seconds.

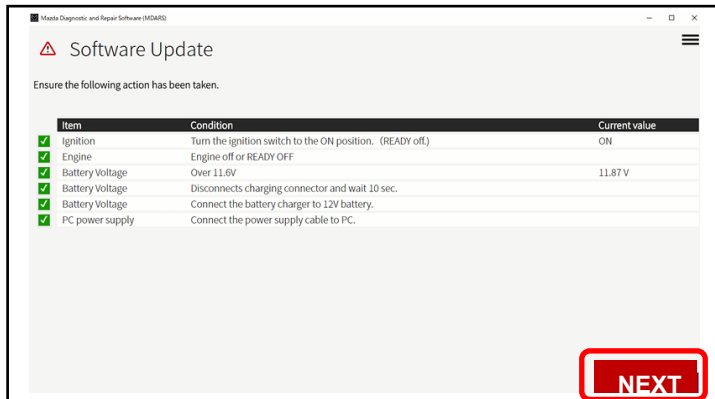
- (4) MDARS may return to screen shown in step (1) multiple times (this is normal operation.). Then each time turn the ignition switch to the ON position and then click 'next'.

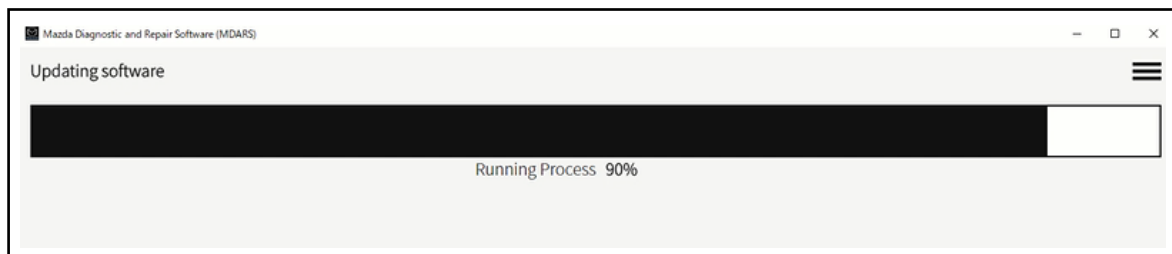
- (5) When the software is being updated and advances to 90% on the screen, it may stop advancing for about 60 seconds. Wait until reprogramming is complete.

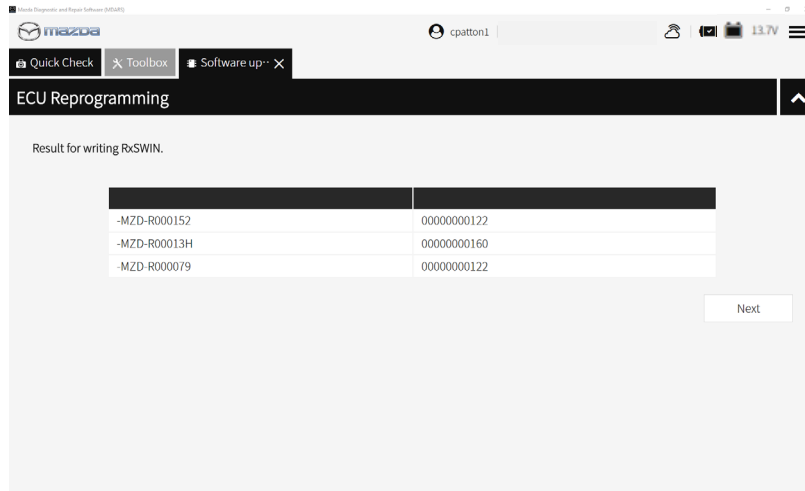
7. After completion of software update, the previous and current software version are shown.
 - Check current version at "Calibration File information below".
 - Then, click on "Finish" to exit the ECU reprogramming.
 - **If module is up to date or current version, proceed to ODR Update**

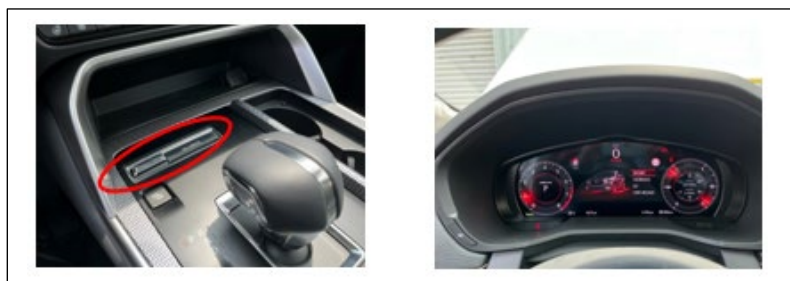
1. Start the engine.
2. Switch to 'Sport Mode'

3. While idling, depress the brake and perform the following steps.
 - i) Move the shift lever in "D".
 - ii) Move the shift lever from "D" to "R" and wait 5 seconds *
 - iii) Move the shift lever from "R" to "D" and wait 5 seconds *
 - * Do not stop in N range while moving the shift lever.
 - iv) Repeat steps from i) to iii) 5 times.

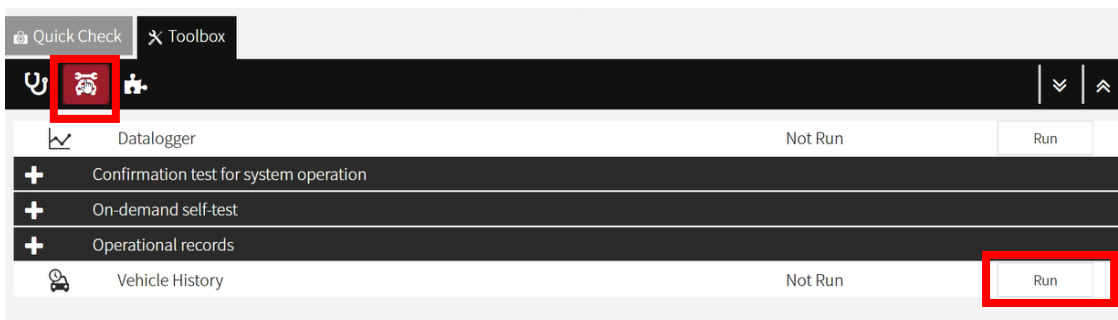
- A. Open the vehicle history on toolbox tab.

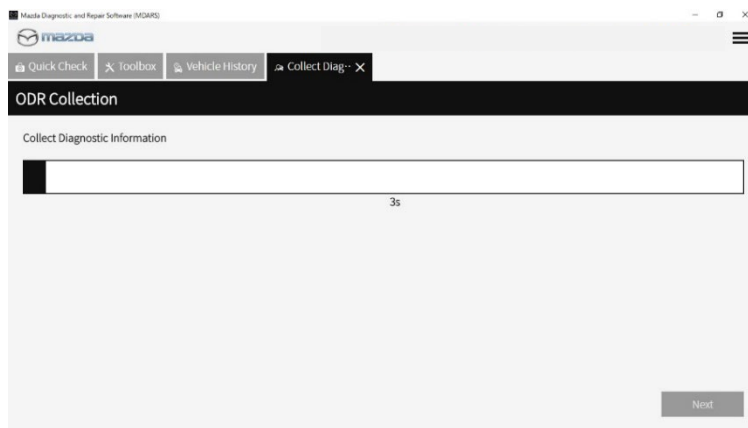
E. This may take around 60 seconds.

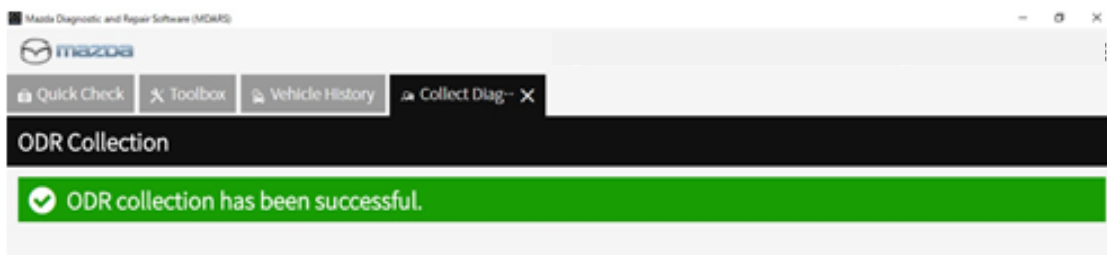
F. MDARS has collected ODR data and confirmation has been sent to the server.

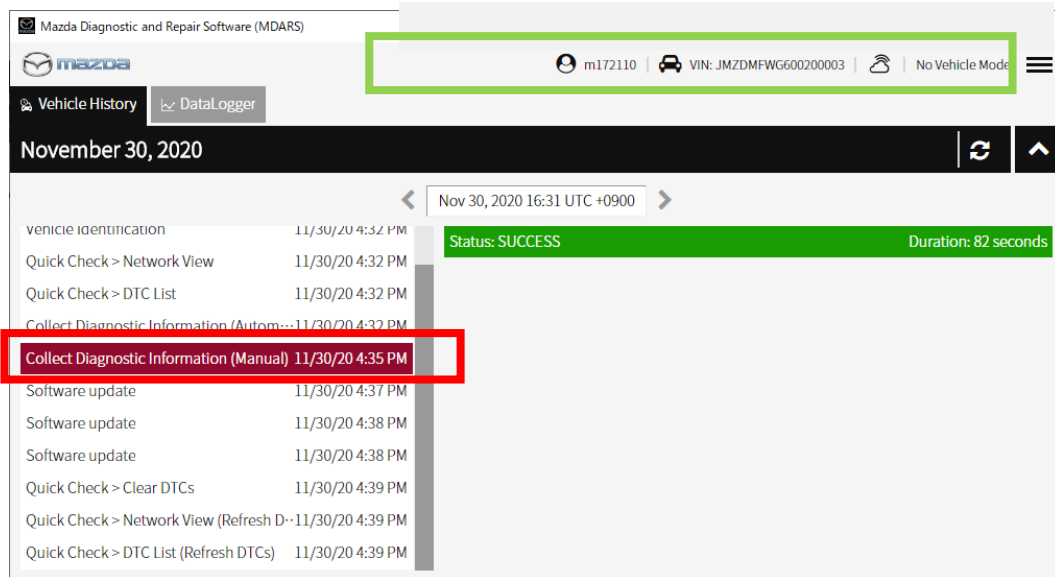
- G. Check to make sure “Collect Diagnostic Information (Manual)” appears and Status shows ‘SUCCESS’ in green. ***If this step is not completed, your warranty claim will not be approved and the customer will need to return for a re-repair.***
