**SAFETY AND EMISSIONS RECALL 7024J
MHEV VEHICLE REPAIR PROCEDURE**

Section B : Repair Procedure Recall 7024J

Reprogram ECUs by MDARS (each car updates MHB module AND PCM with TCM relearn)

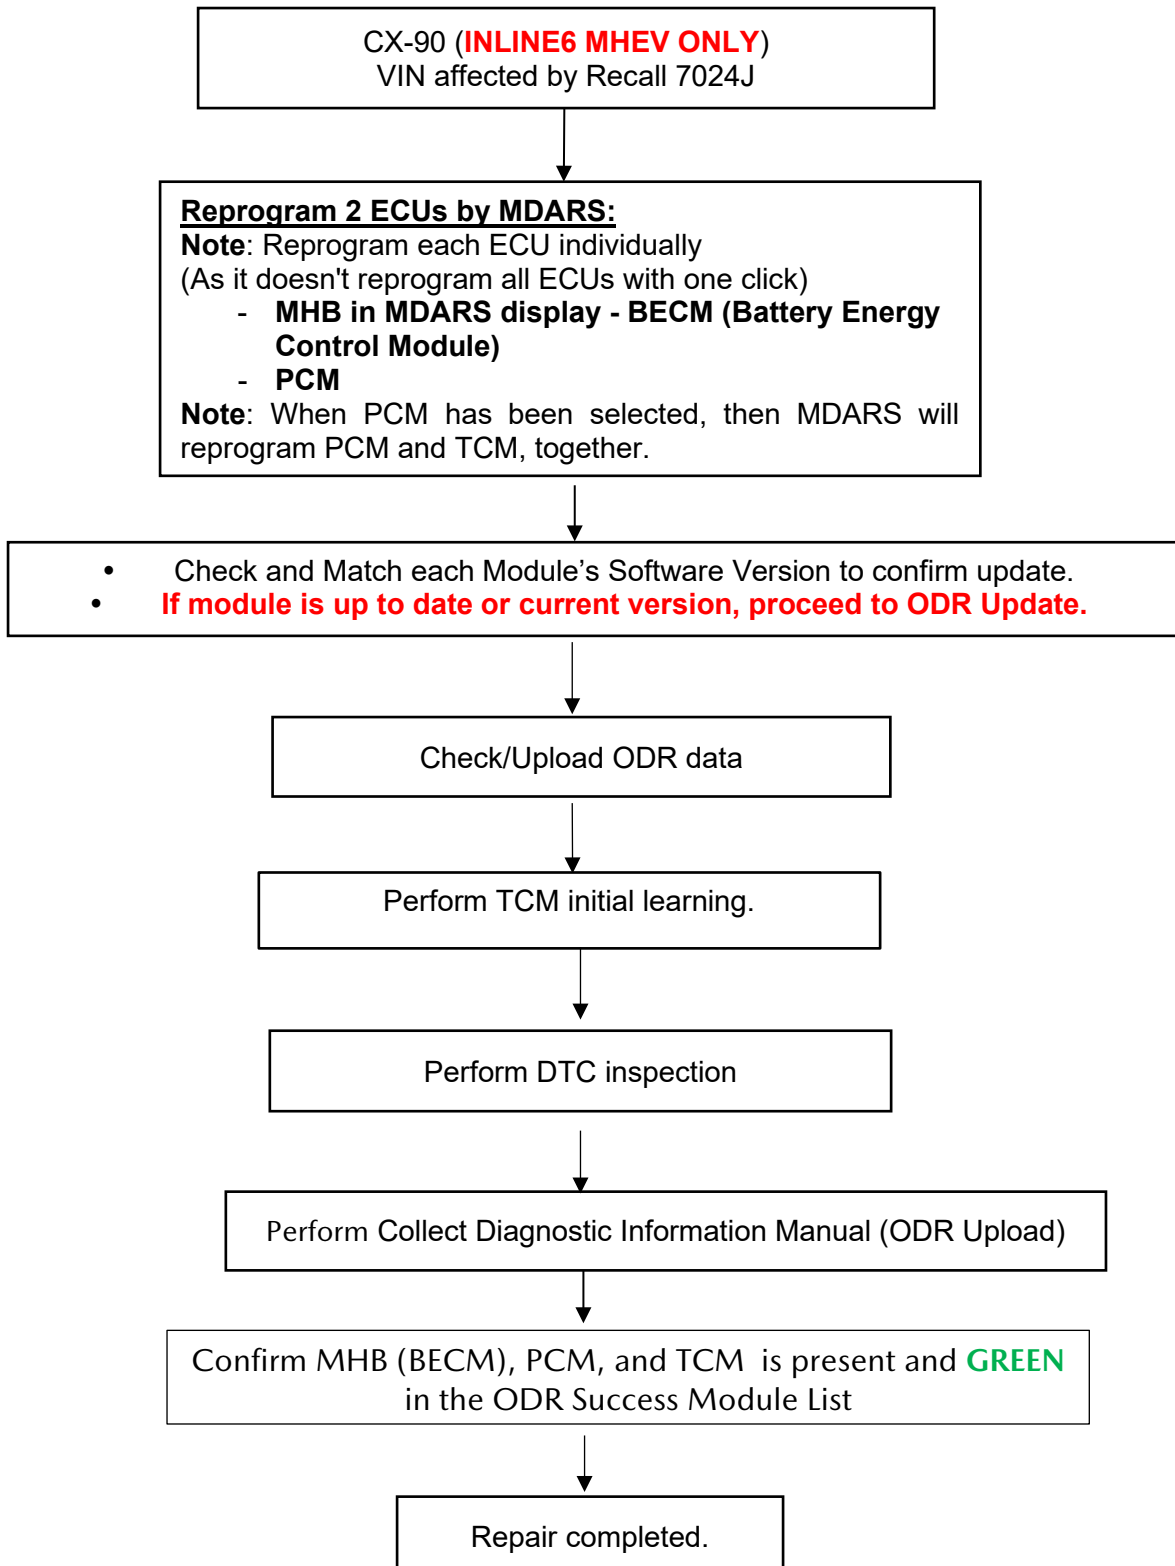
Section A: Flow Chart – MHEV vehicle model ONLY

NOTE: This Flow Chart needs to be followed strictly

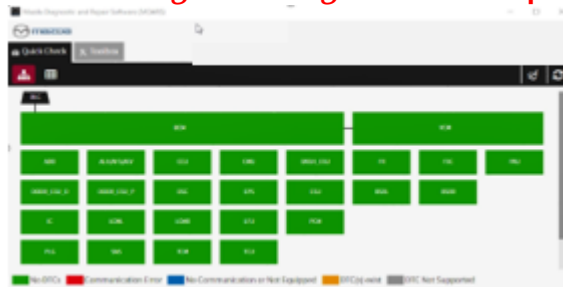
- Verify the DTC according to the directions on the quick check screen. **If any DTCs are displayed, perform troubleshooting according to the corresponding DTC inspection.**

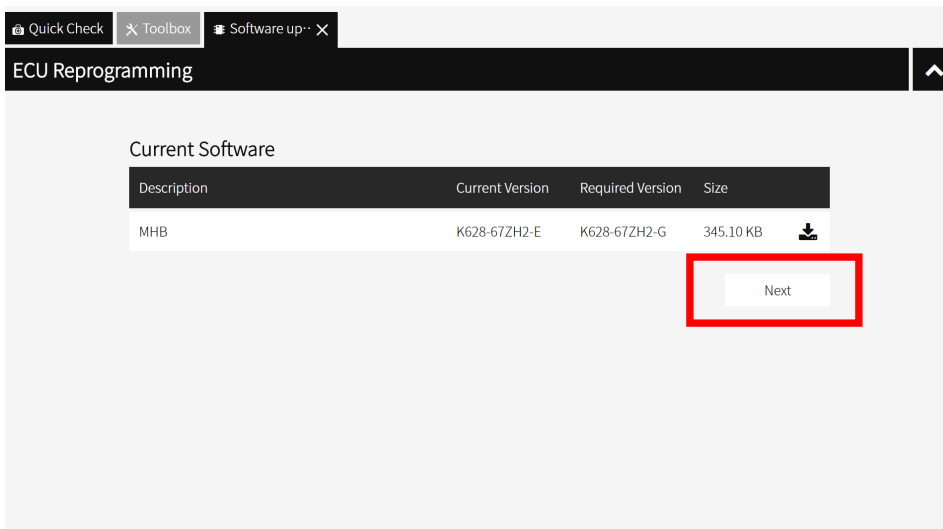
- Select **MHB (BECM)** on the 'ECU Reprogramming' screen. Start Reprogramming. Once you are finished you will need to update the PCM module.

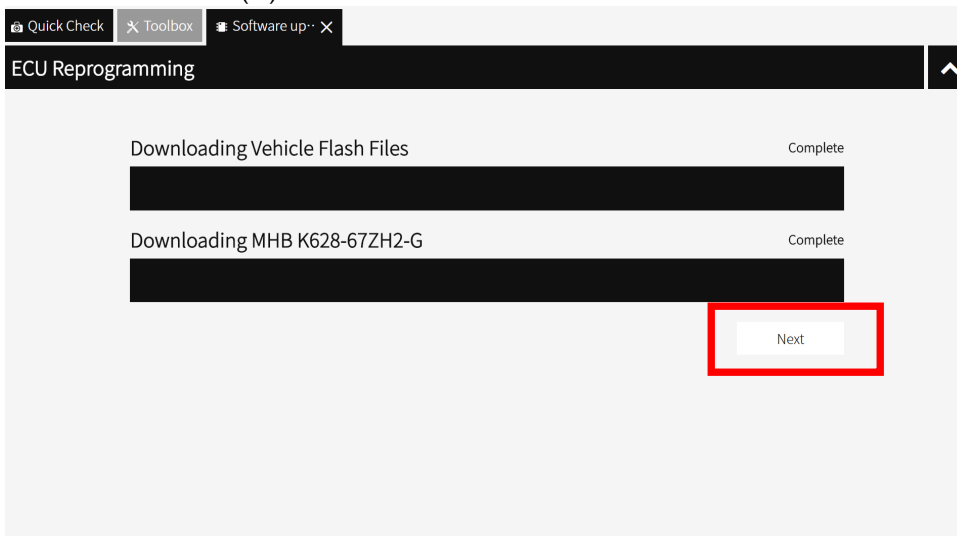
(1) Follow instructions in the screen and click "Next".

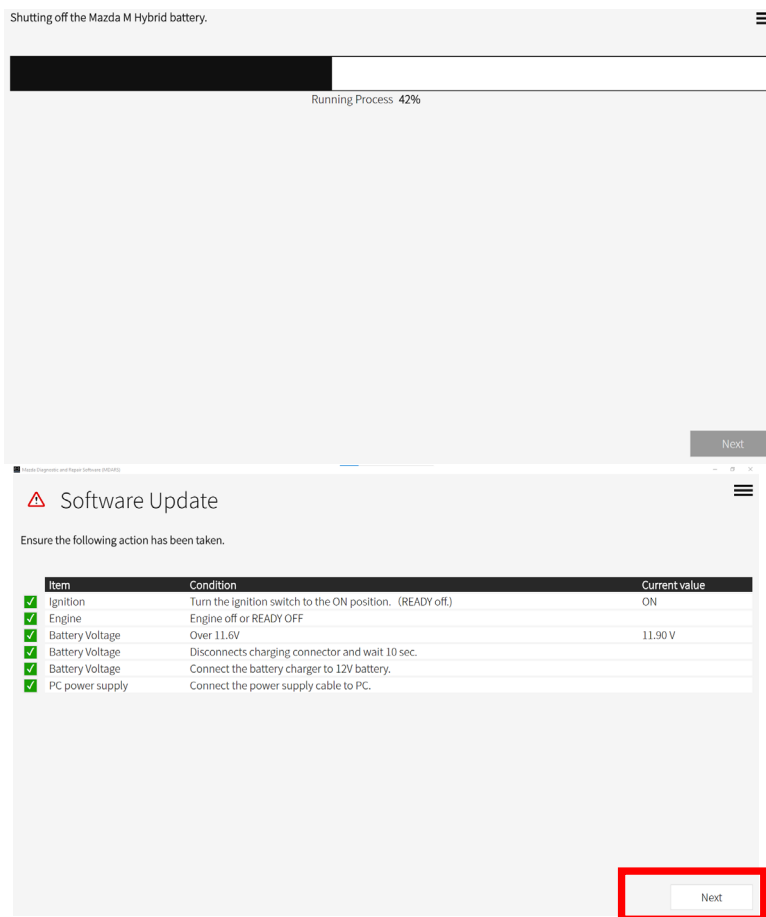
- (2) This is the screen while the software is being updated. The progress bar does not change for about 60 seconds.

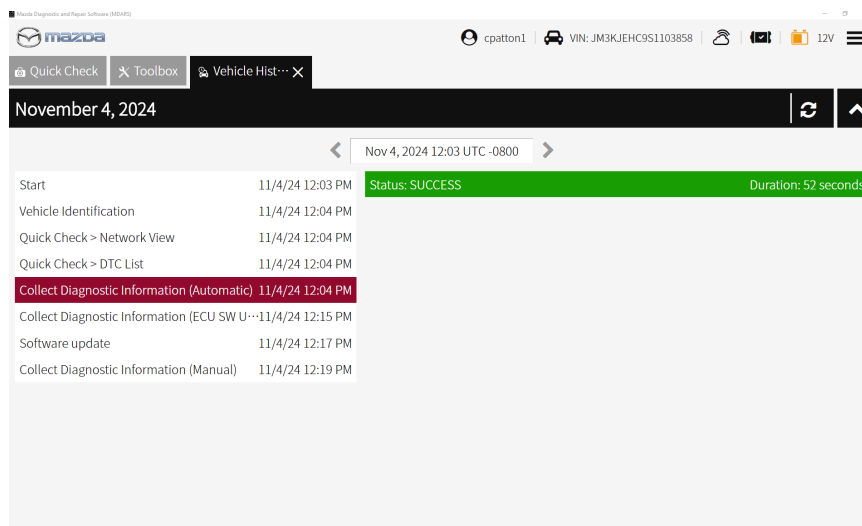
9. Click the 'Collect Diagnostic Information' and the status has "SUCCESS" on green.

Note: Only the latest "Collect Diagnostic Information" is the valid one and that needs to show "SUCCESS"

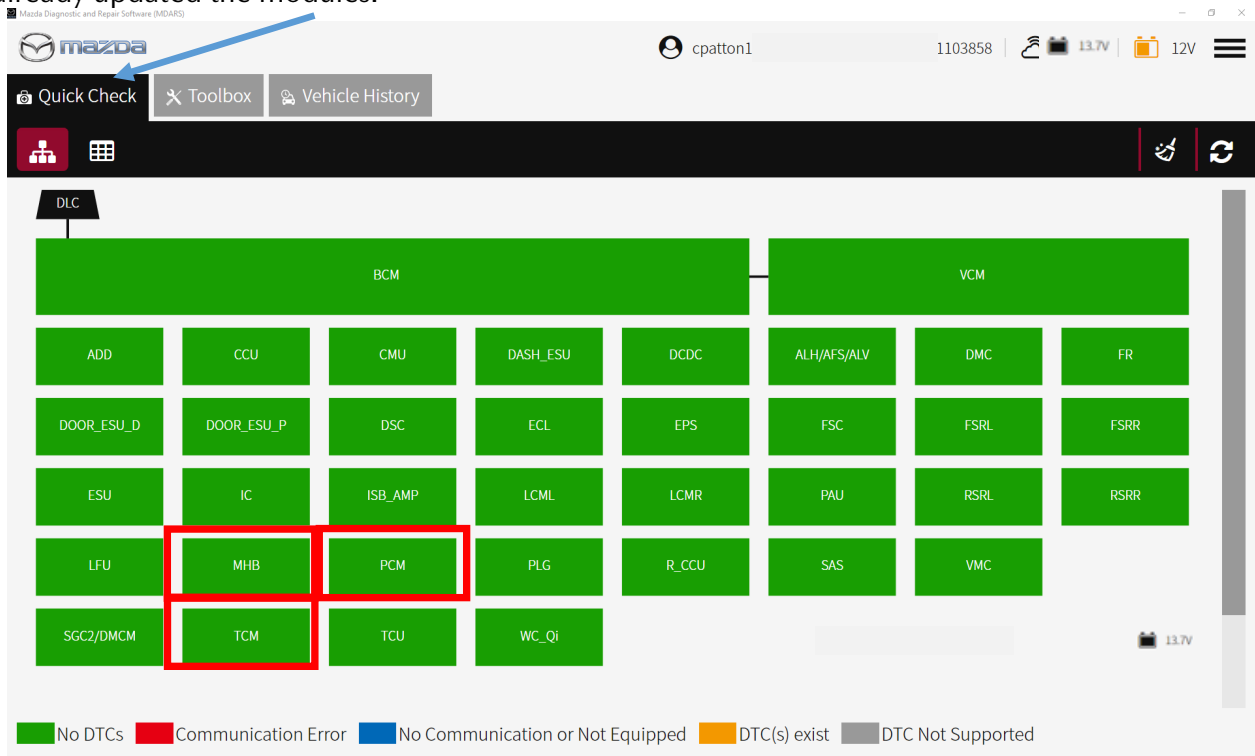
Confirm with Quick Check the following Modules MHB, PCM, TCM are highlighted in Green after you have already updated the modules.

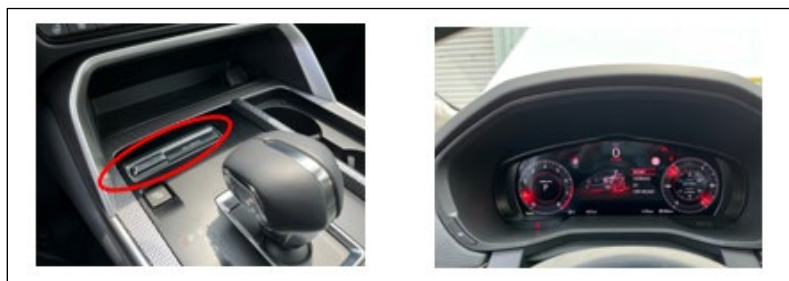
1. Start the engine.
2. Switch to 'Sport Mode'
