**MHEV - Vehicle Inspection Procedure and Preparation for Repair**

**SAFETY AND EMISSIONS RECALL 7024J  
MHEV VEHICLE REPAIR PROCEDURE**

## Section B : Repair Procedure Recall 7024J

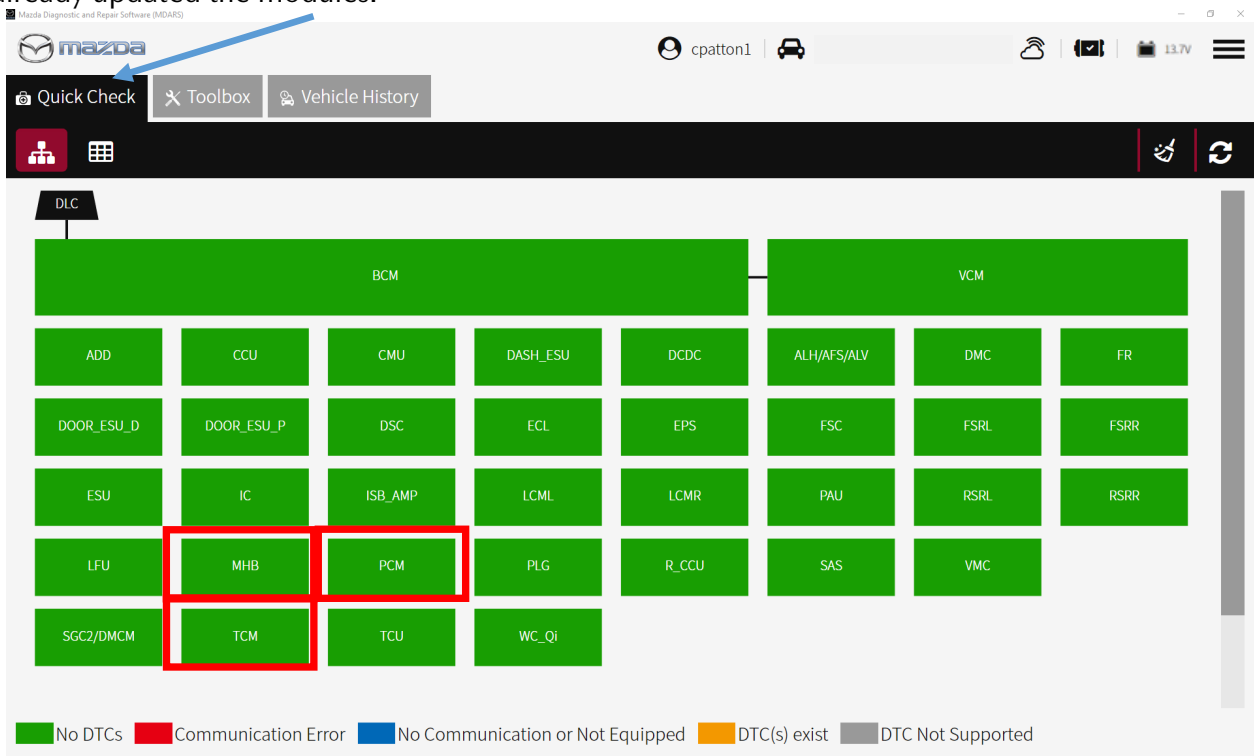
Confirm with Quick Check the following Modules MHB, PCM, TCM are highlighted in Green after you have already updated the modules.

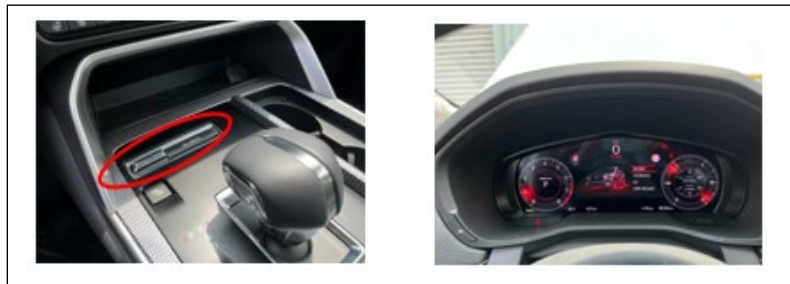
- 1. Start the engine.
- 2. Switch to 'Sport Mode'
