**SAFETY AND EMISSIONS RECALL 7024J  
MHEV VEHICLE REPAIR PROCEDURE**

## Section B : Repair Procedure Recall 7024J

Reprogram ECUs by MDARS (each car updates MHB module AND PCM with TCM relearn)

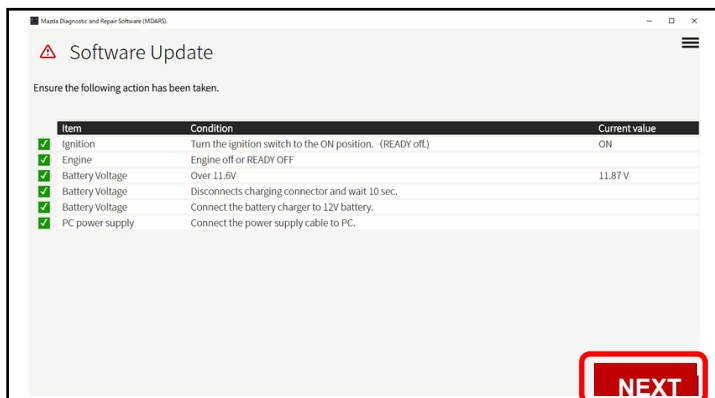
- (4) MDARS may return to screen shown in step (1) multiple times (this is normal operation.). Then each time turn the ignition switch to the ON position and then click 'next'.

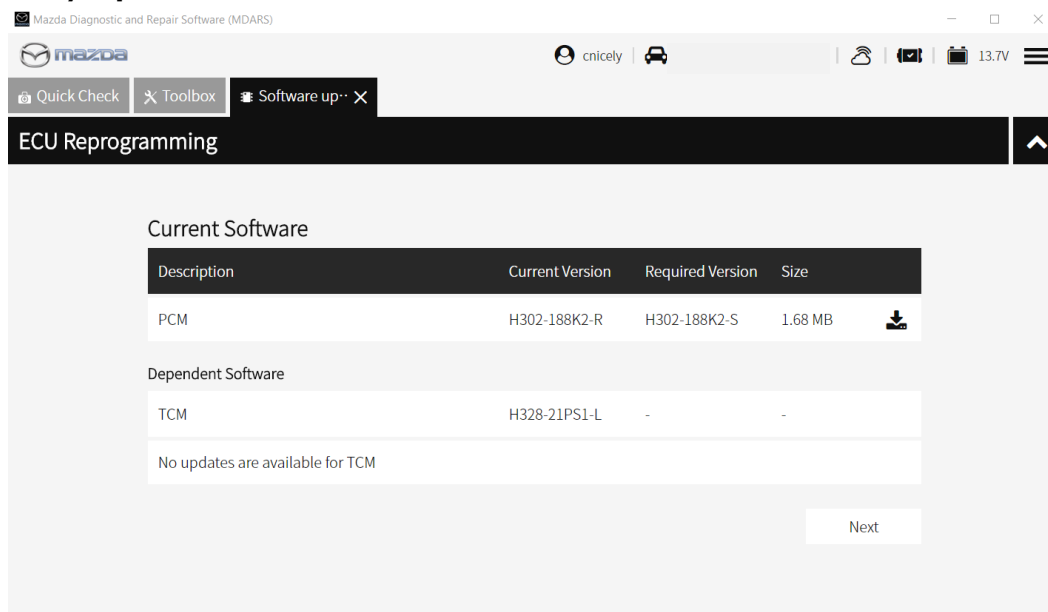
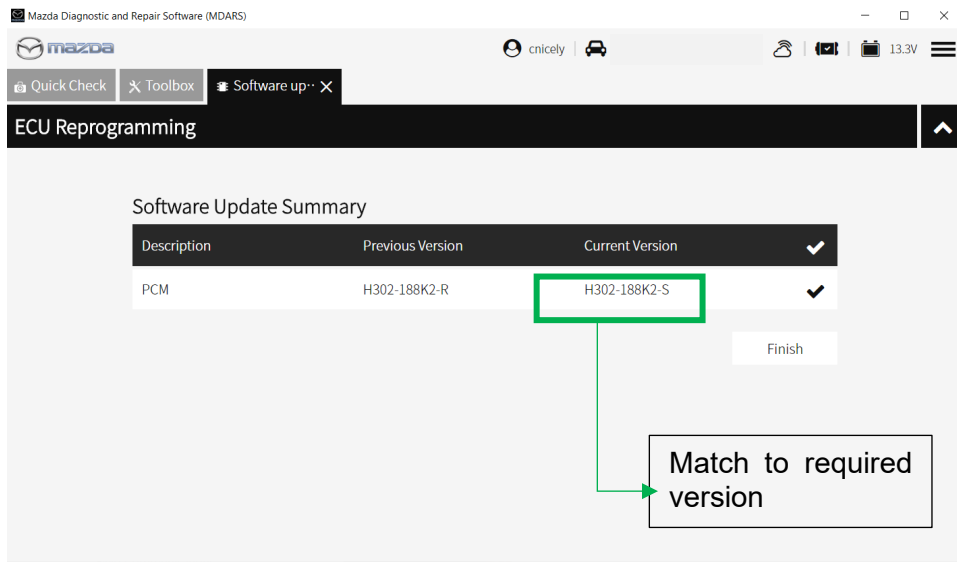
## PCM REPROGRAM with TCM RELEARN:

Go back to step 5 and repeat the same steps and select PCM. This will automatically update the TCM as well. See screenshots below

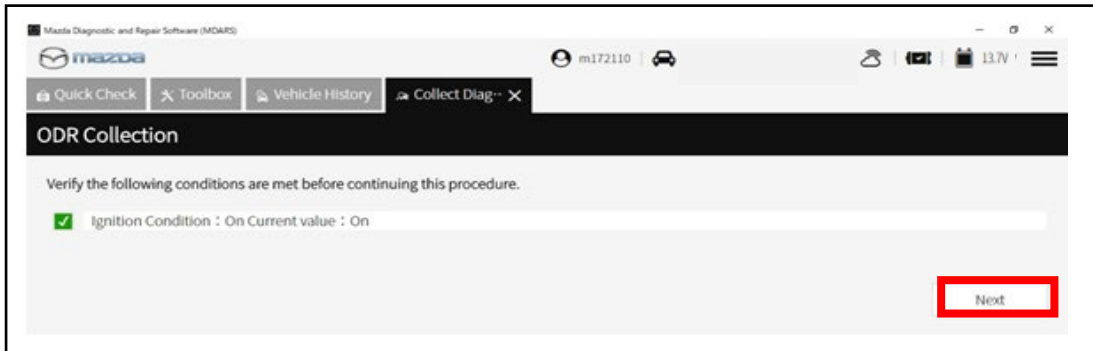
(2) Click 'Next'.
