# Quality Bulletin

**Recall RP1039: PS1 BCM2 Push Rod  
Model Year 2020 Polestar 1**

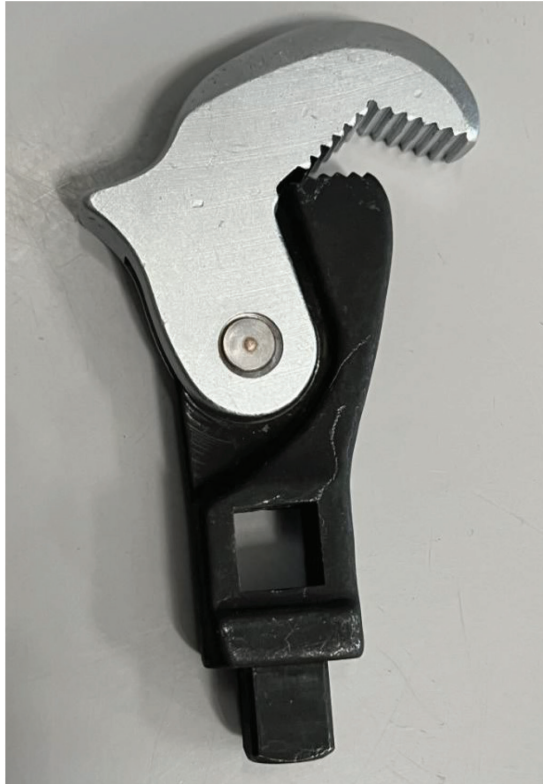
**Note:** There is a special tool required for this repair. However, due to the small population affected by this recall, the tool should only be ordered if needed. The tool needed is a crowfoot adjustable wrench (see below). This tool can be purchased [here](#):

[Amazon \(US\)](#) – Crowfoot adjustable wrench
