# Safety Recall

## N242471620 Momentary Rear Wheel Lock-Up or Low-Speed Change in Intended Direction

<b>Correction</b>	Dealers will update the transmission control module software calibration.

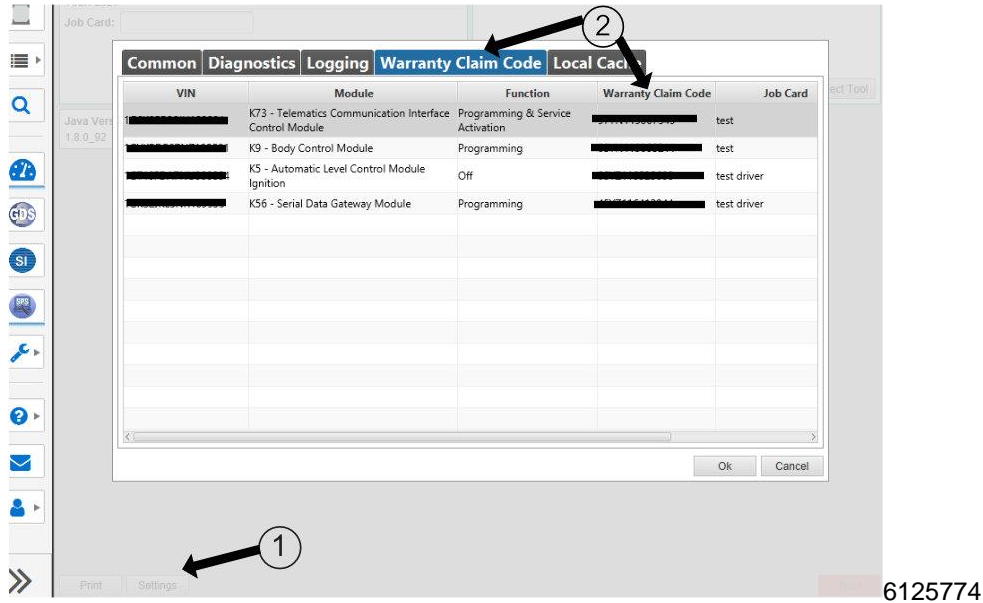
If the Warranty Claim Code was not recorded on the Job Card, the code can be retrieved in the SPS2 system as follows:

1. Open TLC on the computer used to program the vehicle.
2. Select and start SPS2.
3. Select Settings (1).
4. Select the Warranty Claim Code tab (2).

The VIN, Warranty Claim Code and Date/Time will be listed on a roster of recent programming events. If the code is retrievable, dealers should resubmit the transaction making sure to include the code in the SPS Warranty Claim Code field.

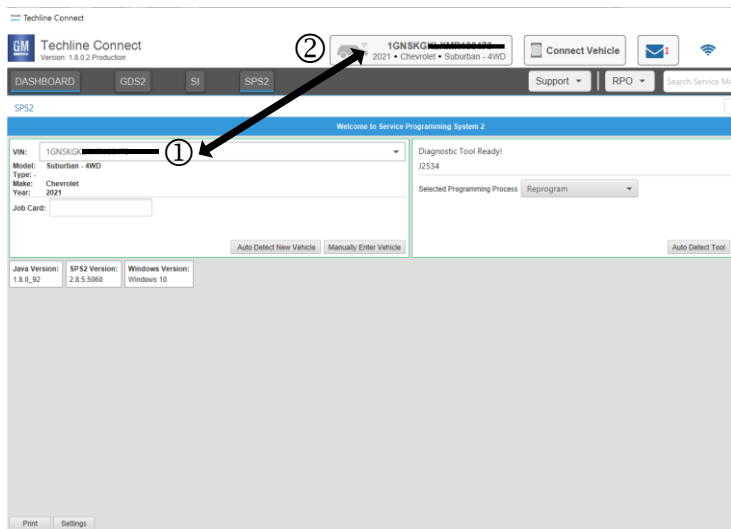
5743643

**Caution:** Be sure the VIN selected in the drop down menu (1) is the same as the vehicle connected (2) before beginning programming.

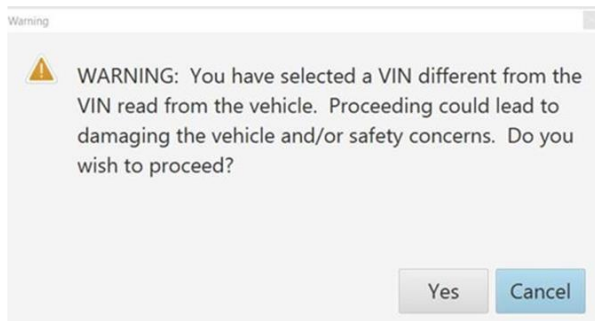
5877000

**Important:** If the vehicle VIN DOES NOT match, the message below will be shown.

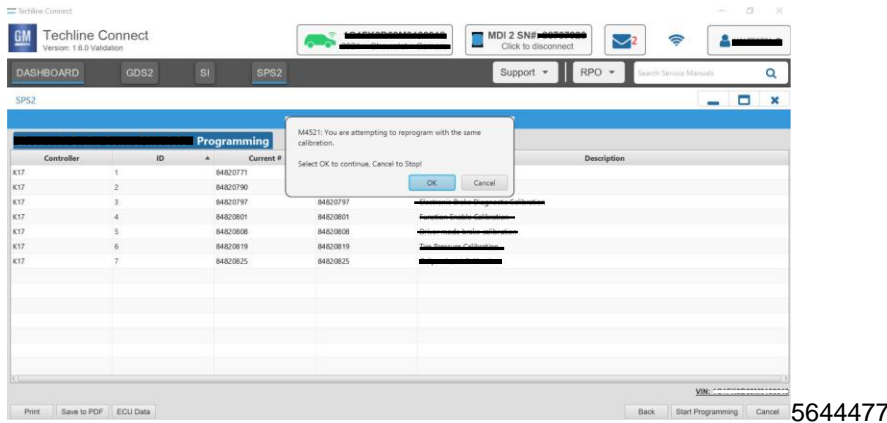
**Important:** Techline Connect screens shown above.

**Important:** If the same calibration/software warning is noted on the TLC Summary screen, select OK and follow screen instructions. After a successful programming event, the WCC is located in the Service Programming System dialogue box of the SPS Summary screen. No further action is required. Refer to the Warranty section of the bulletin.

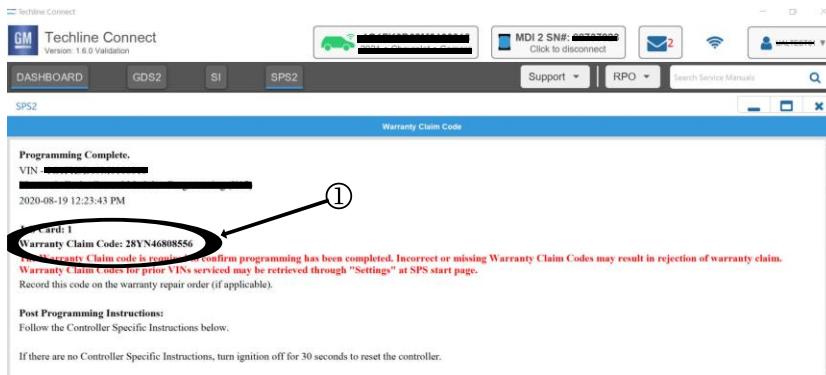
5644478

1. Reprogram the Transmission Control Module. Refer to *K71 Transmission Control Module: Programming and Setup* in SI.

**Note:** The screenshot above is an example of module programming and may not be indicative of the specific module that is being programmed. Module selection and VIN information have been blacked out.
