GROUP	MODEL
Safety Recall Campaign	2022-2024MY EV6, EV6 GT (CV)
NUMBER	DATE
SC327	November 2024

### ICCU AND FUSE INSPECTION/REPLACEMENT AND ICCU SOFTWARE UPGRADE (SC327)

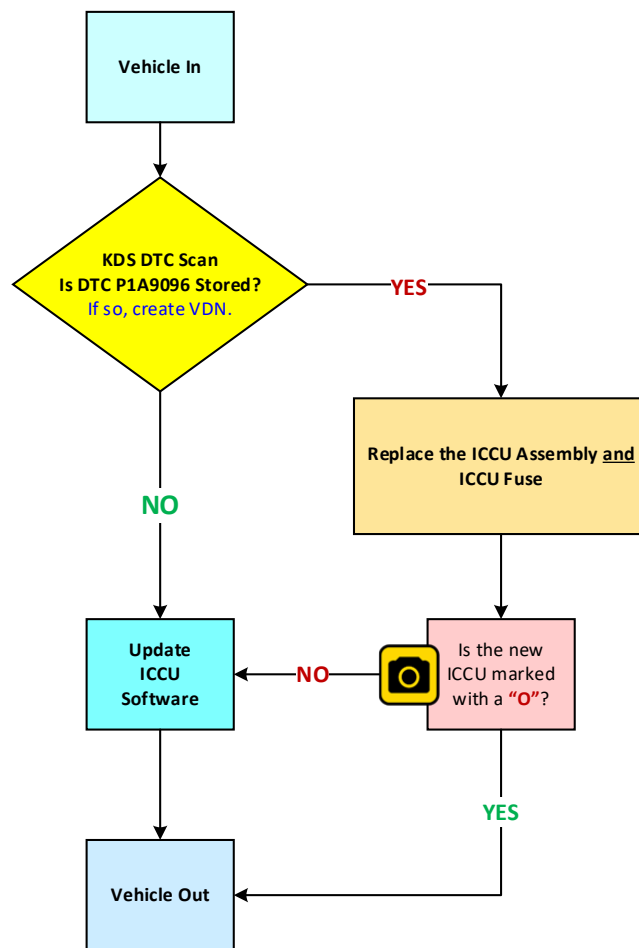
**Flowchart:**

**Using KDS, scan the vehicle for DTC P1A9096 - Is DTC stored?**

- If DTC is not stored, update the ICCU software (Pages 3-4).
- If DTC is stored, replace the ICCU Assembly + ICCU Fuse (Page 5)

**DTC P1A9096 Stored + ICCU Assembly and ICCU Fuse Replacement**

**Is the 'new' ICCU Assy marked with a letter "O"?**

- No - Take a KDS Warranty Attachment photo of ICCU NOT marked "O" + Update the ICCU software (Pages 3-4)
- Yes - Vehicle Out

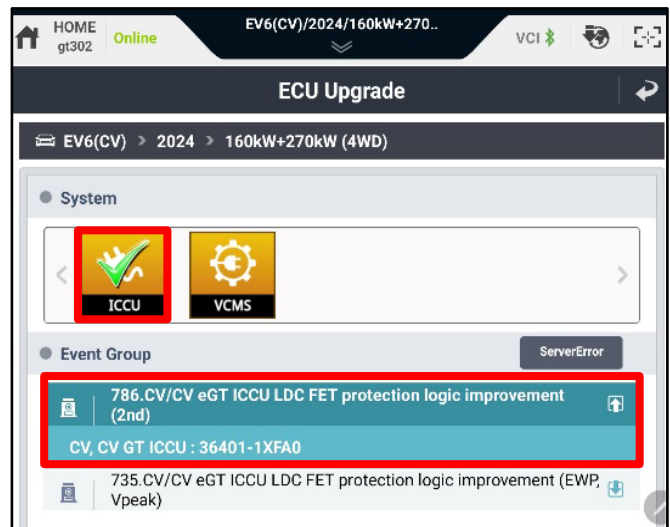
Refer to [TSB SST081](#) for instructions to upgrade the 'ICCU' system:

**UPGRADE EVENT:**

#786.CV/CV eGT ICCU LDC FET Protection Logic Improvement (2nd)

**NOTICE**

**Prior to performing the ECU upgrade, be sure to check that the KDS is fully charged.**

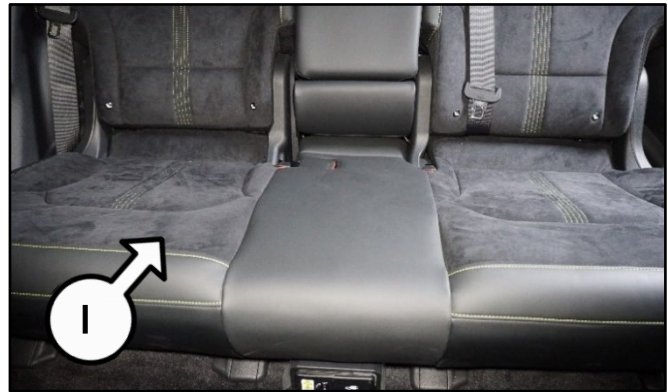
11. Remove the rear seat assembly (I) by referring to "Body Interior and Exterior → Rear Seat Assembly → Removal and Installation" in the applicable Shop Manual on KGIS.

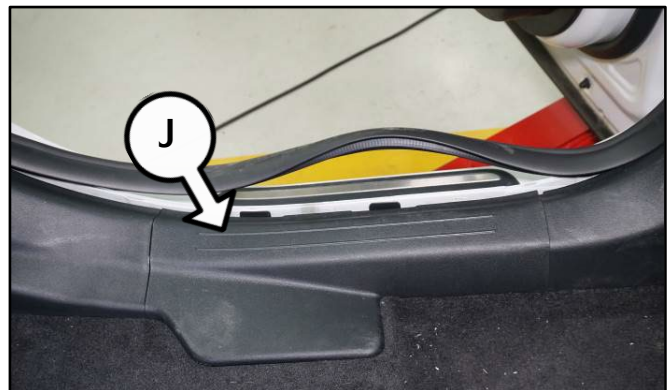
12. Remove the left (LH) and right (RH) side rear door scuff trim (J).

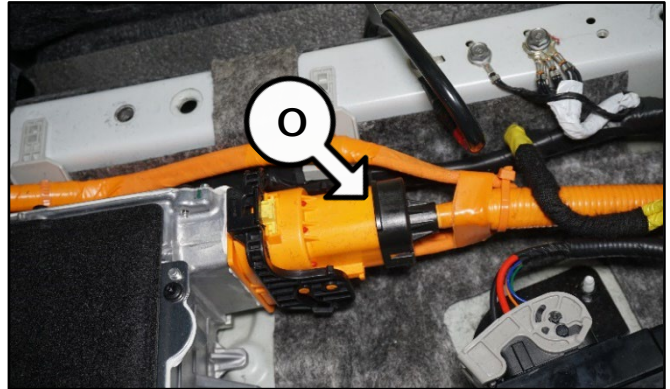
- 17. Disconnect the combo charge inlet wire harness connector (O).
