# Service Bulletin

CRF1100L/LD/L4/L4D #3  
November 2024

## SAFETY RECALL

### 2022, 2024, 2025 CRF1100L/LD/L4/L4D Africa TWIN PGM-FI Unit Update

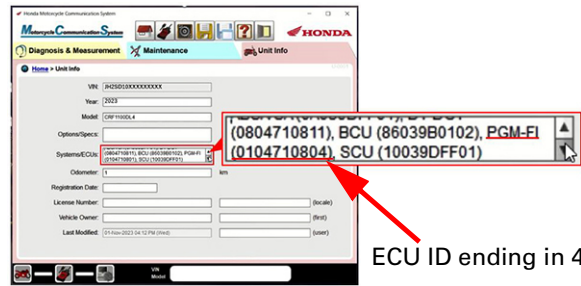
The ECU ID can be verified to ensure an affected unit has been repaired by connecting an MCS and reviewing the Systems/ECUs section of the Unit Info tab.

The ECU ID should end in a 4 after the ECU has been rewritten according to this service bulletin.

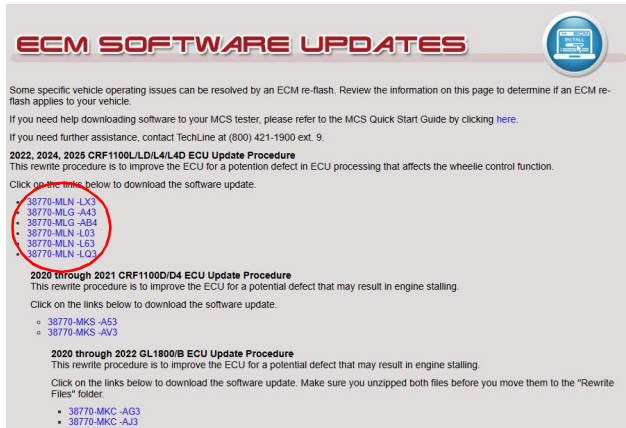
1. Navigate to the ECM Software Updates page on *iN* by following this path:  
***iN* > Service > TechLine > TechLine > Diagnostic Tools > MCS > ECM Software Updates**
2. Click the link **2022, 2024, 2025 CRF1100L/LD/L4/L4D ECU Update Procedure** to download the software.

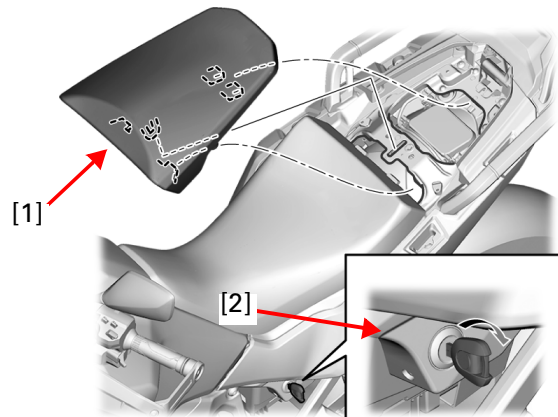
1. Connect the MCI to the computer using the USB cable.
2. Locate the DLC connector by unlocking the pillion seat [1] using the key [2]. Remove the pillion seat.
  - Refer to the service manual for instructions.

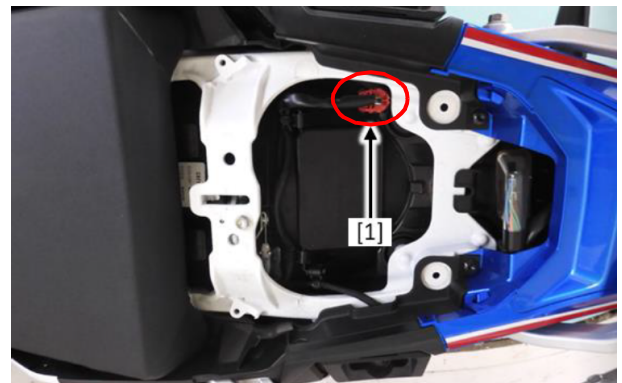
3. Remove the dummy connector from the DLC connector [1], and then connect the MCI to the DLC connector.

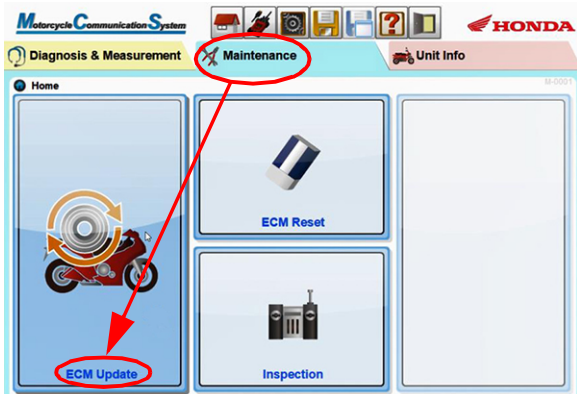
2. Select the Maintenance tab then ECM Update.

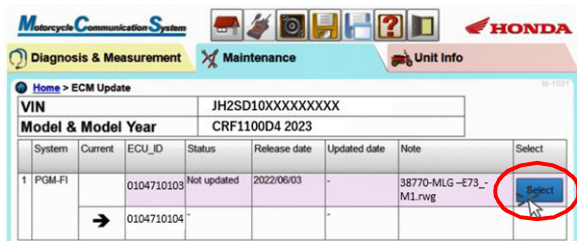
3. Select the PGM-FI file from the table as shown, click the Select button next to the software revision file.

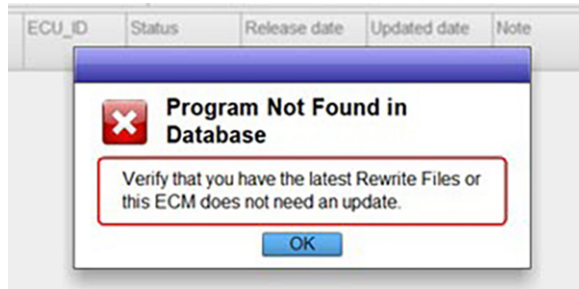
**Note:** If files are not saved correctly, an error may appear like shown below. Check the files are uploaded in the correct location (see Download the ECM Update File section above).

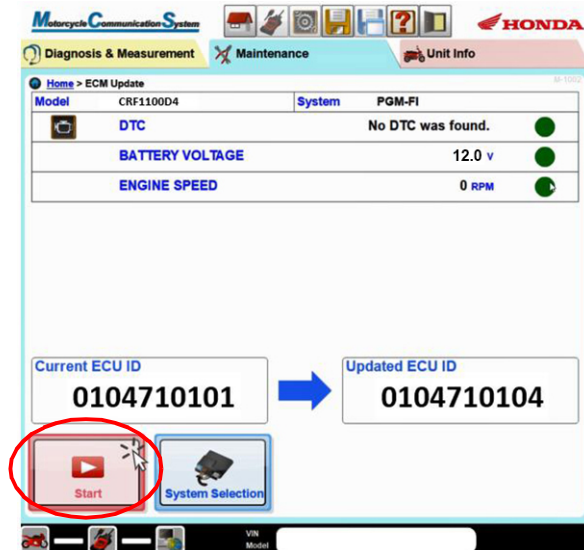
4. When the Updated ECU ID information populates on-screen as shown, click the Start button.

**Note:** ECU ID numbers will change for each vehicle type. The numbers shown below are for example only. The PGM-FI rewrite process will take approximately four minutes, indicated with a progress bar in green.

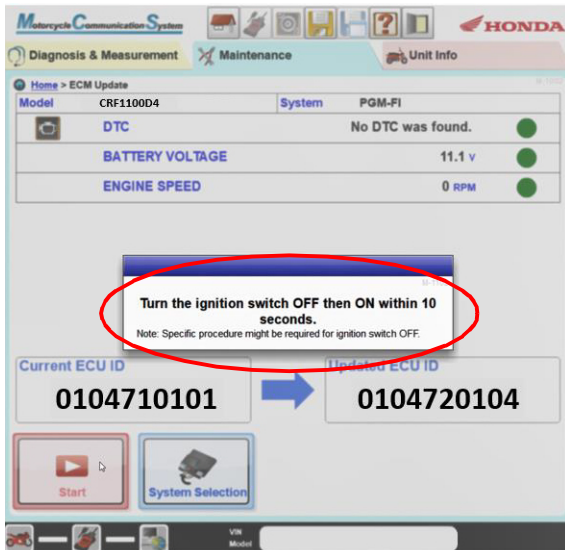
- Once the rewrite process is complete, turn the ignition switch to the OFF position and back ON within ten seconds.

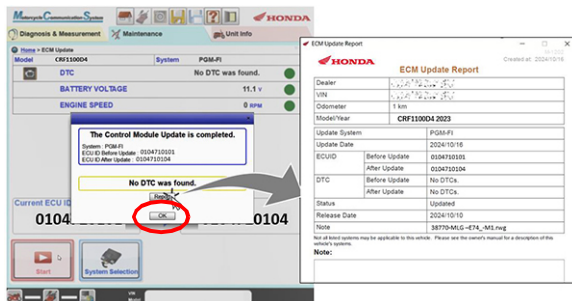
- When the **Control Module Update Completed** window appears, click **OK**.

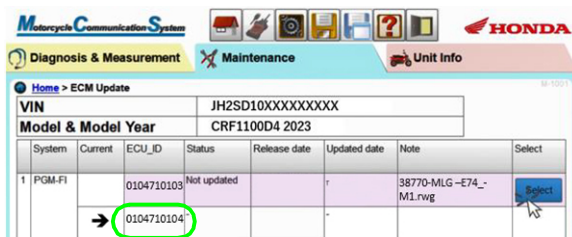
The ECU ID should change from 0104710101 (depending on the model and year) to 0104710104.

The leading eight (8) digits of the ECU ID will vary based on the model and year.
