ARC5 – Re-Coding Main Control Unit for Body Electronics (HCP4) and Control Unit for Headlights (Recall Campaign)

Model Year: **As of 2024 up to 2025**

Model Line: **Macan Electric (XAB)**

Concerns: **Main control unit for body electronics (HCP4) and headlight control units (MX1, MX2, MX14, MX15)**

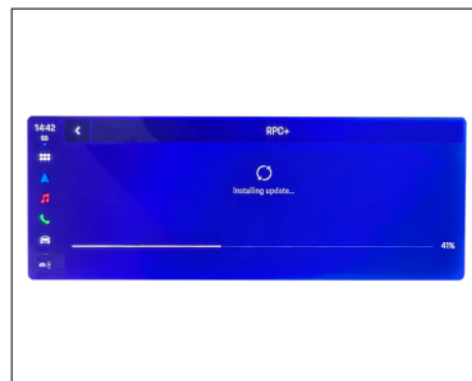
If WiFi coverage is insufficient, the connection between the PIWIS Tester and VCI may be interrupted (battery charge indicator inactive on the Tester display at the top right). The vehicle will nevertheless continue the update **independently**. In the meantime, no entry must be made on the PIWIS Tester, and the programming or coding must not be restarted. In such a case, the progress of the update can still be followed inside the vehicle via the central display by activating the **“Messages”** tile.

Update progress on central display
